JTBO0595NAS2

**TECHNICAL BULLETIN**

501-08

Windshield Finisher Loose

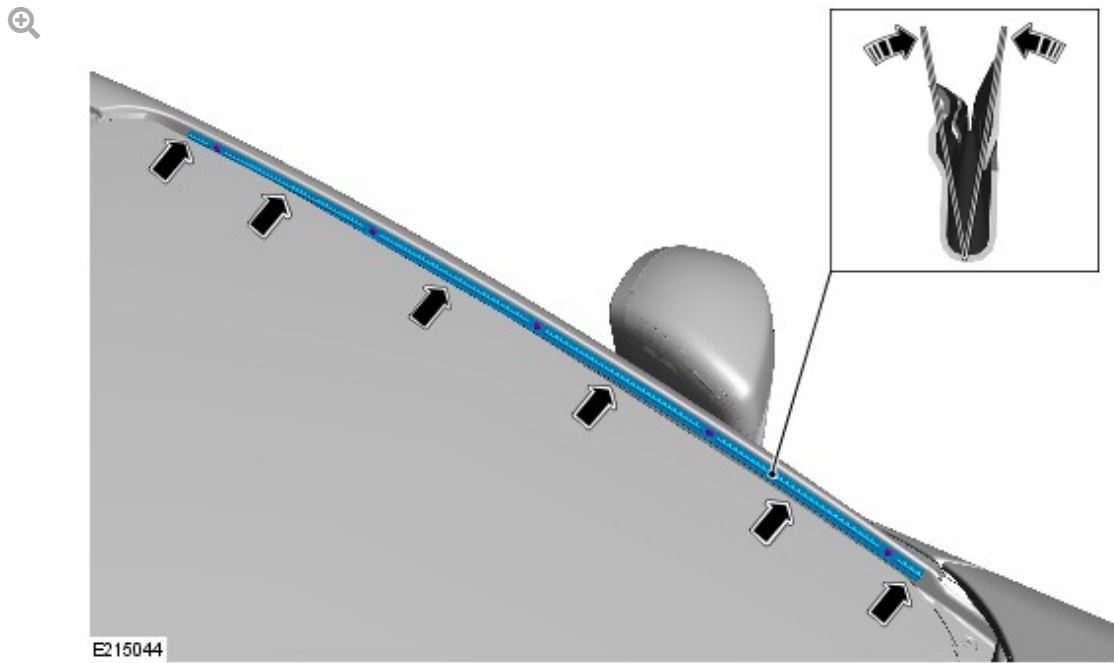
2.

Windshield finisher retaining channel not retaining the windshield finisher correctly.

At the 6 positions shown, close the internal dimension of the windshield finisher retaining channel on the A-pillar.
