LTB01287NAS4

TECHNICAL BULLETIN

04 DEC 2020

Vibration Felt In Passenger Compartment When Starting and/or Idling Engine

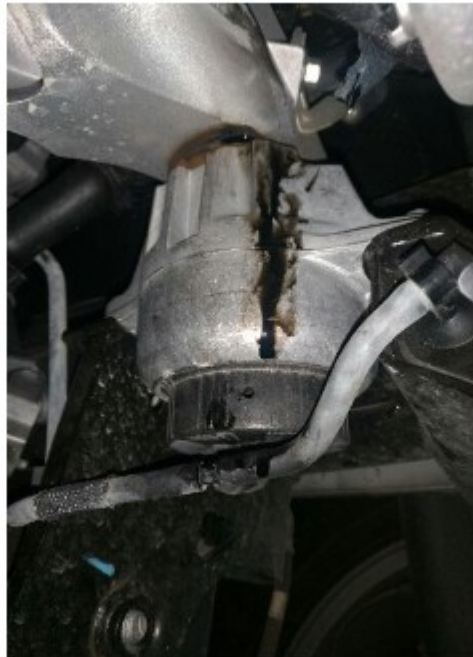
E246391

For the release of the new active engine mounts, the parts team will require a photograph of the damaged/leaking active engine mounts. Make sure a clear photograph is taken, with the active engine mount still installed to the vehicle, as shown in the illustration.

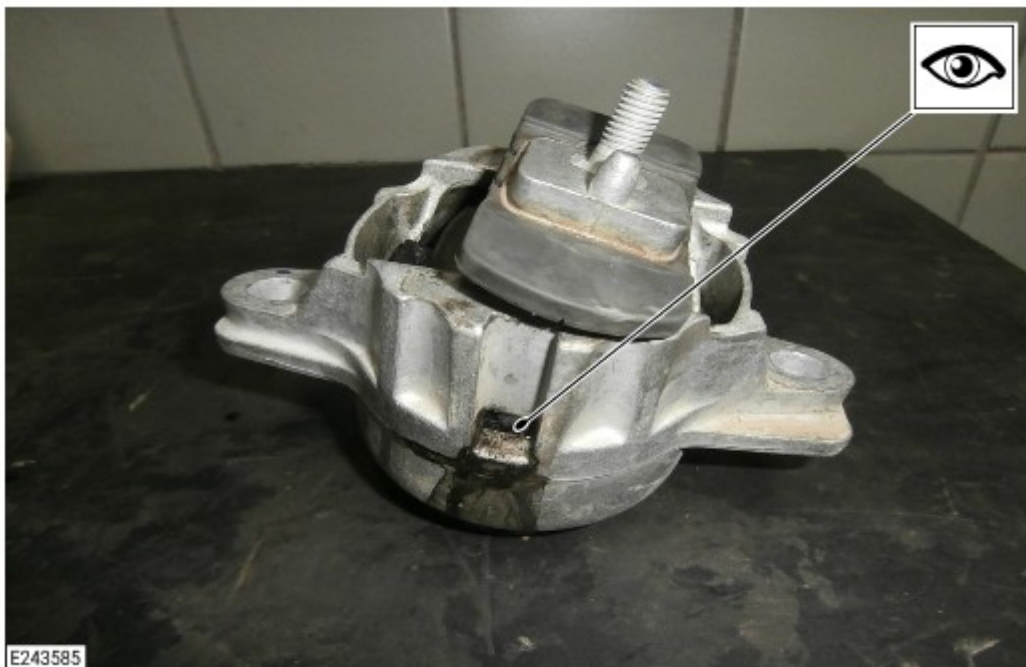
2.

Example photograph of an excessively worn and/or leaking active engine mount.

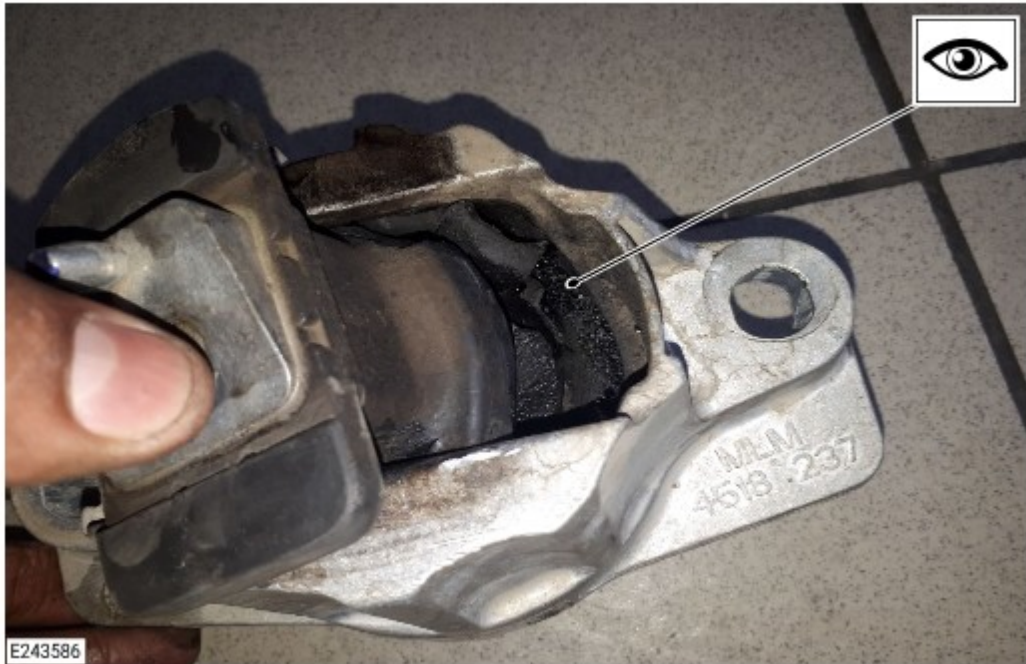
3.

Example photograph of an excessively worn and/or leaking active engine mount.

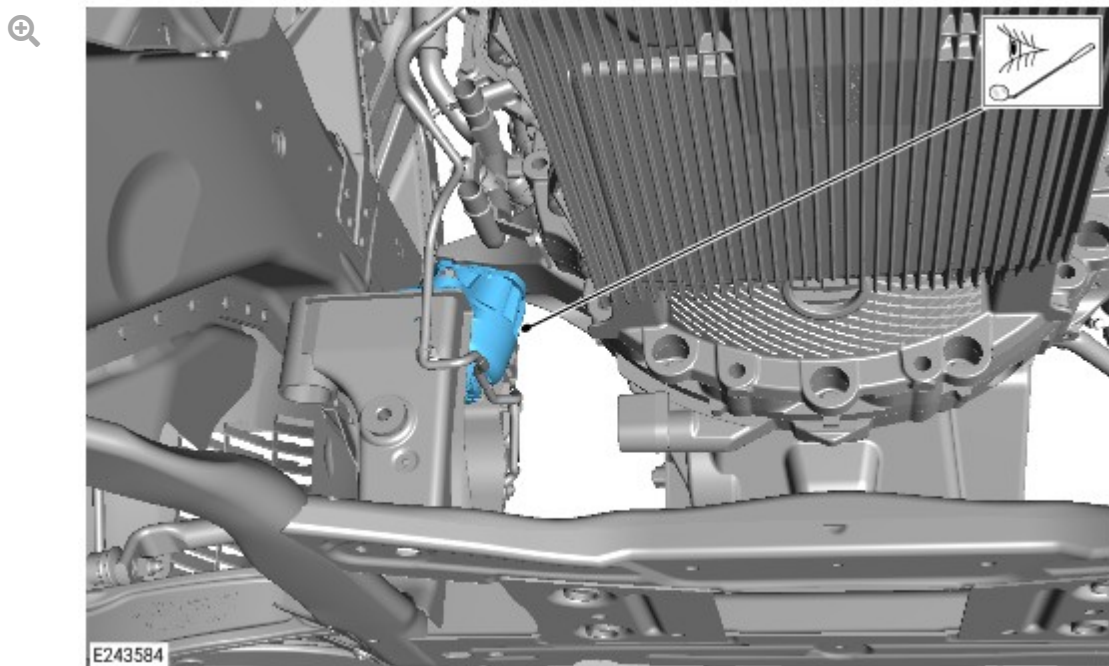
Inspect the active engine mount for signs of excessive wear and/or leaking fluid.

- ■ If **both** active engine mounts show **no** signs of excessive wear and/or leaking fluid, **do not continue with this technical bulletin**, as the content of this technical bulletin does not directly relate to the customer's concern. Continue to diagnose the vehicle using the TOPlx workshop manual, (see TOPlx workshop manual section 303-00: Diagnosis and Testing - Engine).
- ■ If **any** of the active engine mounts show **any** signs of excessive wear and/or leaking fluid, **continue to step 3**.

3. Renew **both** active engine mounts, (see TOPlx workshop manual section 303-01: Removal and Installation - Left/Right Engine mount).
