N472NAS3

# TECHNICAL BULLETIN

Service Action: Windshield Molding Tapping Noise

MODEL:	MODEL YEAR:	VIN:
Defender (LE)	2020	000584-008252

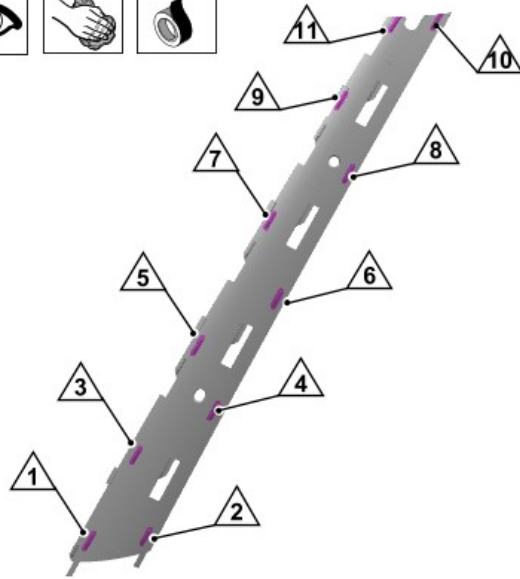
E266562

Locate the 11 windshield molding retaining ribs as shown highlighted.

- Clean the area around each windshield molding retaining rib.
- Apply felt tape to cover each of the 11 windshield molding retaining ribs as shown.

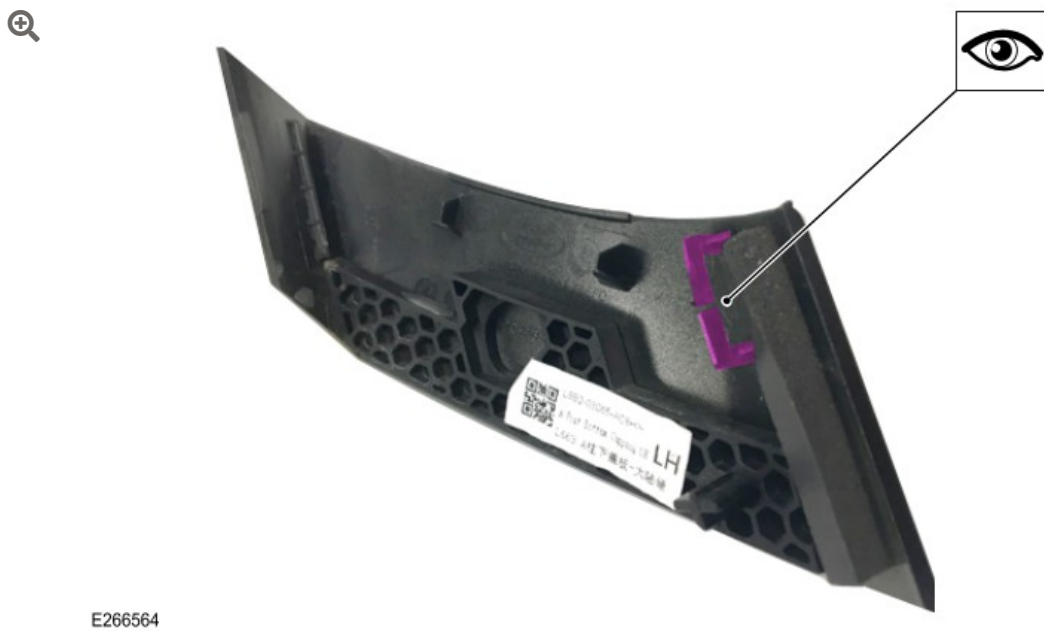
Inspect the retaining clip on the windshield molding bolt cover.

- If the retaining clip **is** broken, as shown highlighted, install a new windshield molding bolt cover during the next step.
- If the retaining clip **is not** broken, install the original windshield molding bolt cover during the next step.
