HYUNDAI Technical Service Bulletin	GROUP Body	NUMBER 20-BD-020H
	DATE December, 2020	MODEL(S) Sonata (DN8a)

SUBJECT: FRONT DOOR MODULE ASSEMBLY REPLACEMENT

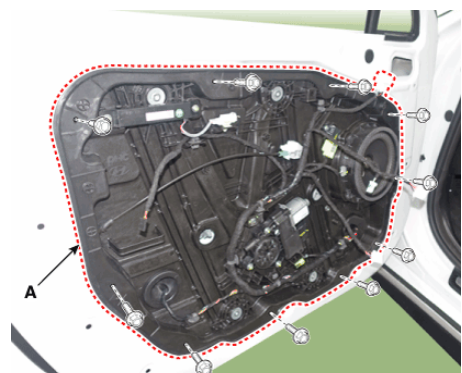
- If the front door window cannot close or if the door regulator cables are separated from the regulator track, replace the front door module.

Refer to the shop manual to replace the front door module.
