<b>HYUNDAI</b> <b>Technical Service Bulletin</b>	GROUP <b>BODY ELECTRICAL</b>	NUMBER <b>20-BE-014H</b>
	DATE <b>DECEMBER, 2020</b>	MODEL(S) <b>VARIOUS</b>
<b>SUBJECT: WIRELESS CARPLAY DISCONNECTION</b>

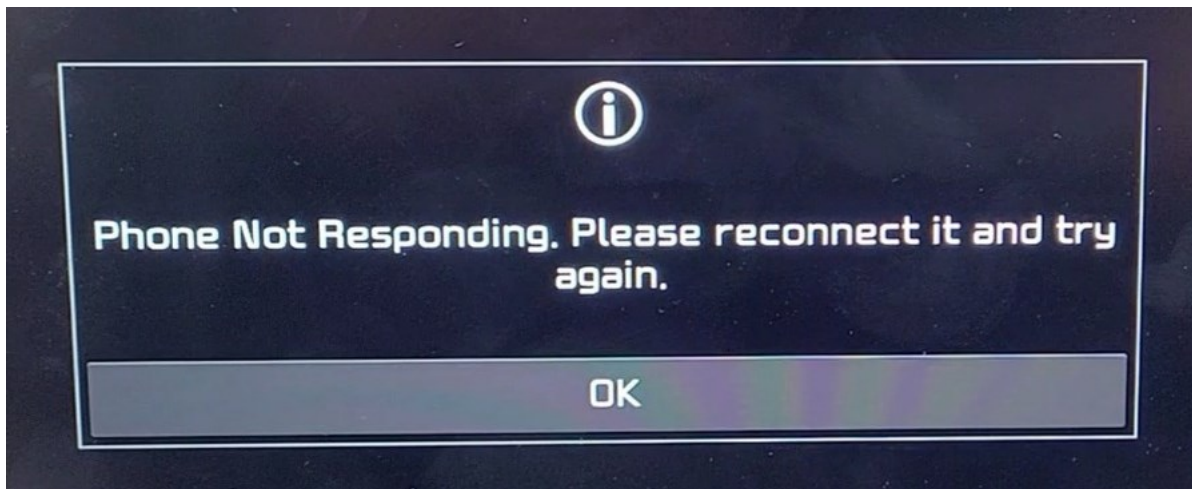
**Description:** When using Wireless CarPlay, the system may intermittently auto disconnect. When Wireless CarPlay is disconnected, a pop up message “Phone Not Responding. Please reconnect it and try again” will appear on the radio screen.

**Note:** If the intermittent Wireless CarPlay disconnection occurred, do not replace the radio. The disconnection phenomenon is caused by the Apple IOS software. Apple IOS software intermittently pause the data transmission, causing the communication interruption between the radio and CarPlay.
