SERVICE BULLETIN

Classification: HA20-002	Reference: NTB20-098	Date: December 23, 2020
-----------------------------	-------------------------	----------------------------

2017-2018 ROGUE SPORT; NO AIR FLOW FROM HVAC VENTS DUE TO SNOW BUILD-UP

APPLIED VEHICLES: 2017-2018 Rogue Sport (J11)

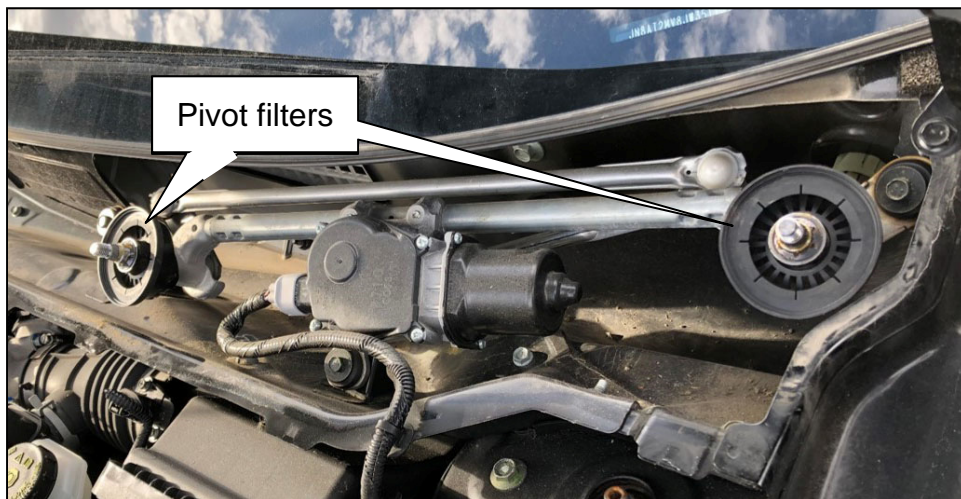
Figure 1

Make sure to install both wiper pivot filters. If the wiper pivot filters are not installed, snow may enter the blower motor inlet and cause damage to the blower motor.

1. Remove all snow, water, and any debris from the HVAC intake, cowl area, and where the blower motor mounts.
 - For removal of the cowl top cover and related parts, refer the Electronic Service Manual (ESM), section **BODY EXTERIOR, DOORS, ROOF & VEHICLE SECURITY – EXTERIOR – REMOVAL AND INSTALLATION – COWL TOP**.
2. Clean or replace the blower motor as needed.
3. If not already equipped, install a wiper pivot filter on each wiper pivot (see Figure 1).
 - See **PARTS INFORMATION** on the last page of this bulletin.

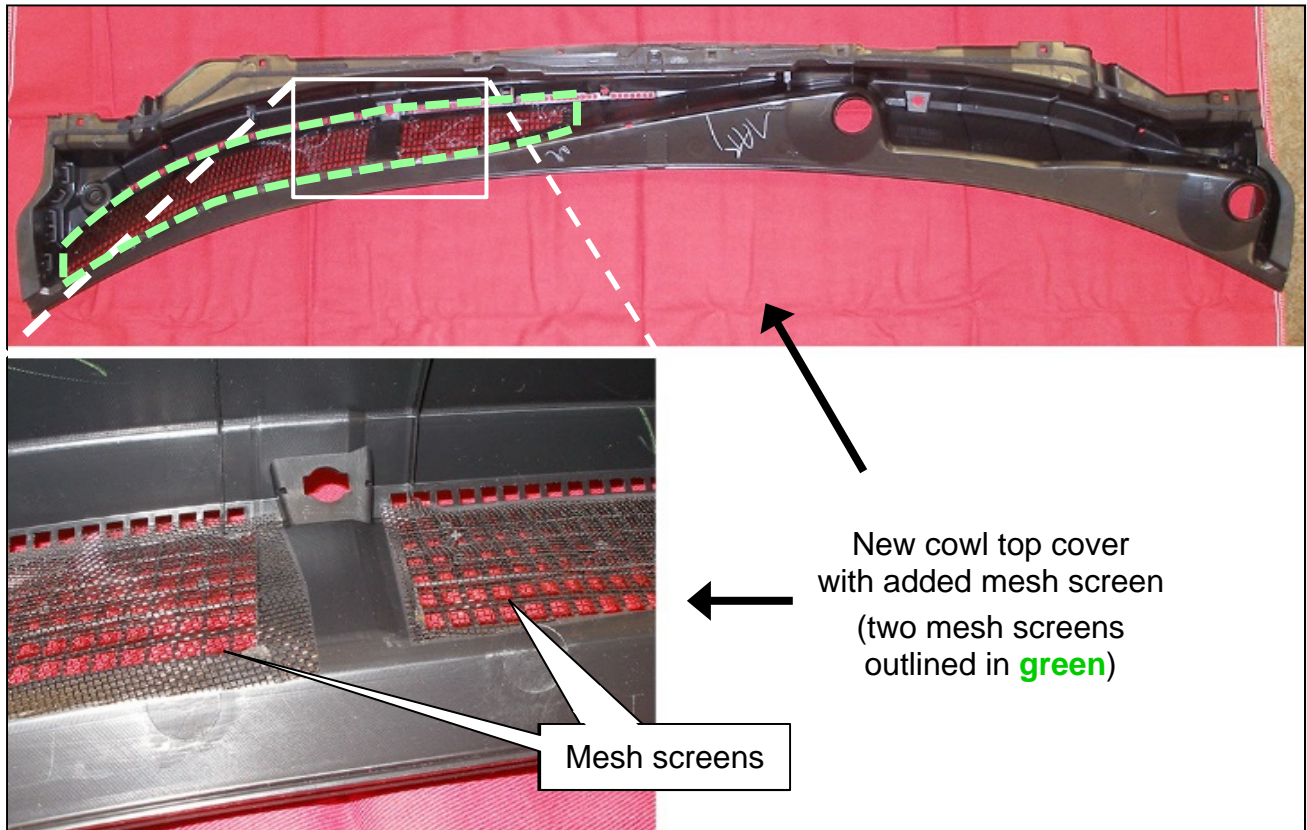
Figure 2

Make sure to install the new cowl top cover listed in the **PARTS INFORMATION**. If the new cowl top cover is not installed, snow may continue to enter the blower motor inlet and cause damage to the blower motor.

4. Reassemble the vehicle using the new cowl top cover listed in the **PARTS INFORMATION**.
