CAMPAIGN BULLETIN

Rear Combination Lamp Dealer Inventory

Reference: PC746

PC746 2020 TITAN REAR COMBINATION LAMP

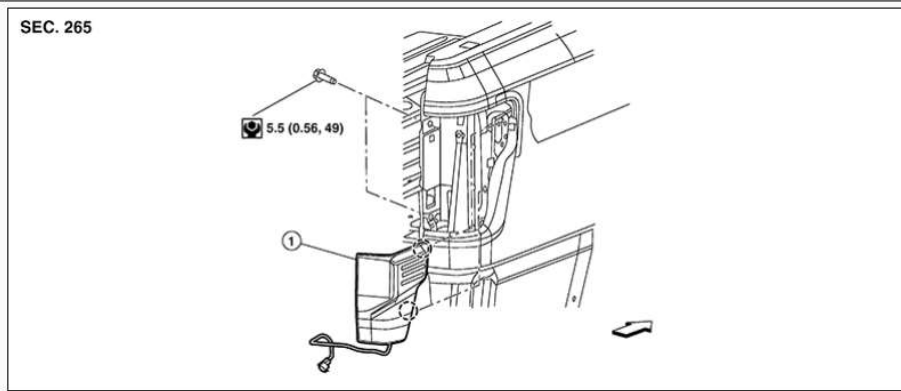
Exploded View

Nissan is conducting a dealer inventory quality action to replace both rear combination lamps on **697** specific 2020 Titan vehicles identified in Service Comm. Due to a supplier issue that has since been resolved, the tail light function of the Rear Combination Lamp on Light-emitting diode (LED) equipped vehicles may not illuminate under certain conditions during vehicle start-up.

1. Replace both rear combination lamps.
 - Refer to the Electronic Service Manual (ESM) procedure for removal and installation of the rear combination lamps. **DRIVER CONTROLS - EXTERIOR LIGHTING SYSTEM - LED HEADLAMP - REMOVAL AND INSTALLATION - REAR COMBINATION LAMP**

1.	Rear combination lamp	⊙	Pawl	←	Front
----	-----------------------	---	------	---	-------

NOTE:
RH shown, LH similar.
