CAMPAIGN BULLETIN

Transverse Link Inspection Dealer Inventory

Reference: PC767

Nissan is conducting a dealer inventory quality action to inspect and, if necessary, replace the right and/or left Transverse Link (TV) on **5,472** specific 2020 Murano vehicles identified in Service Comm. Due to a supplier issue that has since been resolved, the subject vehicles may have been produced with incorrectly forged transverse links that could reduce the structural integrity of the transverse links.

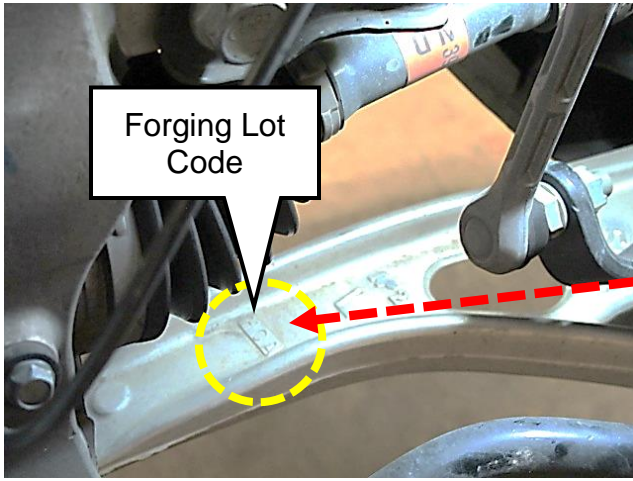
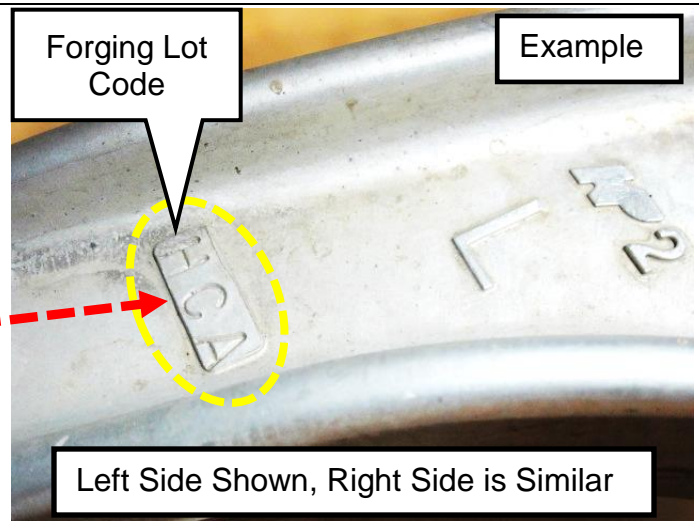
4. Locate three-digit TV Link Forging Lot code on the top side of both TV Links. (Figures 4 & 5)

6. Are the first two digits of the forging lot code one of the following listed below?

LH (Driver side) **GF**

RH (Passenger side) **GH** or **GL**

- **YES = SUSPECT**, Continue to Step 7 to inspect for machining deformation and lap condition on the TV Links.
- **NO = GOOD**, Do NOT replace the TV Links. Continue to Step 9 to reinstall the wheel and tire assemblies.

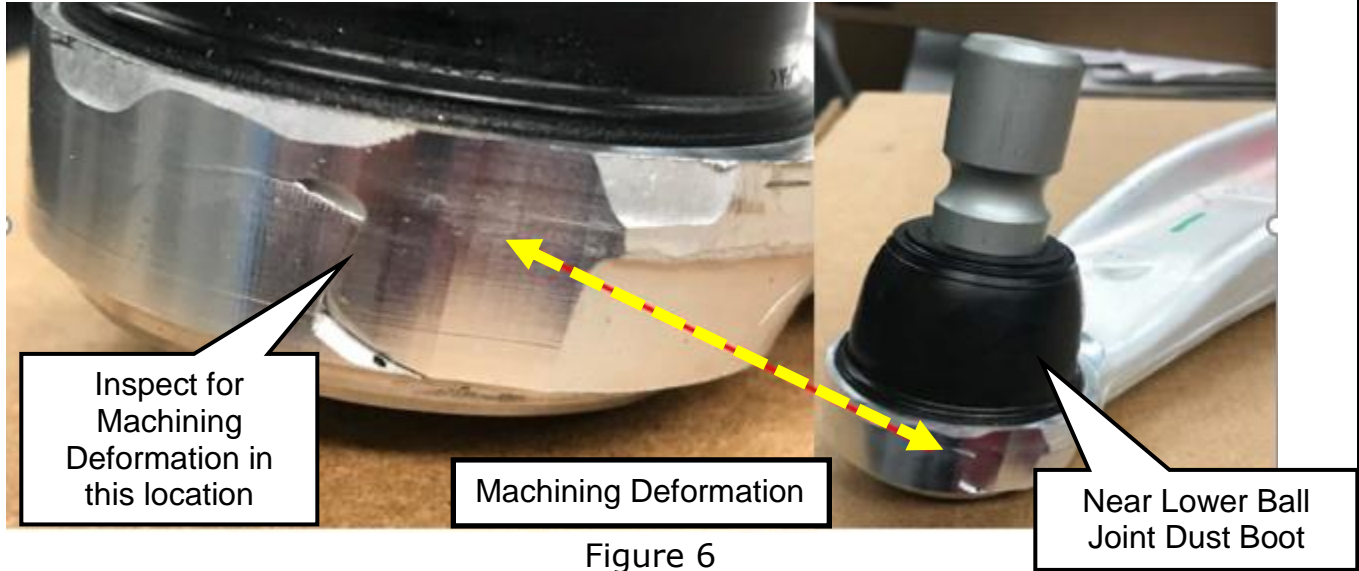
Figure 6

7. Inspect both TV Links for two conditions below (Figures 6 & 7):

- **Machining Deformation**

8. Does either of the TV Links have machining deformation or a lap condition?

- **NO = GOOD**, Do NOT replace the TV Links. Proceed to Step 9 to reinstall the wheel/tire assemblies.
- **YES = NG**, Do NOT submit a warranty claim, provide clear photos of the affected TV Link condition to FQA using the information below and **HOLD** the vehicle until further notice.
 - a. Take clear pictures of the VIN certification label, the TV Link forging lot code, and if applicable the machining deformation and/or lap condition
 - b. Email photos to nnafqasupport@nissan-usa.com
 - c. Make sure to include the below information:
 - E-Mail Subject Line: PC767 Murano TV Link Inspection
 - Dealer Name:
 - Dealer Code:
 - Dealer Address:
 - VIN:
 - Contact Person Name:
 - Contact Person Phone Number:

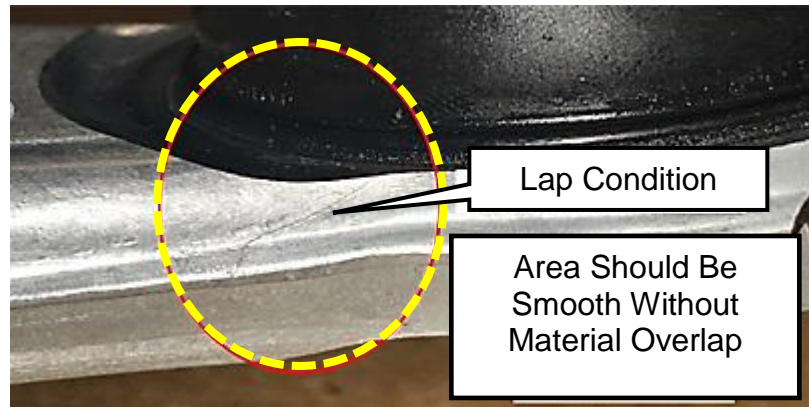
Figure 7

- **Lap Condition**
