# QUALITY ACTION

## CAMPAIGN BULLETIN

### Front Turn Signal Lamp Dealer Inventory

Reference: PM965  
Date: December 23, 2020

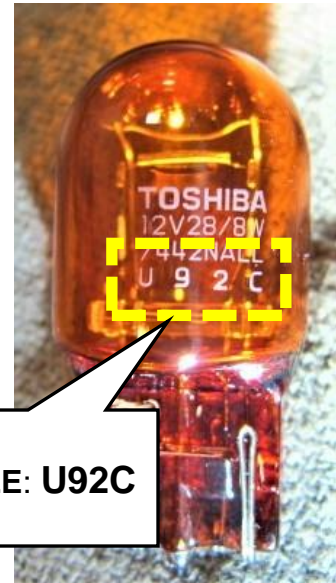
5. Locate the Lot Code of left and right front turn signal lamp bulbs then write both bulb lot codes on the Repair Order.

- Four digit alpha numeric code shown in Figure 7
- Use of a light source may help to read the lot code

6. Does either of the front turn signal lamp bulbs have **NO GOOD** lot code **X9ZR?**

- **YES > Replace** the bulb/s that have a **NO GOOD** lot code. Continue to Step 7.
- **NO > Do NOT replace bulbs.** Proceed to Step 8-11 to reassemble the vehicle.

**IMPORTANT: Only replace bulbs that have lot code X9ZR.**
