# TECHNICAL SERVICE BULLETIN

Technical Service Bulletin: 83-1266

Forest River is alerting you to an issue involving certain 2021 Impression Fifth-Wheel Trailer Recreational Vehicles. Please see the information below, which describes the issue and provides you with details on the steps you should take to have your vehicle repaired.

# TECHNICAL SERVICE BULLETIN 83-1266 REMEDY INSTRUCTIONS

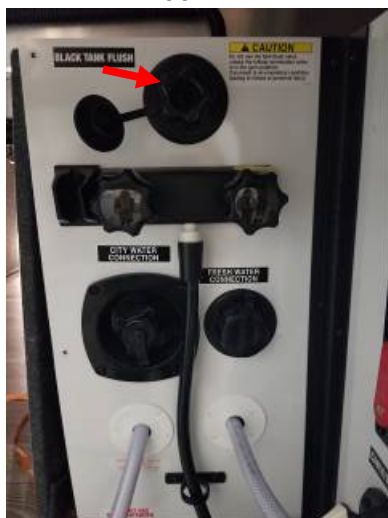
- THE RED ARROW IN FIGURE 1 INDICATE THE BLACK TANK FLUSH FITTING IN THE WATER MANAGEMENT SYSTEM.

STEP 1: ENSURE THERE IS NO WATER HOOKED UP TO THE "BLACK TANK FLUSH" CONNECTION IN THE "WATER MANAGEMENT SYSTEM". IF THERE IS, DISCONNECT AND ALLOW TO DRAIN (FIGURE 1);

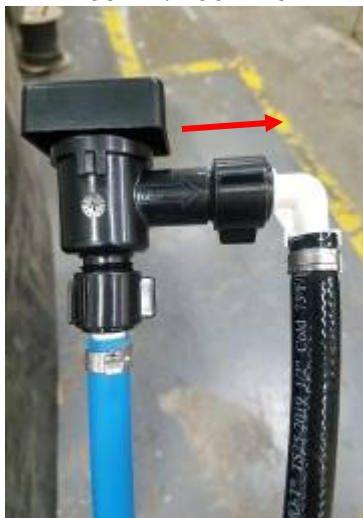
FIGURE 2/INCORRECT

The black tank flush feature is plumbed incorrectly, which will not allow flushing of the black tank.

STEP 3: LOCATE THE BLACK TANK FLUSH VALVE. THIS VALVE WILL HAVE A BLACK HOSE AND A BLUE WATER LINE CONNECTED TO IT. THE CONNECTION SHOULD LOOK LIKE FIGURE 2, WHICH IS PLUMBED INCORRECTLY;

STEP 5: REMOVE THE BLUE WATER LINE AND THE BLACK HOSE FROM THE BLACK TANK FLUSH VALVE;
