# Preliminary Information

## PIT5626C Intermittent Communications Concerns - Possible Multiple MILs on U0073 or Multiple U-Codes Stored

Brand:	Model:	Model Years:	VIN:		Engine:	Transmissions:
			from	to		
Chevrolet	Colorado	2016 - 2021	All	All	LCV	All
GMC	Canyon	2016 - 2021	All	All	LCV	All

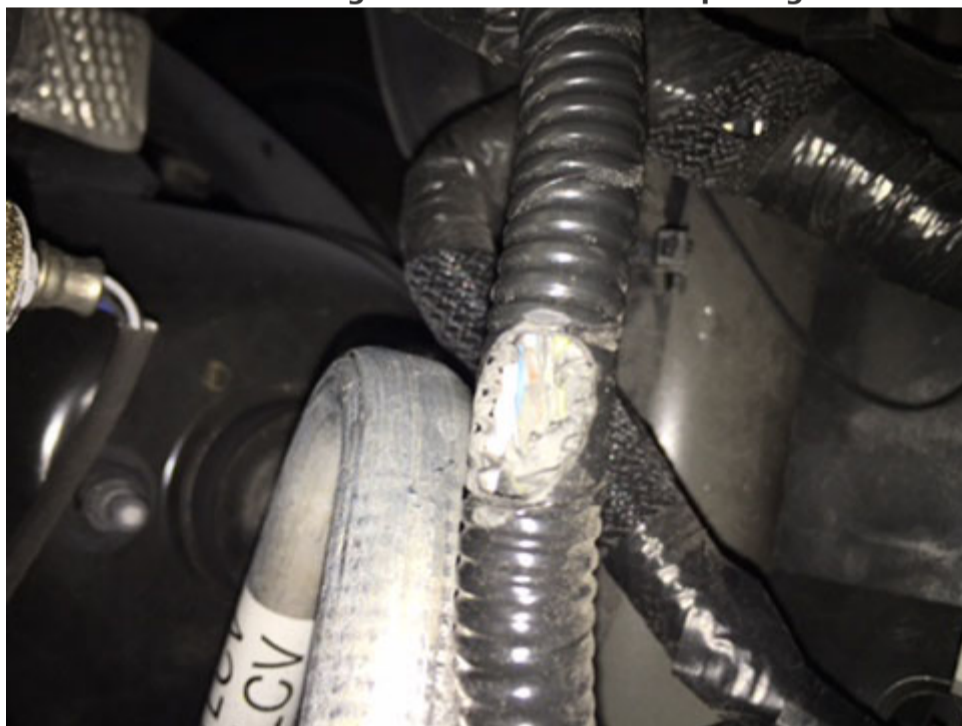
<b>Involved Region or Country:</b>	<b>North America</b>
<b>Condition:</b>	<b>Intermittent multiple MIL's or messages, loss of communication, potential U-codes.</b>
<b>Cause:</b>	<b>Main harness chaffed under hood.</b>

Check for harness chaffing on the low side A/C pipe, left side below the exhaust manifold. This is best observed through the left wheel well opening.

Repair per instructions in SI and secure harness away from the pipe.
