Preliminary Information

PIP5764A 3.0L Diesel with DTC P2B60, P26C0 and/or P26BB

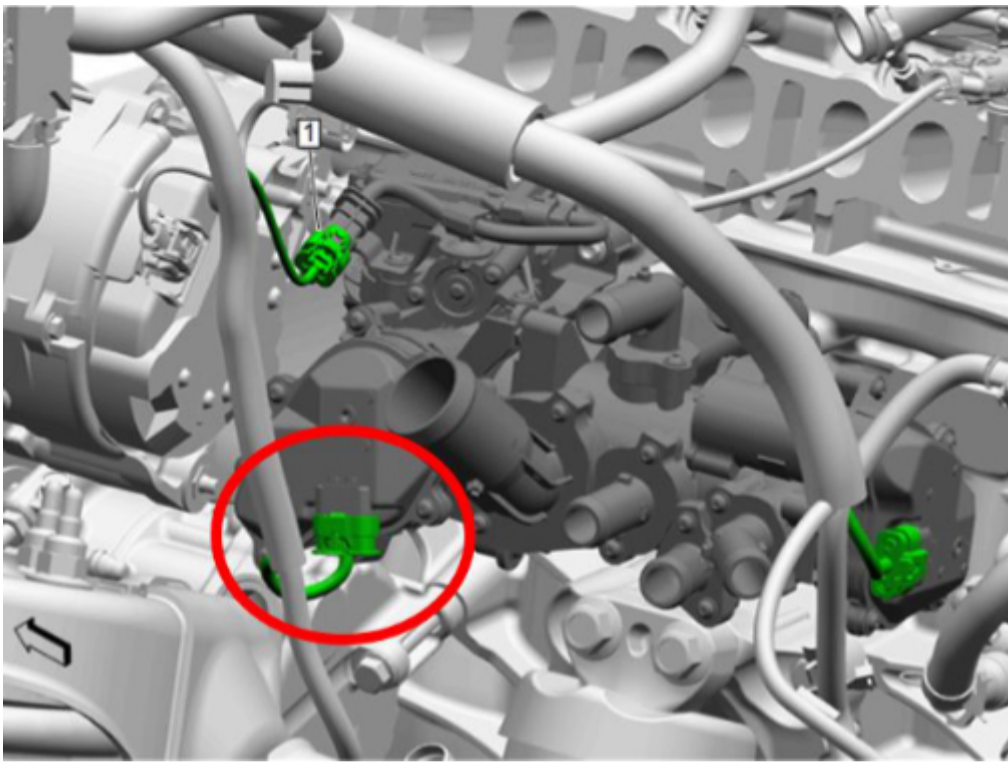
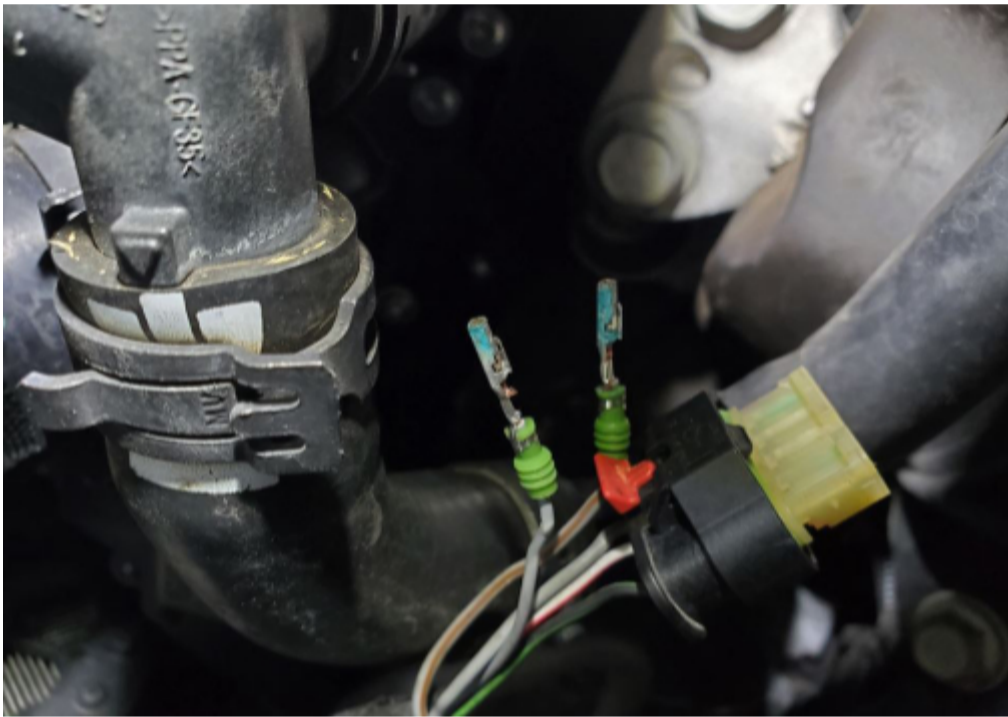
Involved Region or Country	North America
Condition	SES Light On with DTC P2B60, P26C0 and/or P26BB set.
Cause	Possible terminal corrosion in the Coolant Flow Control Valve Actuator harness connector

1. Inspect for corroded terminals at the Flow Control Valve Actuator connector (it's the center actuator circled below). If corrosion on the terminals is found, replace the harness connector and inspect the Flow Control Valve Actuator pins for corrosion damage.
2. If the actuator pins are also corroded, replace the Coolant Control Valve.
3. If there is no corrosion on the connector terminals or the pins, continue with normal SI diagnostics.
