PIP5772 Reduced Engine Power and DTC P200C Set

Brand:	Model:	Model Years:	VIN:		Engine:	Transmissions:
			from	to		
Cadillac (Russia)	XT4	2020 - 2021	All	All	2.0L (LSQ)	All

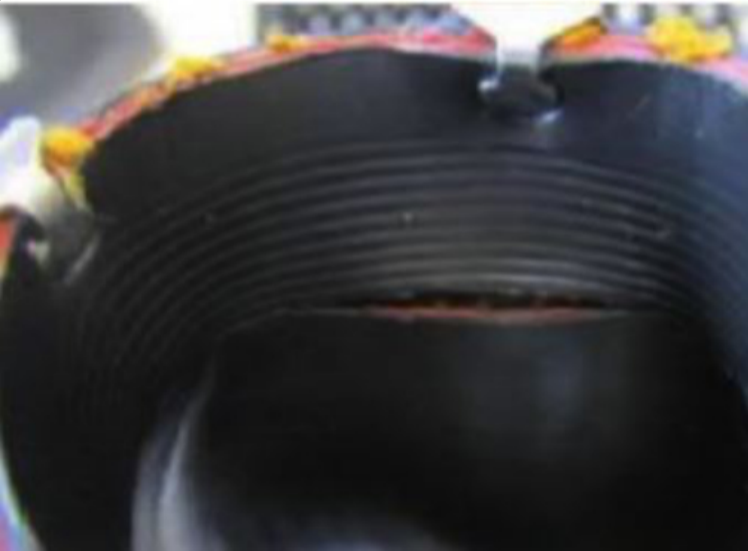
Involved Region or Country	Europe and Russia
Condition	A customer may complain of reduced engine power, a Service Engine Soon light displayed on the driver information center and a P200C may be set.
Cause	<p>The inside of the Charge Air Cooler Inlet Air Hose may be a cut (see the photo below).</p>

Follow P200C diagnostic and if damaged, replace the hose.
