Preliminary Information

PIT5713A SES MIL / IPC Gauges Sweep / IPC Warning Message / Reduced Engine Power / Loss Communication / Various DTCs (V6 Inspect Engine Harness)

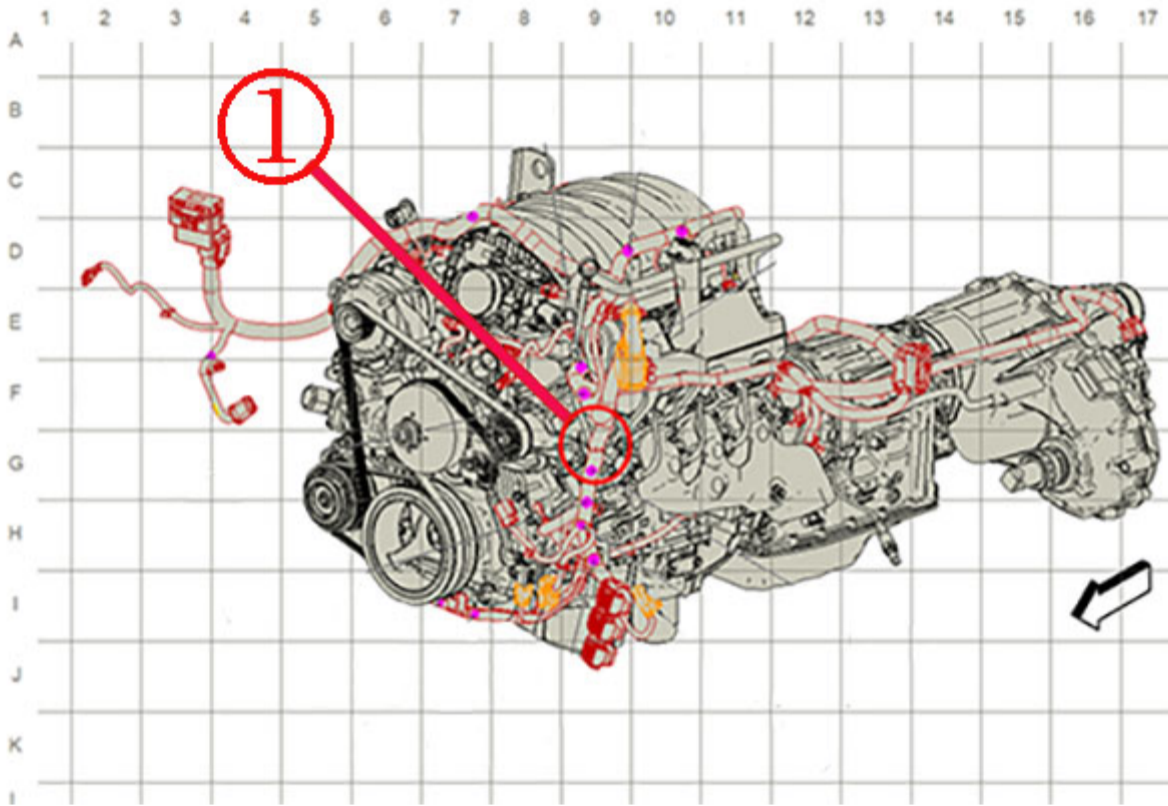
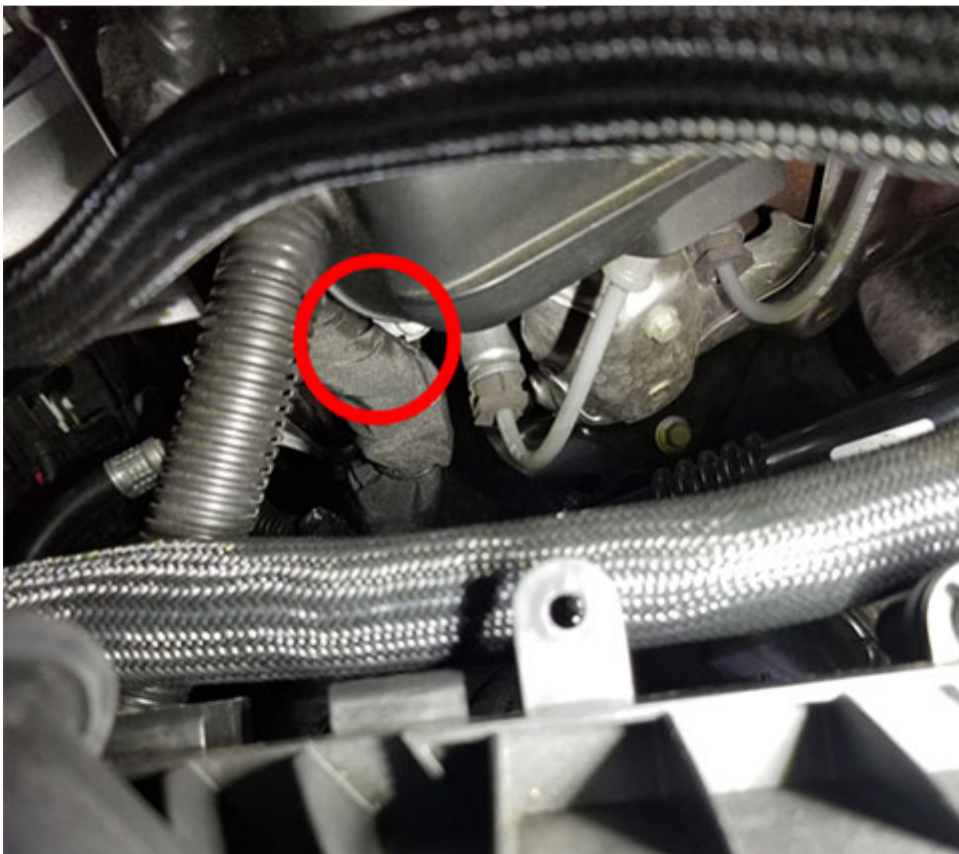
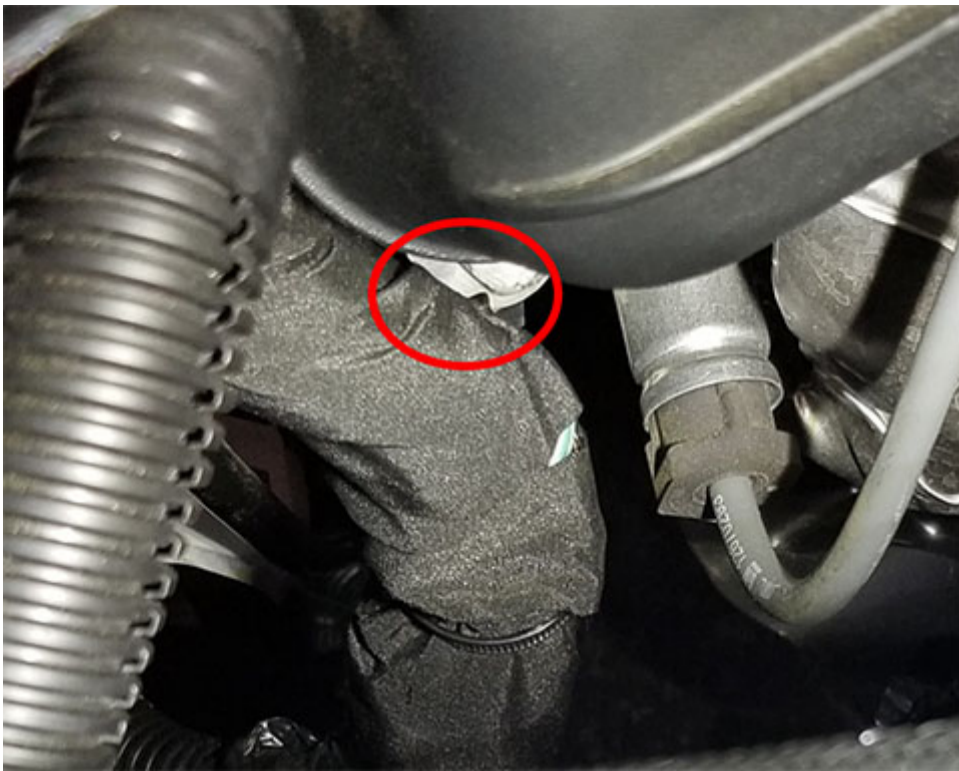
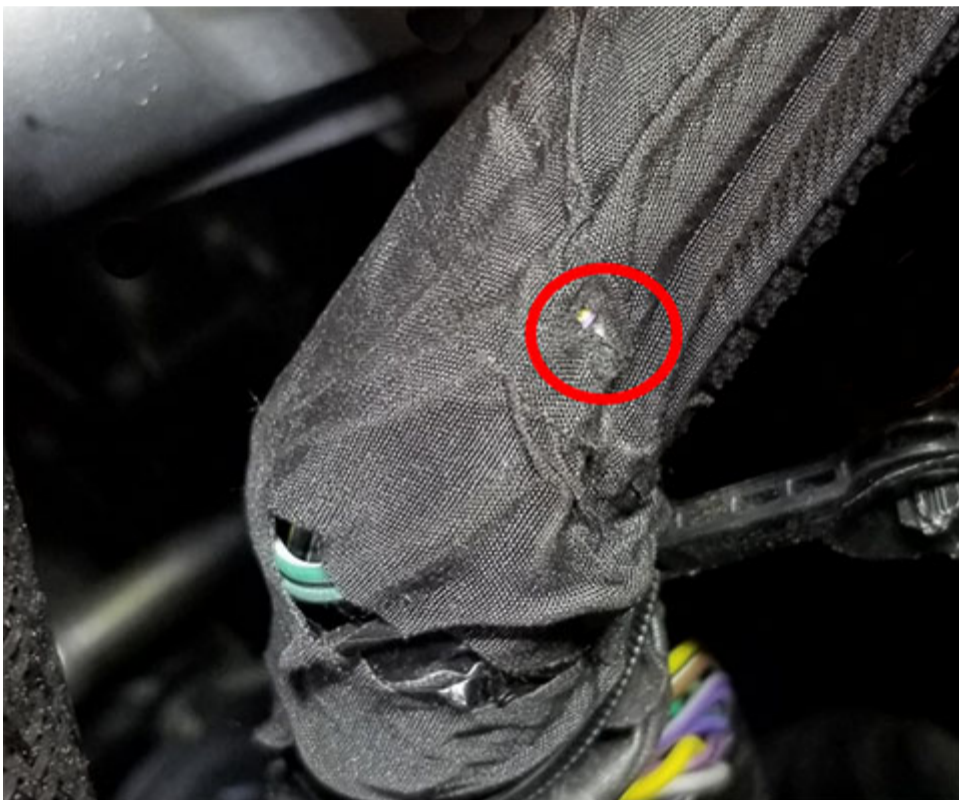
Cause	These concerns could be caused by the engine wiring harness rubbing on the front corner of the left hand cylinder head (1) or drive belt idler bracket and shorting any

number of circuits to ground, see pictures below. Due to the number of circuits in the harness, there is a wide variety of different symptoms that could occur depending on which circuit(s) are damaged.

To correct this concern, repair the damaged wiring following the SI wire-to-wire repair procedures. Once repaired, protect and reposition the engine wiring harness to prevent future harness damage.
