# Preliminary Information

## PIT5765 Rattle Flutter Flapping Wind Noise Coming From The Left Or Right Front Of The Vehicle

Brand:	Model:	Model Years:	VIN:		Engine:	Transmissions:
			from	to		
Chevrolet	Tahoe	2021	All	All	All	All
GMC	Yukon Models	2021	All	All	All	All

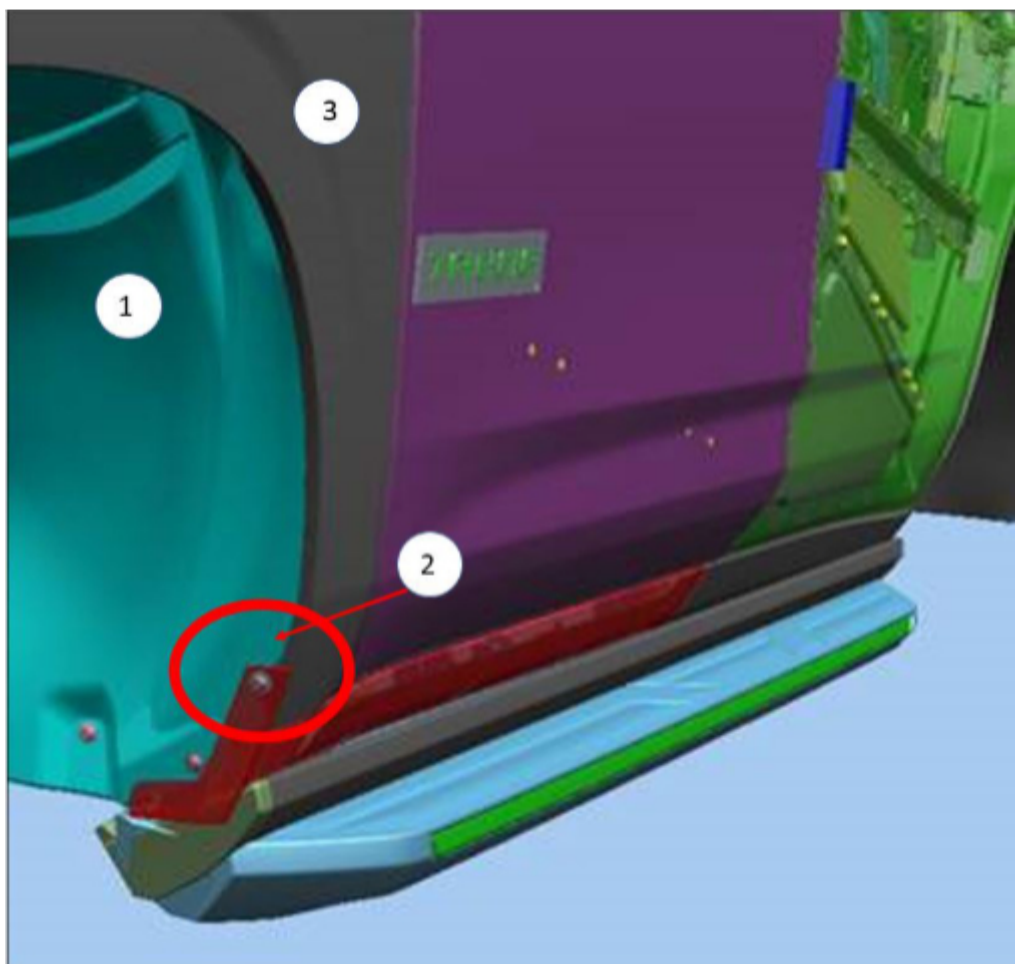
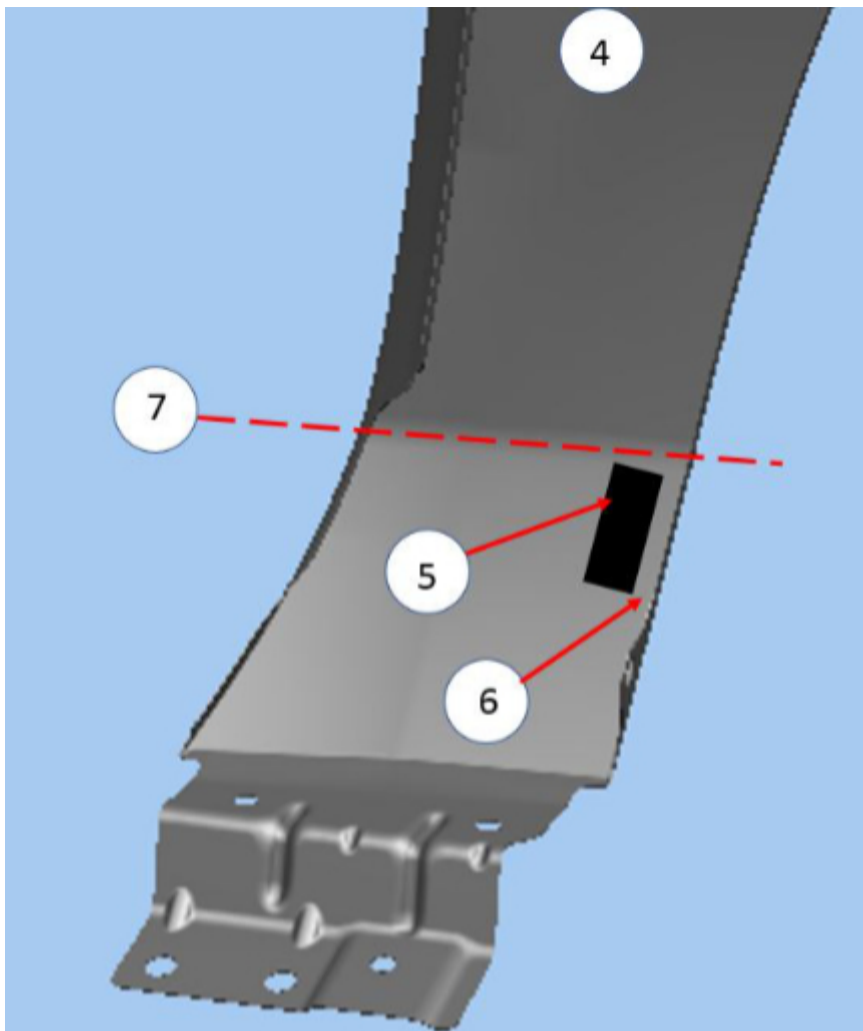
Involved Region or Country	North America
Condition	Some customers may comment on a rattle, flutter, flapping, and/or wind type noise from the front end. The noise could be heard from either the left, right or both sides of the vehicle and may occur at higher speeds. In some cases, the noise may sound like it is coming from the windshield area.
Cause	The cause of the noise could be either the left or right front inner wheel well liner having excessive movement in the area shown below (2).

- 1 - Driver's wheel well liner
- 2 - Area where the wheel well liner is loose and making noise
- 3 - Driver's front fender
- 4 - Inboard side of the driver's front fender
- 5 - Foam/Butyl tape to be installed
- 6 - 10 mm gap between foam/butyl tape and flange on the fender
- 7 - Fender feature/body line

To correct this concern apply a 1"x3"x1/4" thick piece of foam, or a couple layers of butyl tape to the inside of the fender as follows:

1. Partially remove the front wheel well liner to obtain access to the back/inboard side of the front fender (4).
2. If necessary, clean the back/inboard side of the fender to remove any dirt, mud, etc.
3. On the back/inboard side of the fender, start at the fender feature line (7) and 10mm from the fender flange (6), and place the 1"x3"x1/4" thick piece of foam or layers of butyl tape (5), as shown above.  
**Note: The foam/butyl needs to create a cross car interference with the fender liner return flange.**
4. Reinstall the front wheel well liner. With the foam/butyl installed it may be necessary to use a trim pick or similar tool to pull the wheel house liner to the full forward position.
5. Once the wheel well liner is installed there should be no fore/aft movement when the wheel well liner is tapped or lightly pushed on.
