# Loss of Air Conditioning Cooling With DTC B1423

YEAR(S)	MODEL(S)	ADDITIONAL INFORMATION
2020	Highlander, Highlander HV

Some 2020 model year Highlander and Highlander Hybrid vehicles may experience a sudden loss of air conditioning cooling with Diagnostic Trouble Code (DTC) B1423 (Open in Pressure Sensor Circuit/Abnormal Refrigerant Pressure) present. Follow the Repair Procedure in this bulletin to address these conditions.

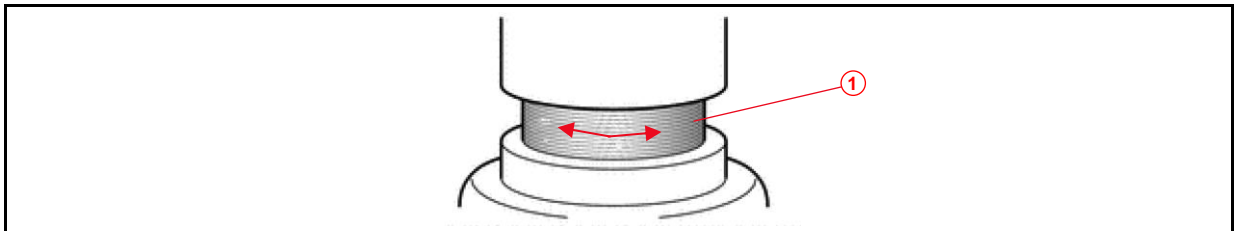
**Figure 1. OK Condition – Pipe Replacement NOT Needed**

<b>1</b>	<b>Light Scratching Parallel With O-ring Groove Caused by Normal Part Processing</b>
----------	--

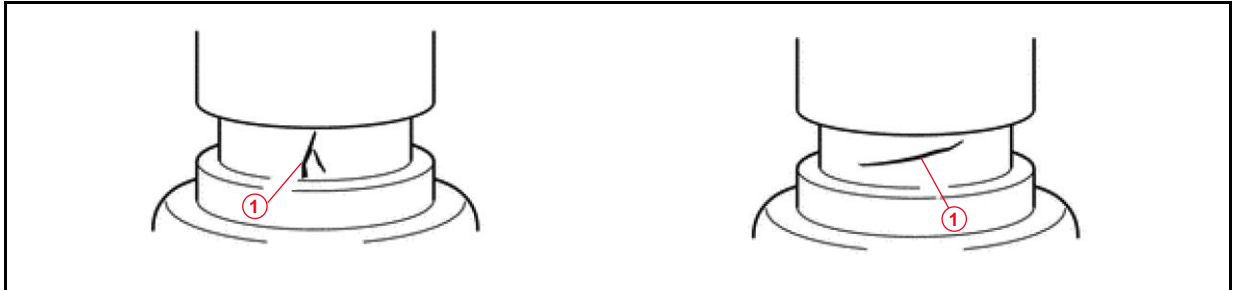
**Figure 2. Damage Condition – Pipe Replacement Recommended**

<b>1</b>	<b>Damage – Deep Scratching or Gouge of Base Metal</b>
----------	--

7. Did the inspection show ANY damage or abnormalities in the O-ring surfaces?
  - **YES** – Proceed as follows:
    - For Highlander vehicles continue to step 8.
    - For Highlander Hybrid vehicles go to step 10.
  - **NO** – Go to step 12.

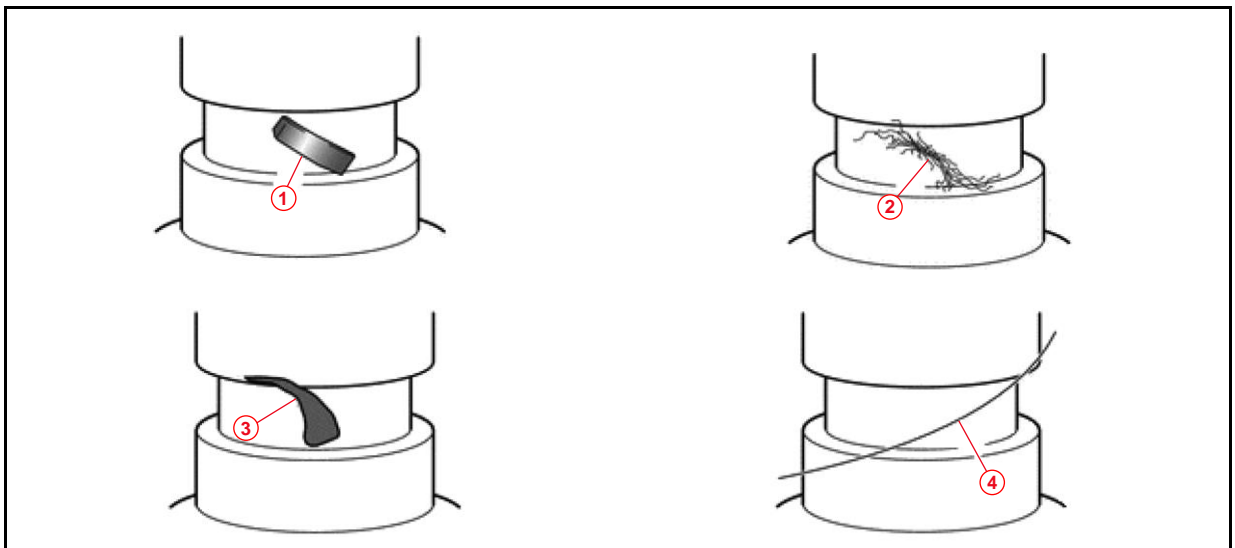
**Figure 3. Foreign Matter – Pipe Replacement NOT Needed (Clean Using Non-metallic Tool)**

<b>1</b>	<b>Metal Fragment</b>
<b>3</b>	<b>Resin Fragment</b>

<b>2</b>	<b>Lint</b>
<b>4</b>	<b>Hair</b>

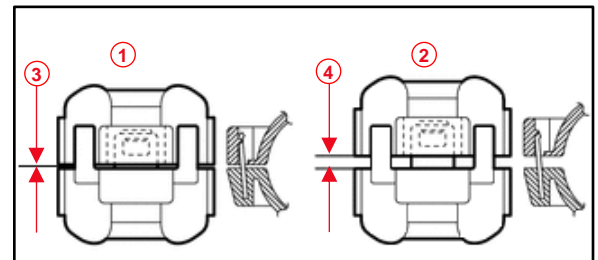
**Figure 10.**

<b>1</b>	<b>Correct</b>
<b>2</b>	<b>Incorrect</b>
<b>3</b>	<b>No Gap</b>
<b>4</b>	<b>Gap</b>

Make sure that the piping clamp is engaged securely with no gap.

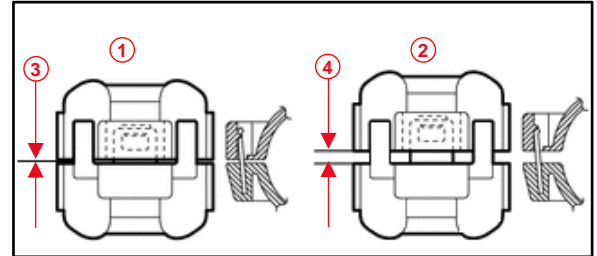
**Figure 22.**

1	Correct
2	Incorrect
3	No Gap
4	Gap

Make sure that the piping clamp is engaged securely with NO gap.

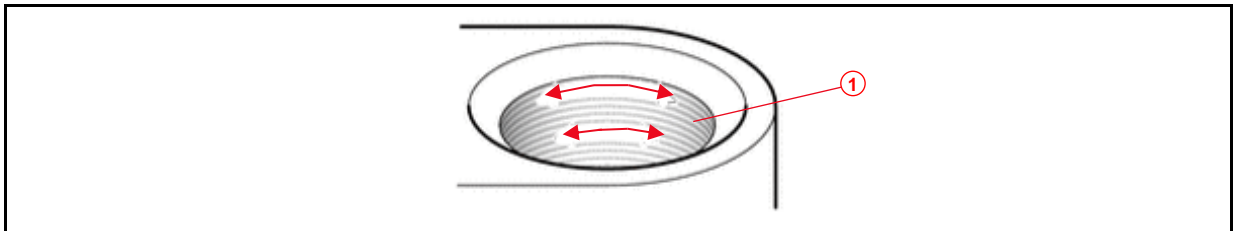
**Figure 23. OK Condition – Condenser Assembly Replacement NOT Needed**

1	Light Scratching Parallel With O-ring Groove (Caused by Normal Part Processing)
---	---

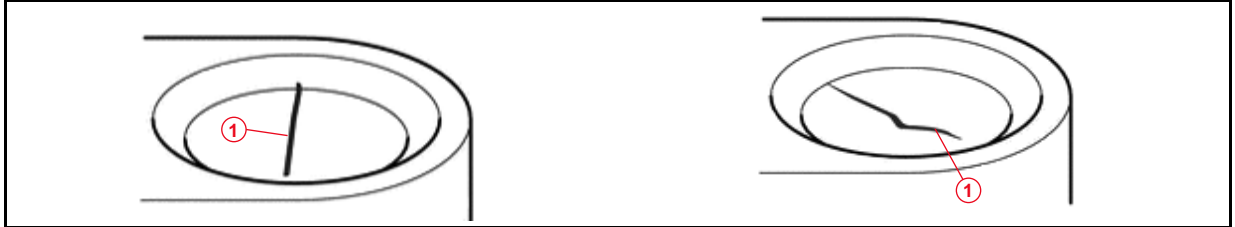
**Figure 24. Damage Condition – Condenser Assembly Replacement Recommended**

<b>1</b>	<b>Deep Scratching Perpendicular to the O-ring Groove</b>
----------	---

- A. Did the inspection show ANY damage or abnormalities in the O-ring surfaces?
- **YES** – Continue to step 13.
  - **NO** – Go to step 15.

13. Remove the condenser assembly.

14. Install the NEW condenser assembly.

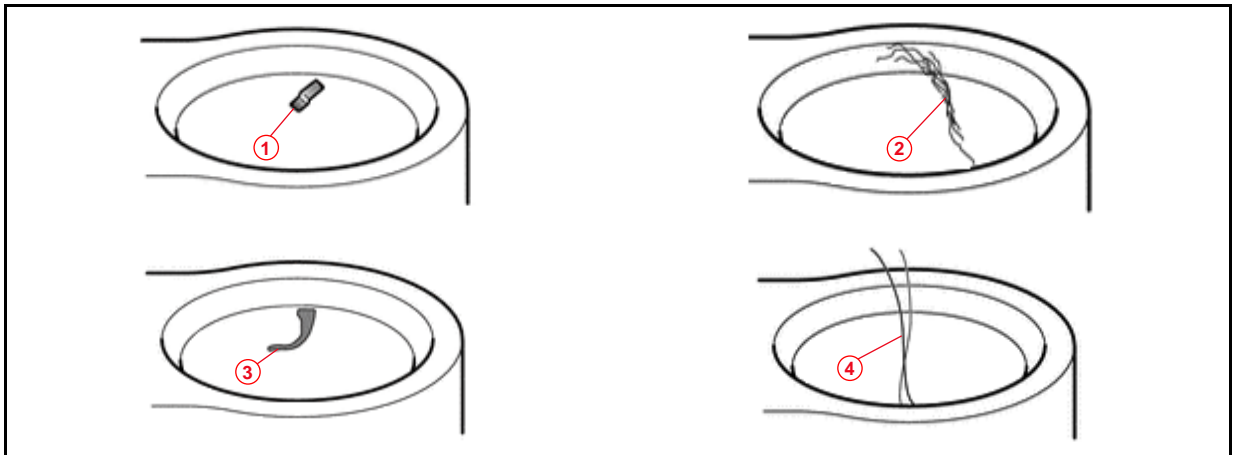
**Figure 25. Foreign Matter – Pipe Replacement NOT Needed (Clean Using Non-metallic Tool)**

<b>1</b>	<b>Metal Fragment</b>
<b>3</b>	<b>Resin Fragment</b>

<b>2</b>	<b>Lint</b>
<b>4</b>	<b>Hair</b>
