# Water Entry/Condensation in Rear Combination Lamp(s)

YEAR(S)	MODEL(S)	ADDITIONAL INFORMATION
2018 - 2019	Prius C

Some 2018 – 2019 model year Prius C vehicles may exhibit water entry or condensation in one or both of the rear combination lamps. Follow the Repair Procedure in this bulletin to address this condition.

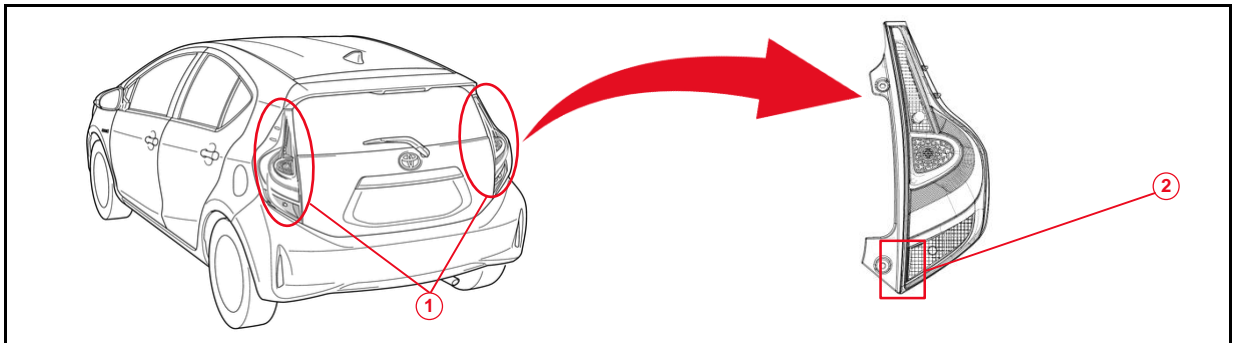
**Figure 1.**

Is water entry or condensation found in one or both rear combination lamps as shown in Figures 1 and 2?

<b>1</b>	Rear Combination Lamps
<b>2</b>	Location of Water Intrusion in Rear Combination Lamps

3. Remove the affected rear combination lamp(s).

4. Install NEW rear combination lamp(s).

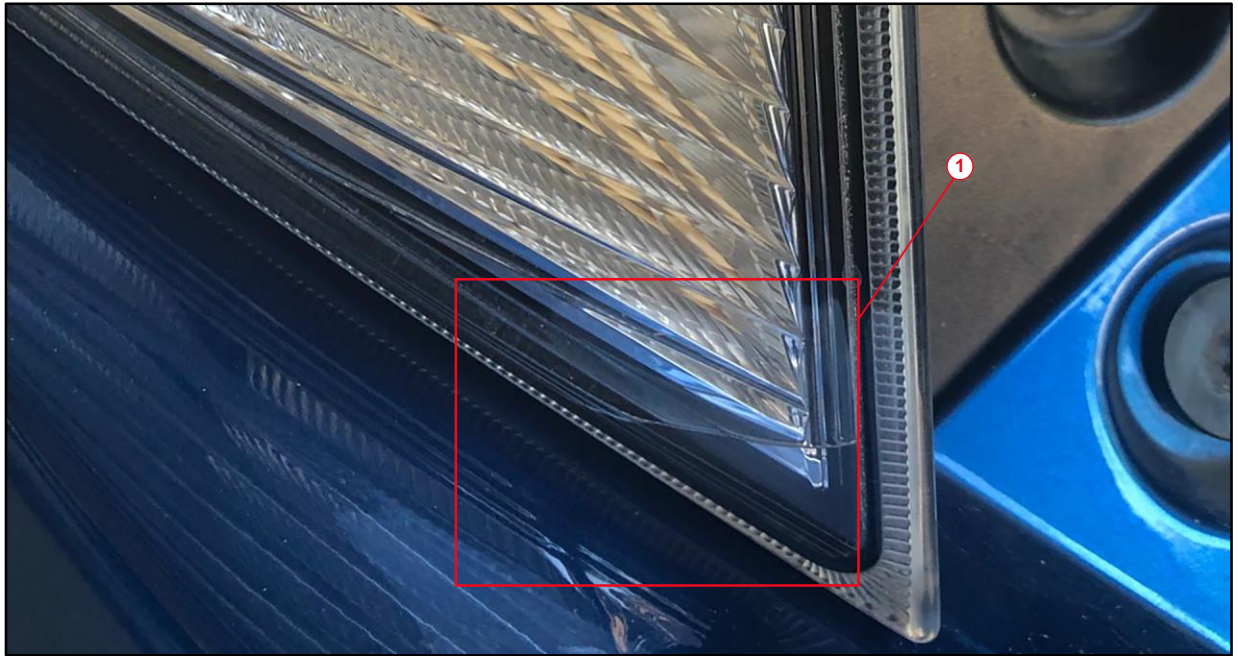
**Figure 2. Closeup of Rear Combination Lamps**

1	Example of Water Sitting at the Bottom of the Lens
---	--

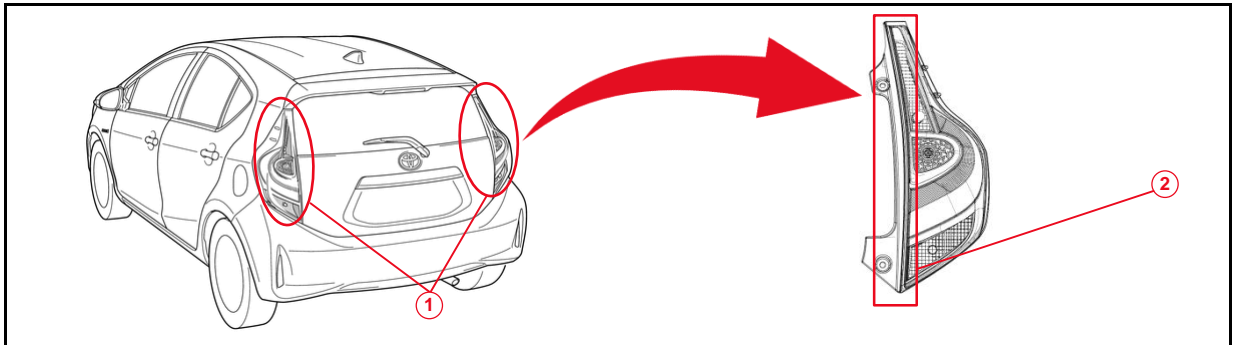
**Figure 3.**

2. Perform a visual inspection of rear combination lamps for cracks in the seam.  
Is there a crack in the rear combination lamps seam(s) as shown in Figures 3 and 4?
  - **YES** — Continue to step 3.
  - **NO** — This bulletin does NOT apply.  
Continue diagnosis using the applicable Repair Manual.

<b>1</b>	<b>Rear Combination Lamps</b>
<b>2</b>	<b>Crack Along This Area of Housing</b>

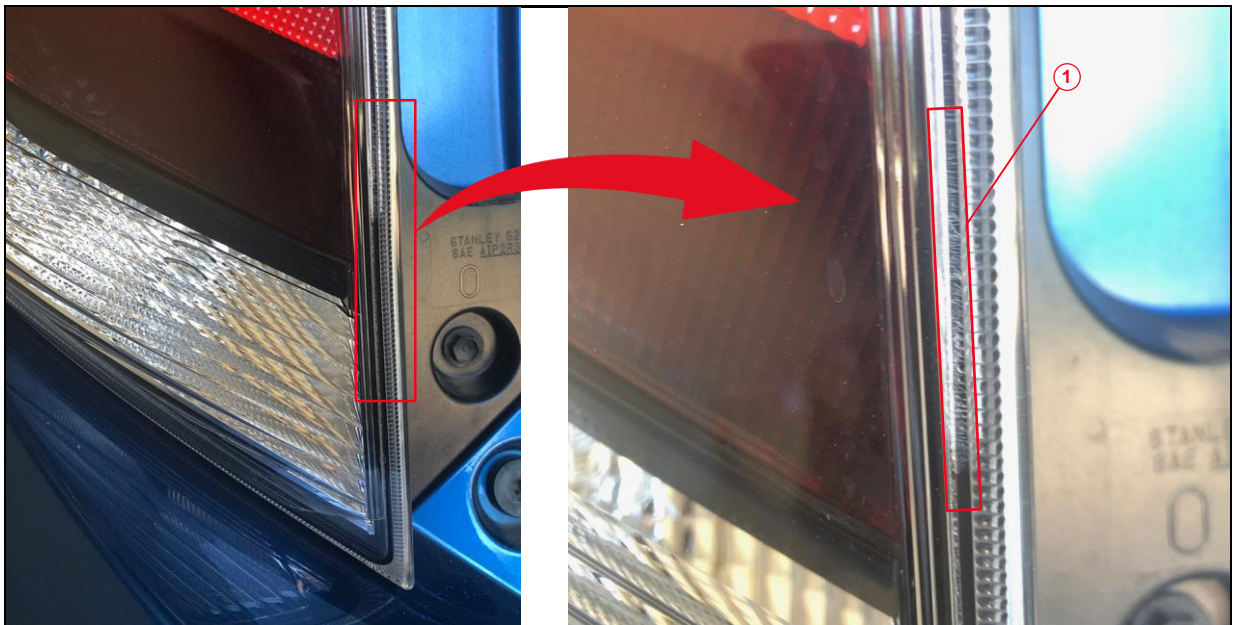
**Figure 4.**

<b>1</b>	<b>Example of a Crack in the Lens Housing</b>
----------	---
