Instrument Panel Trim Reflection

Service Category Vehicle Interior

Section Interior Panels/Trim

YEAR(S)	MODEL(S)	ADDITIONAL INFORMATION
2018 - 2020	Camry, Camry HV

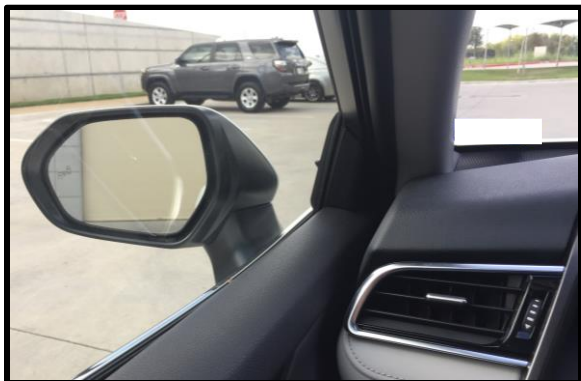
Figure 1. Brushed Aluminum Trim

Some 2018 – 2020 model year Camry and Camry Hybrid vehicles with brushed aluminum or gray metallic trim may exhibit a condition where the instrument panel LH and RH outside register assemblies reflect upon the side window glass.

Below are some examples of this condition. Alternative outside register assemblies with a gloss black finish have been developed to reduce this condition. Follow the Repair Procedure in this bulletin to reduce this condition.
