Air Conditioning System Occasionally Does Not Cool Correctly At Outside Temperatures Above 40°C

Topic number	LI83.30-P-070309
Version	6
Function group	83.30 Air conditioning
Date	10-30-2020
Validity	Model series 118, 177 and 247 from SOP to clean point of the manufacturing plant; see list
Reason for change	Adaptation to country distribution. MBD removed at own request. Breakpoint updated for Aguascalientes. Brief description of cause.
Reason for block

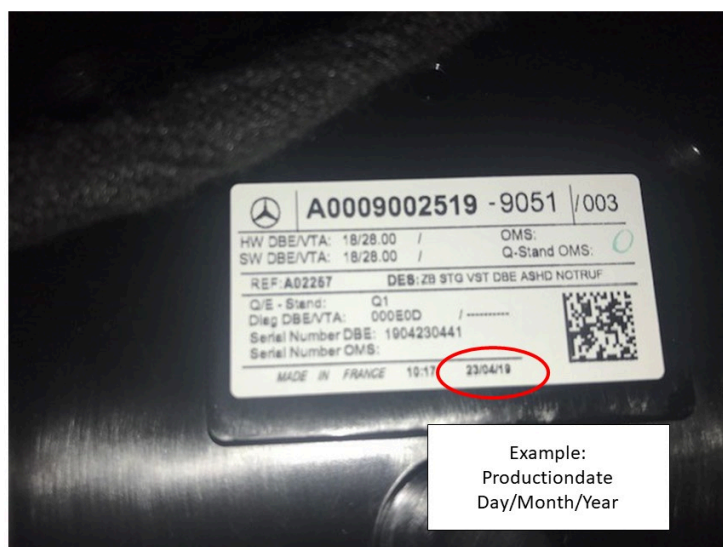
pic.1.jpg:

Attachments	
File	Description
pic.1.jpg	OCP picture

Note: If vehicle returns after reducing refrigerant charge quantity, please open a PTSS case stating the original refrigerant quantity, the manufacturing date of the OCP, the customer's AAC settings (when the problem occurs) and the measurement values recorded.
