Model Series 167: Cracks In ARTI-CO Seat Cushion Cover On Front Seat

Topic number LI91.18-P-071629
Version 2

Function group 91.18 Seat covers

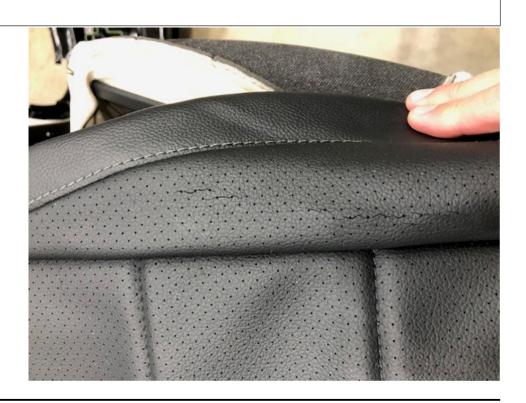
example1.jpg:

The seat cushion cover on the front seat cracks when side bolster is equipped with "ARTICO man-made leather upholstery".

Replace seat cover.
