# Technical Journal

**Oxygen sensor thread repair method**REF NO:  
**TJ 35818.1.1**ISSUING DEPARTMENT:  
**Technical Service**CAR MARKET:  
**United States and Canada**PARTNER:  
**3 US 7510 Volvo Car USA**ISSUE DATE:  
**2020-12-15**STATUS DATE:  
**2020-12-21**FUNC GROUP:  
**2544**FUNC DESC:  
**Lambda sond system****Page 1 of 3****“Right first time in Time”**

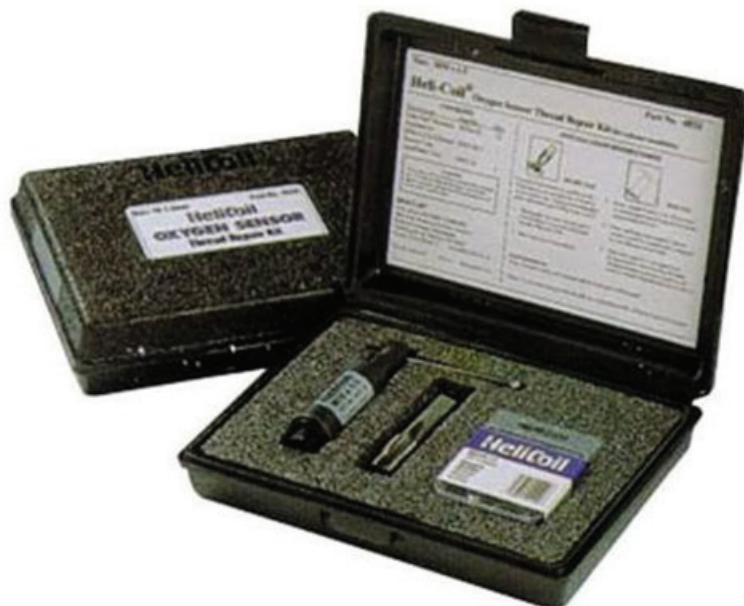
## Helicoil 4833 Oxygen Sensor Thread Repair Kit M 18 x 1.5

There is a new repair method listed in VIDA for reconditioning the oxygen sensor thread if they are damaged upon removal.

Follow VIDA instructions:

**Overhaul instructions/ Engine with mountings and equipment/ 25 intake and Exhaust systems/  
Catalytic Convertor**

See Example of Heli coil kit that can be ordered thru an aftermarket supplier (Amazon, tool dealer, parts store)
