SIB 09 01 20

2020-12-02

BMW REMOTE SOFTWARE UPGRADE IS NOT OFFERED FOR INSTALLATION

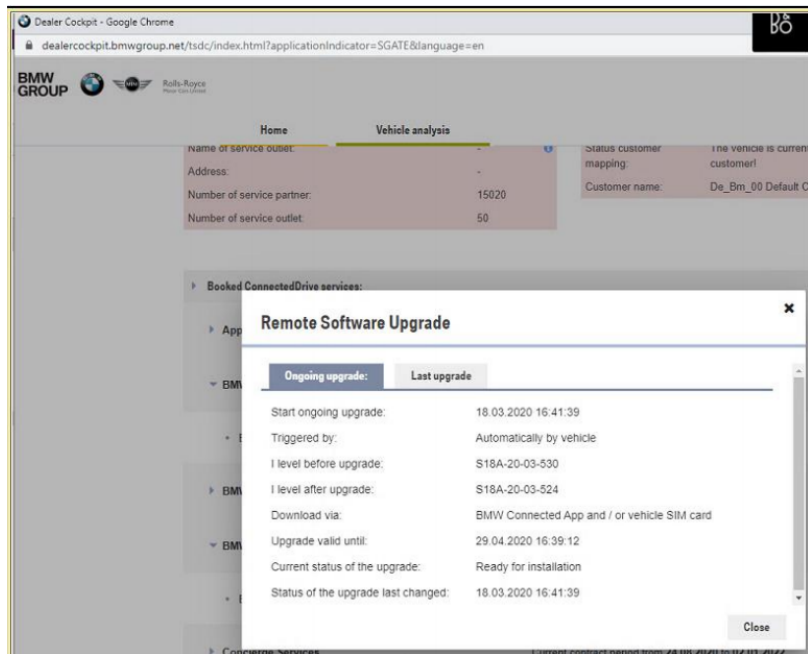
RSU status in the Dealer Cockpit Application

If the above situations occur, check either in the Dealer Cockpit (see figure below) or in the vehicle in the General settings → RSU menu whether a BMW RSU is currently offered for this vehicle.

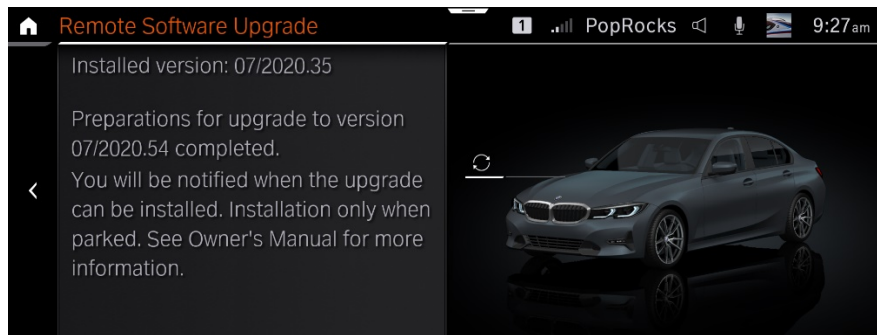
RSU status in the vehicle menu

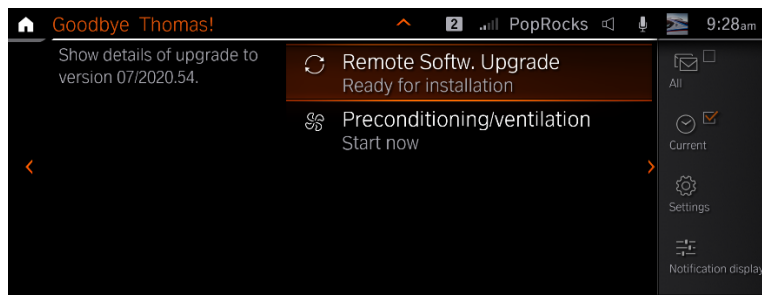
Remote Software Upgrade ready for installation in the Goodbye Screen

Exit the diagnostic mode, then carry out a test drive for at least 1 minute at a speed greater than 7 mph. After switching off the engine, observe the notes in the central information display (CID). After the ISTA session has been ended, the RSU process can be restarted manually in the RSU menu. When the upgrade is running, the "Goodbye Screen" shows RSU "Preparing". When the download is completed in the Goodbye Screen, the Menu is shown RSU "Ready for installation" as shown in the screen below.
