SIB 52 10 19

2020-12-14

THIGH SUPPORT UPHOLSTERY DETACHES FROM SEAT

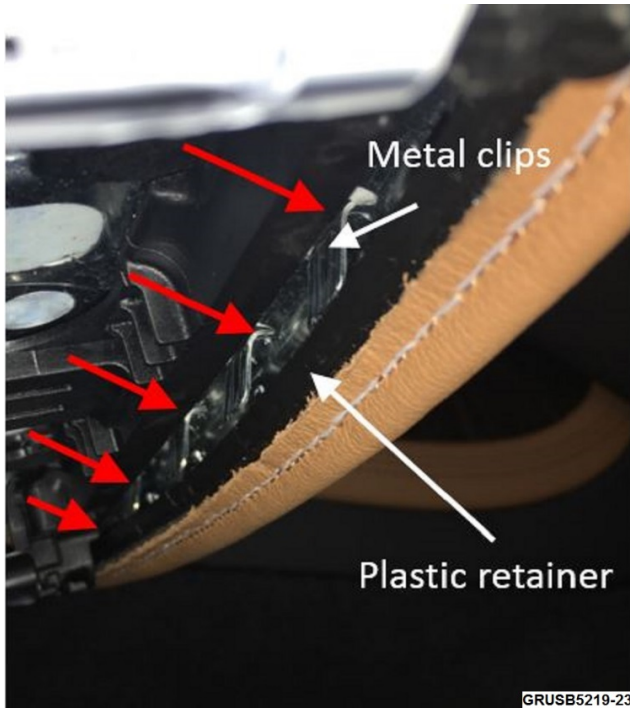
2. **Incorrect:** Retainer and trim are not properly installed (red arrows).

- The edge of the leather seat upholstery is sewn onto a plastic retainer strip

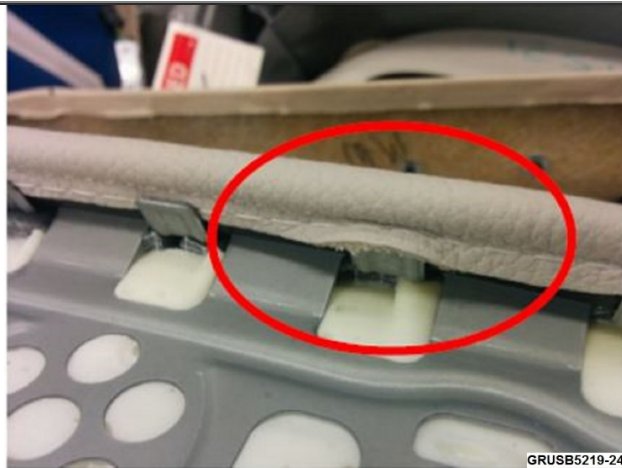
- The retainer strip is supposed to be held in place by the firm contact of the 5 metal clips

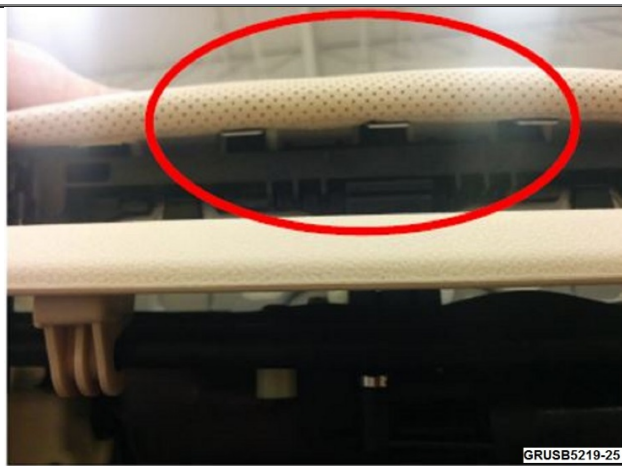
3. **Incorrect:** Retainer and trim not properly installed-
- Left clip too loose against retainer
 - Leather is overlapping the right clip (circled) so that the clip cannot press against the retainer

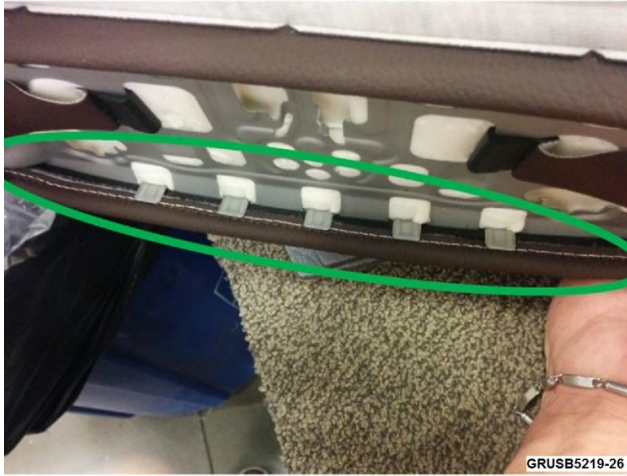
5. **Correct:** Retainer and trim placed correctly inside the metal clips.
- Clips are firmly pressed against the trim
 - No gap exists between the trim and metal clips

Note: Bend the 5 metal clips as necessary.
