## SIB 62 08 18

### INSTRUMENT CLUSTER DISPLAY SHAKES-SHIFTS TO THE LEFT

This Service Information Bulletin (Revision 4) replaces SI B62 08 18 **dated August 2020**.

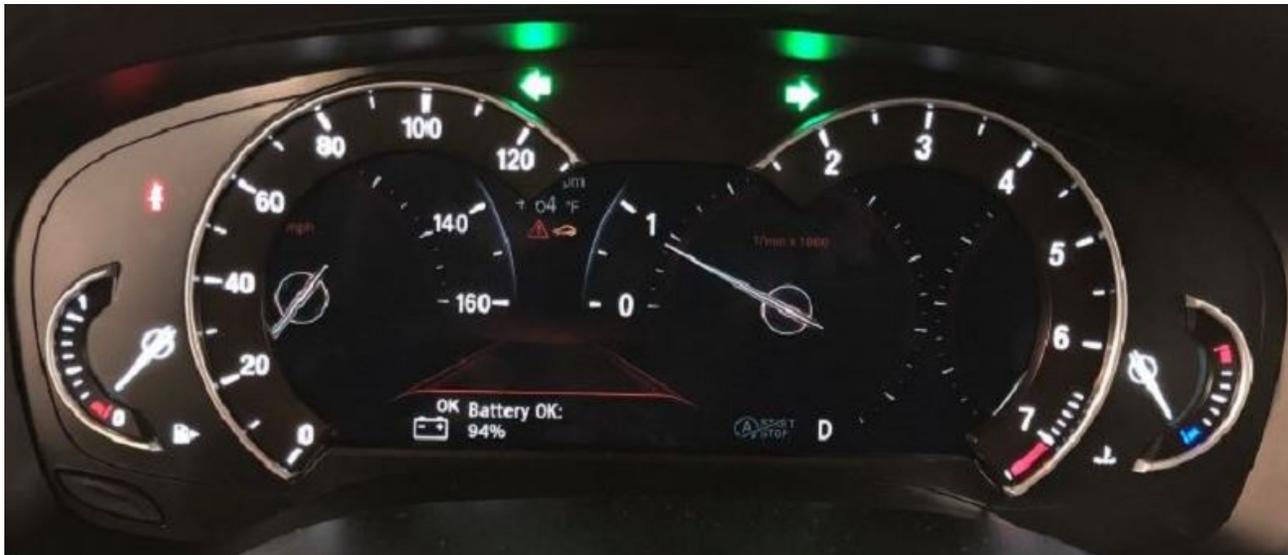
The  
Instru  
ment

cluster intermittently flickers, shakes and has shifted to the left.

The fault is resolved once the vehicle goes into sleep mode.

The fault can reoccur at any point.

Problem with the contact at the Automotive Pixel Link connection plug on the instrument cluster.

Software error in the Instrument cluster (Kombi)

Replace the instrument cluster (Kombi).

Program vehicle and perform ABL Dashboard: "Display jitters/shifts to the left"
