SIB 64 06 13

2020-12-28

A/C COOLING: INTERMITTENT REDUCTION OF AIR FLOW

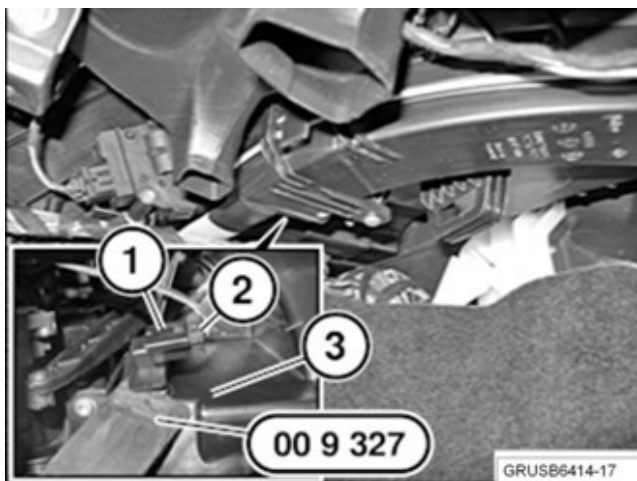
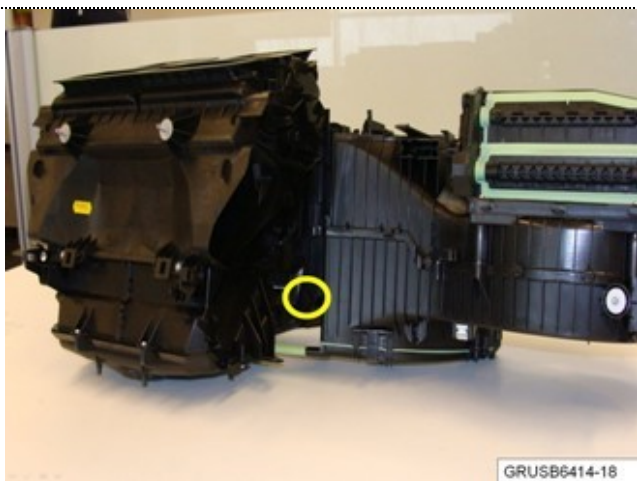
4. The IHKA housing (removed for clarity) shown is viewed from the passenger's side.

The circle shows the approximate location of the evaporator temperature sensor.

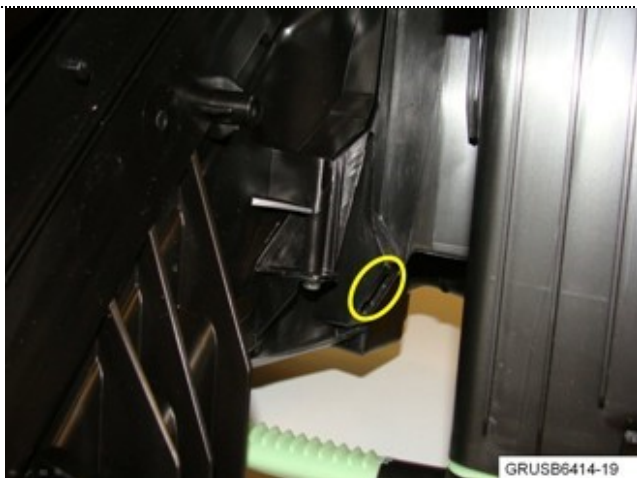
5. The close-up picture shows the exact location (circle) of the sensor opening. The following steps will be performed from the lower passenger's footwell area at the bottom of the IHKA housing.

Note: As a reference point, the evaporator temperature sensor is located just above the white ribbed rubber water drain hose, when viewed from below.

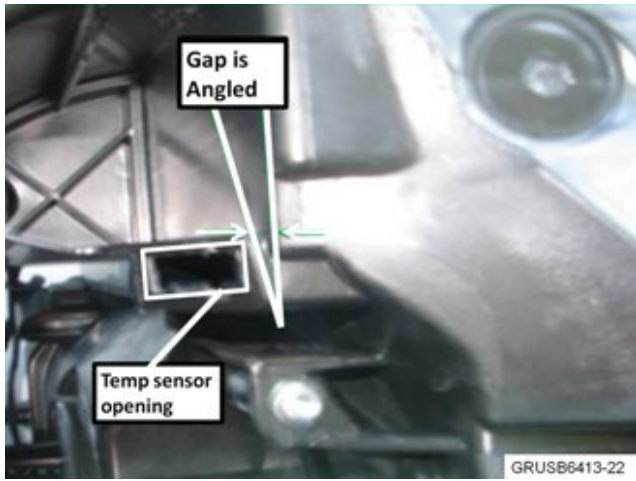
6. Locate the evaporator temperature sensor opening (sensor removed for clarity).

Check the gap between the sensor opening and the evaporator case.

If the sensor opening contact surface is slightly angled as shown, this housing is **NOT** affected by this repair procedure. In this case, proceed with normal A/C diagnostic procedures.

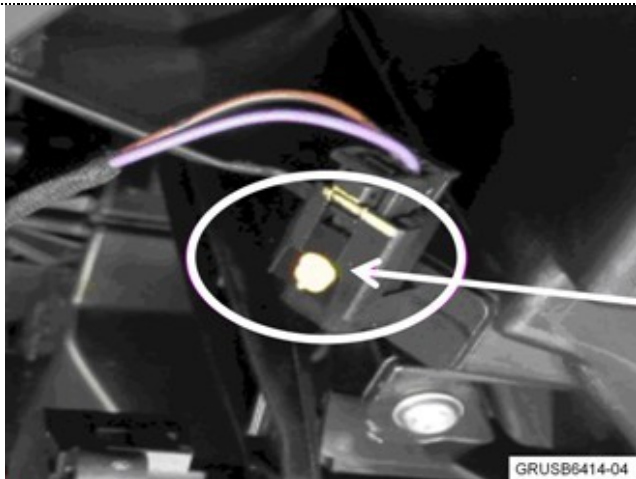
7. Check for a marking on the electrical connector.

If a mark is seen or **NO** gap exists, the IHKA housing must be modified.

Do not replace any parts. The repair procedure includes installing a new adapter to correct the gap.

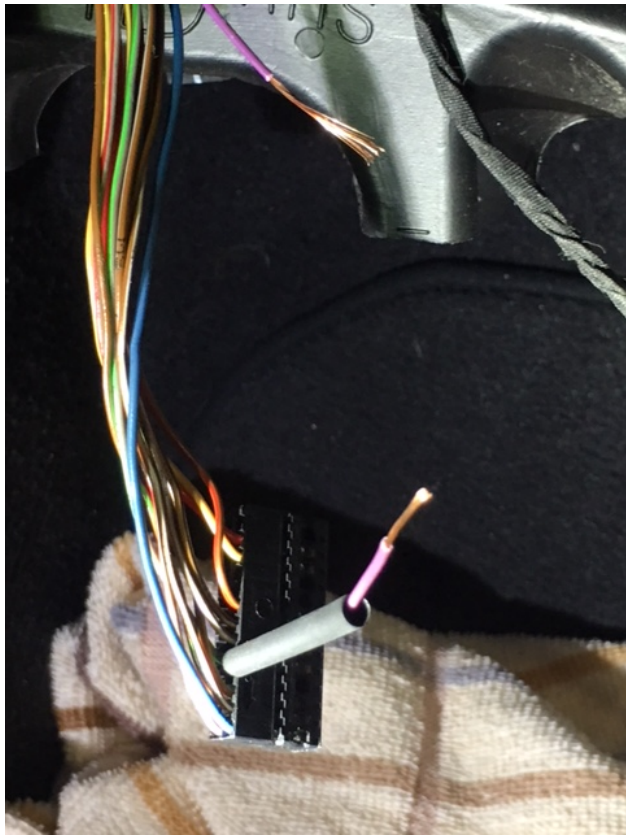
For this F30 the wiring can be found in schematic Temperature Control SP0000058999.

Install resistor inline on pin 22 for the evaporator temperature sensor line at the IHKA.
