### Polestar 2: Charging Issues at Signet Charging Stations (Information Only)

REF NO: TJ 35800.1.1	ISSUING DEPARTMENT: Technical Service	CAR MARKET: United States and Canada		
3 US 75	PARTNER: 510 Volvo Car USA	ISSUE DATE: 2020-12-16	STATUS DATE: 2020-12-16	
FUNC GROUP: 3234			1 of 3

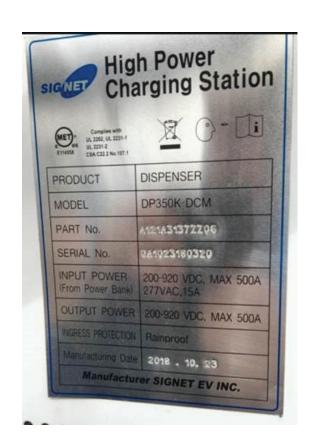
File Size	
Example_Signet_Metal_Sign.jpg	0.0392 MB

Please submit a Vehicle report if this issue is encountered and include a picture of the metal sign (see Example\_Signet\_Metal\_Sign.jpg) on the side of the HV charging station whenever possible.
