# Service Campaign Bulletin

Campaign No. 2020120012 December 2020

SUBJECT: **Model 907 Model Year 2020**  
**Retrofit Lock Nut on Exhaust System**

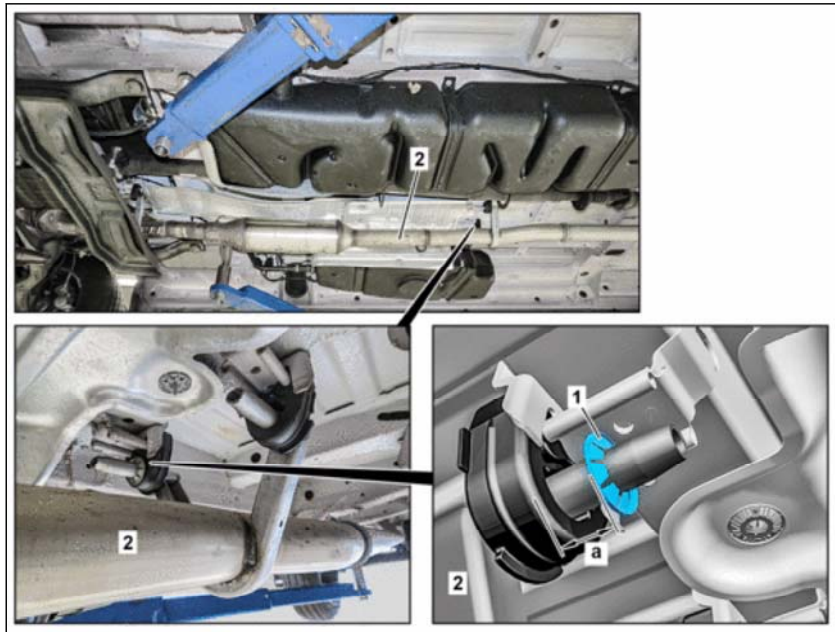
D49.10-A012-76

MBAG, the manufacturer of Mercedes-Benz and Freightliner Sprinter Vans, has determined that the lock nut may not have been installed on the holder of the exhaust system on some vehicles. As a result, the exhaust system may move beyond the tolerance threshold, especially in the case of extreme load changes or other higher loads during vehicle operation. The purpose of the fixing ring is to increase the level of robustness throughout the vehicle's life cycle.

- 1 Spring nut
- 2 Exhaust system
- a Dimension (15 mm)

AR			
3	Retrofit lock nut (1) to holder of exhaust system (2).

Make sure that the dimension (a) between the lock nut (1) and decoupling element is observed.	
4	Lower vehicle.
