SIB 65 21 20

2020-12-02

NO PREVIEW IMAGES DISPLAYED IN THE REAR SEAT ENTERTAINMENT

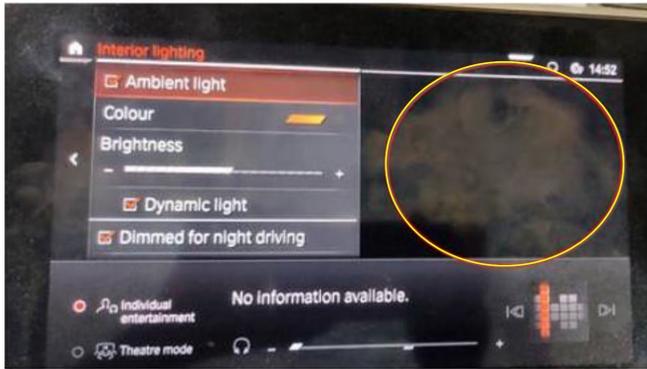
The rear seat entertainment screens do not display any preview images at times.

Software in the Head Unit High (HU-H3).

Program the vehicle.
