Service Bulletin

Bulletin No.: 17-NA-231

Subject: Information on Replacement of Video Processing Module Due to Water Intrusion

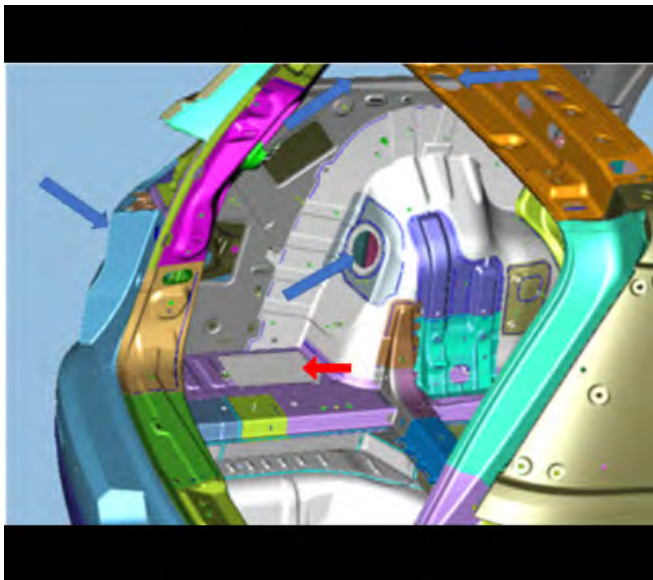
5660052

Possible Water Leak Paths

Red Arrow shows location of VPM.

3. Perform a water leak test/wash test on the vehicle to determine any leak path(s).
4. If a leak path is found, seal and ensure the leak is contained.
5. The following are areas to inspect for water intrusion:

- Ensure the Body harness in left quarter panel to exterior harness grommet is seated fully.
 - Inspect the tail lamp assembly, grommets, and clips.
6. Ensure the body seams are sealed.

- Left rear roof to outer body panel
 - Left rear quarter window
 - Tail lamp pocket seam
 - Sunroof drain hose properly installed in quarter panel
 - Liftgate weatherstrip

- Liftgate wiring harness grommets
 - Liftgate glass
7. Once any water entry point has been determined and contained, replace the Video Processing Module. Refer to *Video Processing Module Replacement* in SI.

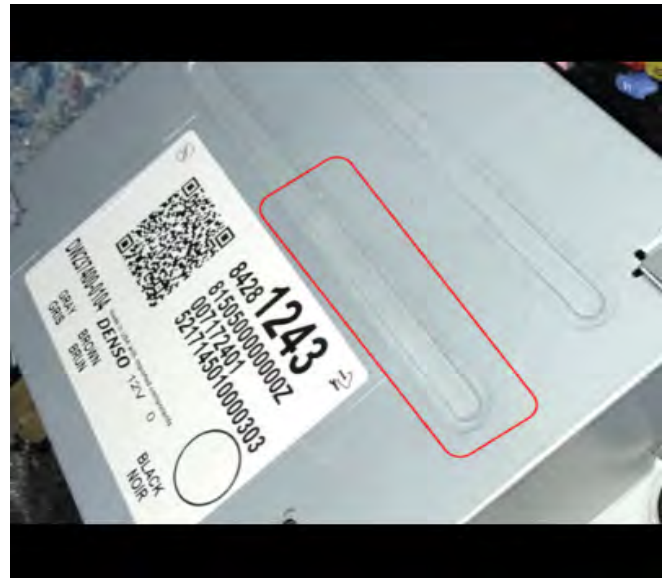
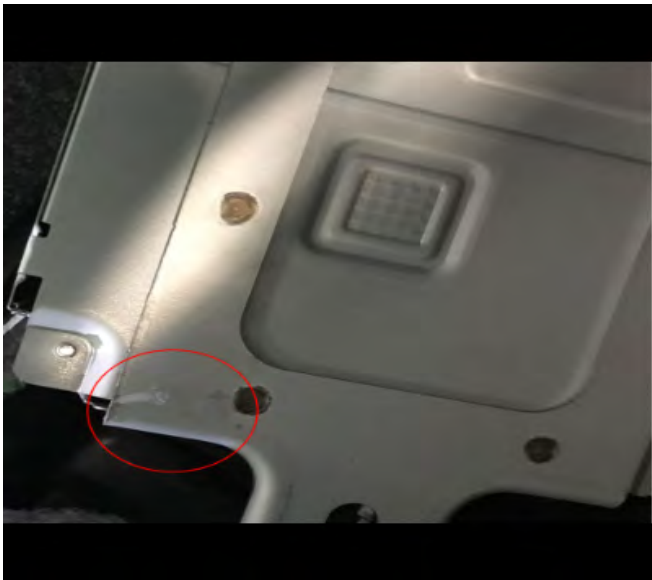
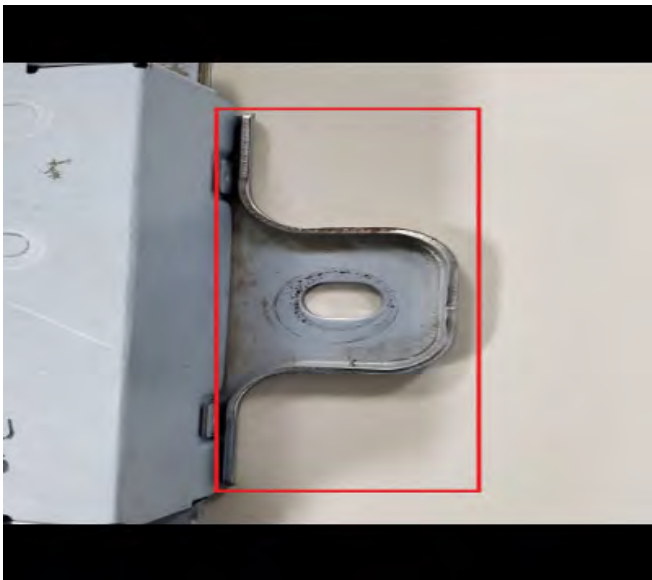
Examples of Video Processing Module with Visible Signs of Water Damage

Important: Please do **NOT** dismantle the VPM. If there is suspected water damage, send the VPM back to GM for evaluation and please ensure, before replacing the VPM in the vehicle, all potential water routes are sealed to prevent a repeat issue.
