# Service Bulletin

Bulletin No.: 19-NA-153

**Subject: Malfunction Indicator Lamp (MIL) Illuminated - DTC P0741 Set**

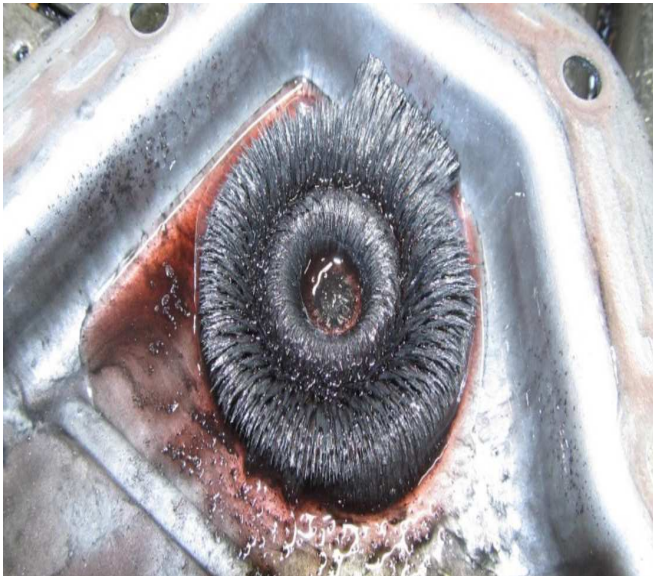
5360216

2. Remove the transmission oil pan.
3. Inspect the magnet in the pan for excessive metal accumulation.
  - If there was no signs of metal in the oil pan, install the pan and no further work is required.
  - If there was excessive metal shaving in the oil pan magnet, Install new filter when reassembling and continue to step 4.
4. Remove the upper and lower valve body and clean thoroughly.
5. Inspect the TEHCM solenoid screen for debris:
  - If there was no signs of metal in the TEHCM, install the pan and no further work is required.
  - If there was excessive debris in the TEHCM, replace the TEHCM/solenoid valve body **Only** if there is debris on the screen as shown above and continue

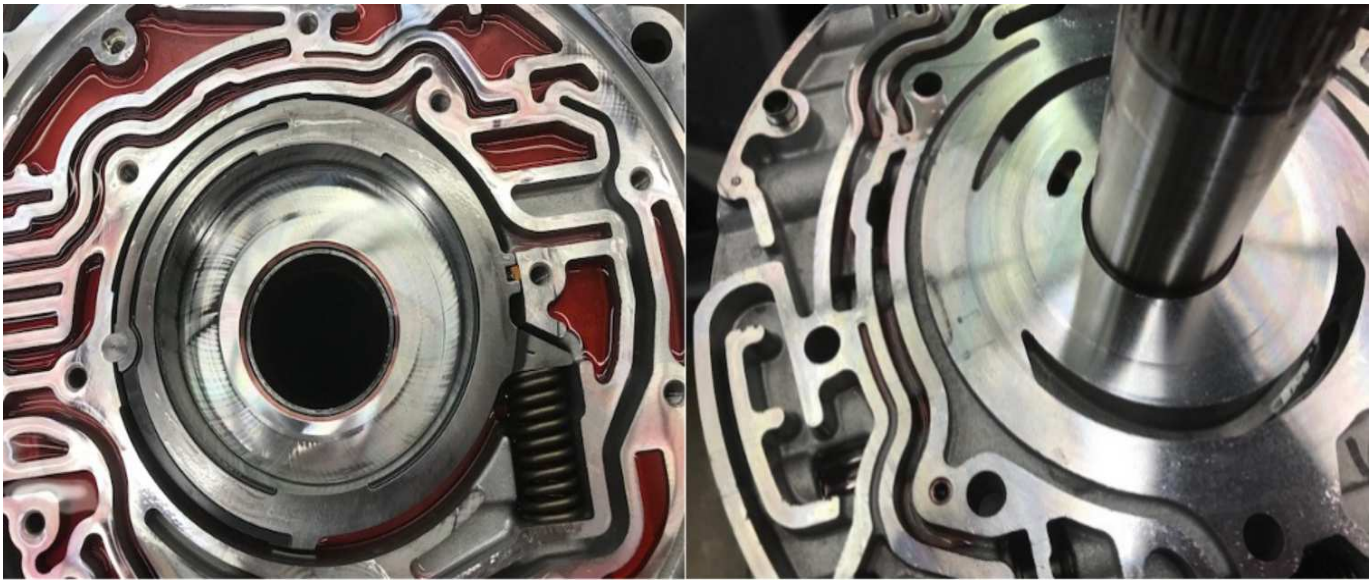
5360776

**Do Not** replace the pump if no signs of damage or excessive wear was not validated during inspection as shown above.

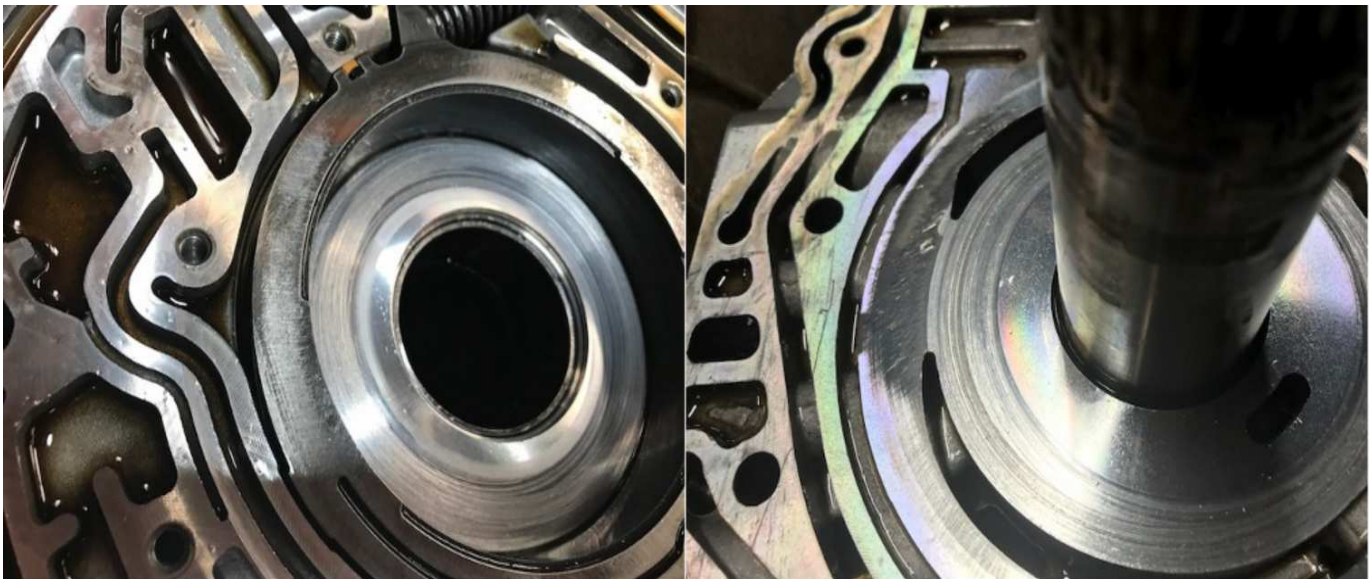
5360218

**Note:** Refer to the latest version of PI1447 for possible bushing/shaft scoring. Replace parts as necessary.

Perform an inspection of the transmission pump for signs of excessive wear as shown above.

Replace pump components as necessary.
