# Service Bulletin

Bulletin No.: 19-NA-217

**Subject: Manual Transmission Stalling, Clutch Chatter and/or Hard Shifting into 1st Gear or Reverse; Automatic Transmission Vibration on Launch and/or Engine Noise**

Brand:	Model:	Model Year:		VIN Breakpoint		Engine:	Transmission:
		from	to	from	to		
Chevrolet	Corvette	2014	2019	—	—	6.2L (LT1, LT4)	6L80 Automatic (MYC), 8L90 Automatic (M5U) or Manual

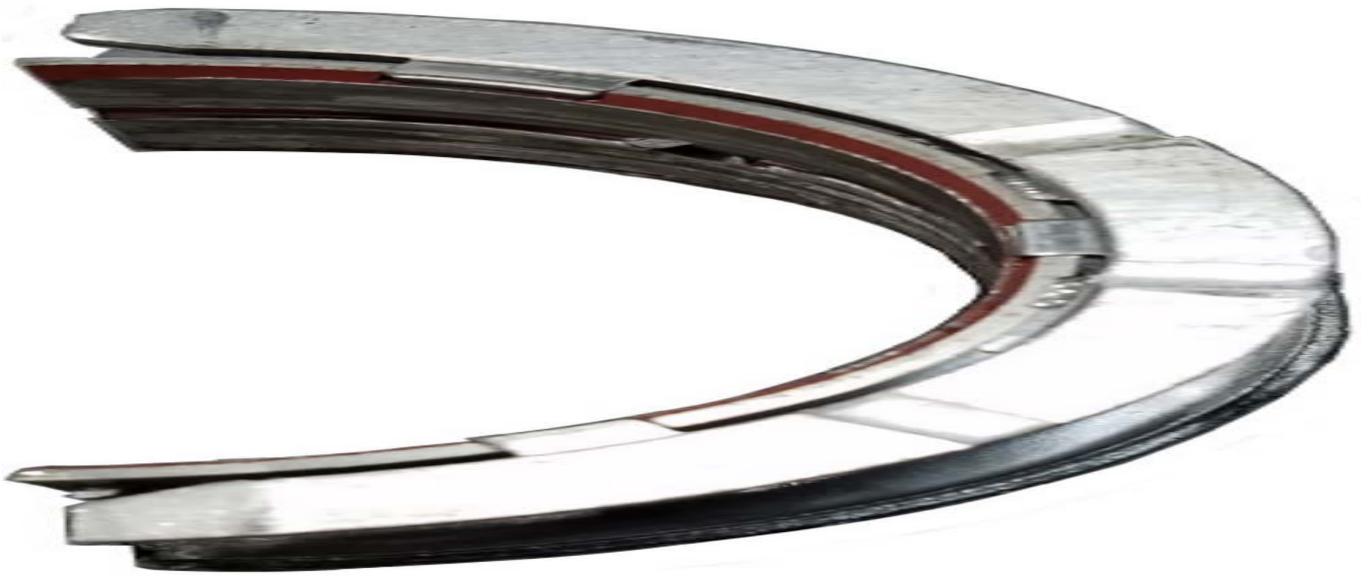
5403465

**Example of a good thrust bearing face.**

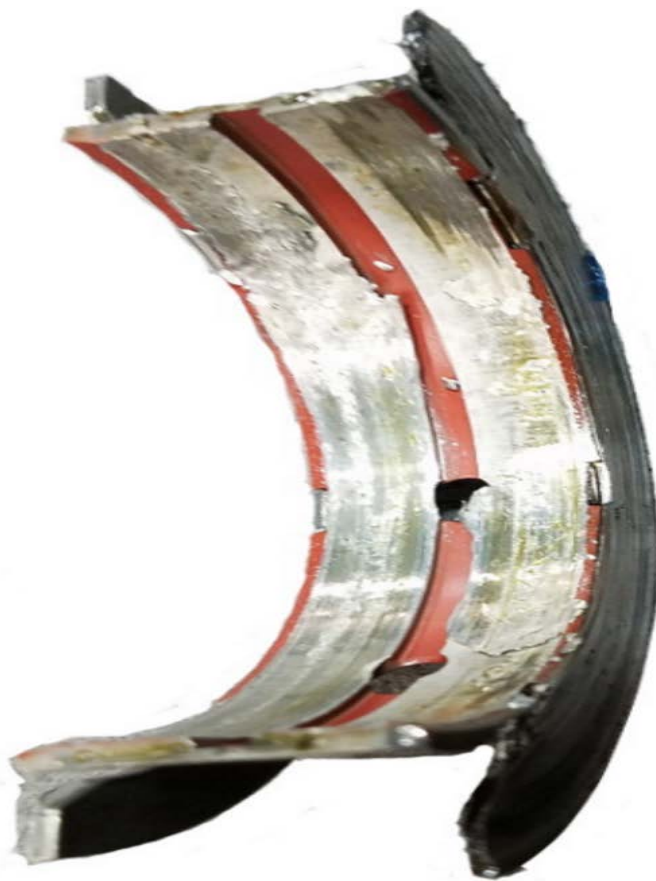
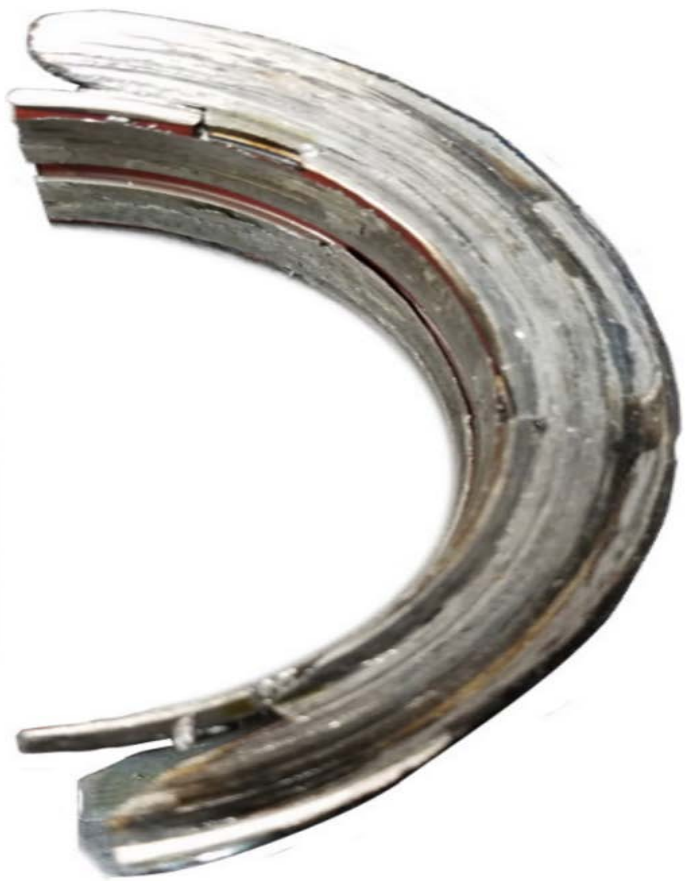
5403464

<b>Cause</b>	<p>This condition may be caused by excessive crankshaft endplay associated with a damaged thrust bearing.</p> <ul style="list-style-type: none"> <li>– Please use following information before considering an engine or crankshaft replacement.</li> </ul>
<b>Correction</b>	If a vehicle comes in with the conditions listed above, refer to the Service Procedure below.

3. Inspect the thrust bearing for wear on one side and crankshaft on the corresponding mating surface. The graphic above shows an example of a damaged thrust bearing.

- ⇒ If wear is evident (3 vertical channels worn off), it will be necessary to replace the crankshaft, connecting rods and main bearings.

If bearing damage is found and if the vehicle is equipped with a dry sump system, it will be necessary to replace the oil tank with lines and oil cooler.
