Service Bulletin

Bulletin No.: 20-NA-198

Subject: Trailer Running Lights Shut Off Due to Excessive Load on the Running Lamp Circuit

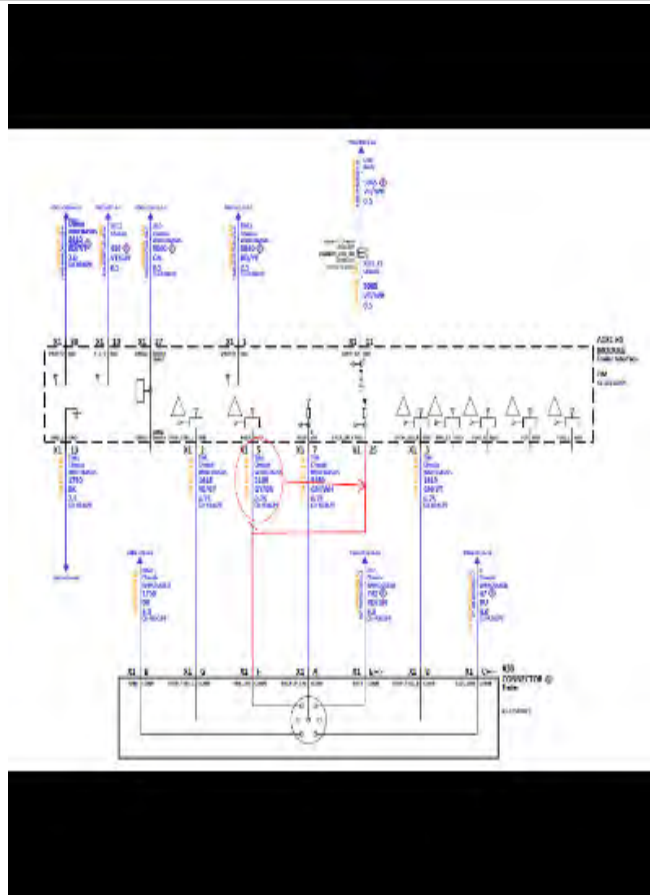
5652571

Additional Information	<p>2019 Model Year vehicles, equipped with U1D, use the K68 Trailer Lighting Control Module to control all trailer lighting through pulse width modulated (PWM) voltage. The Trailer Lamp Control Module has a current handling capability on the running lamp circuit of about 9 amps. On a trailer with a large number of incandescent lights, in-rush current can exceed 20 amps before it settles back to around 8-9 amps. During this inrush or "marriage" current period, the Trailer Lamp Control Module sees the current as an "overload" and goes into protection mode.</p> <p>This was changed for MY 20 to allow 16 amps of continuous current flow by routing the current through an internal relay in the Trailer Lamp Control Module. 2019 Trucks can be modified to operate in the same way. If we use 2020 design software and re-pin the running lamps to pin 25 using the internal relay to operate the running lamps. This requires a terminated lead to be inserted into cavity 25 on the chassis harness X1 connector. Wiring connected to pin 5 on the X1 will be cut and reconnected to Pin 25. Terminal in cavity 5 will remain, be blunt cut, and sealed with a closed end duraseal splice to prevent water entering through pin 5.</p> <p>Software will have to be managed by TCSC. A record must exist of what trucks have been flashed and that the bulletin has been completed. Software will not work with the production configuration of wiring. This also changes the trailer connection detection flashing of LED lighting from every 10 seconds to every 42 minutes. (Connection detection will still be enabled if trailer theft deterrent is enabled).</p>

For 2019 models ONLY, Follow the steps in the Service Procedure below, and move circuit 2109 on the Trailer Lamp Control Module from X1 cavity 5 to X1 cavity 25, and load new software from SPS into the Trailer Lamp Control Module.
