Service Bulletin

Bulletin No.: 20-NA-223

Subject: Steering is Sticking, Binding, Hard to Turn, or Stiff

Brand:	Model:	Model Year:		VIN:		Engine:	Transmission:
		from	to	from	to		
Chevrolet	Malibu	2018	2019	—	—	—	—

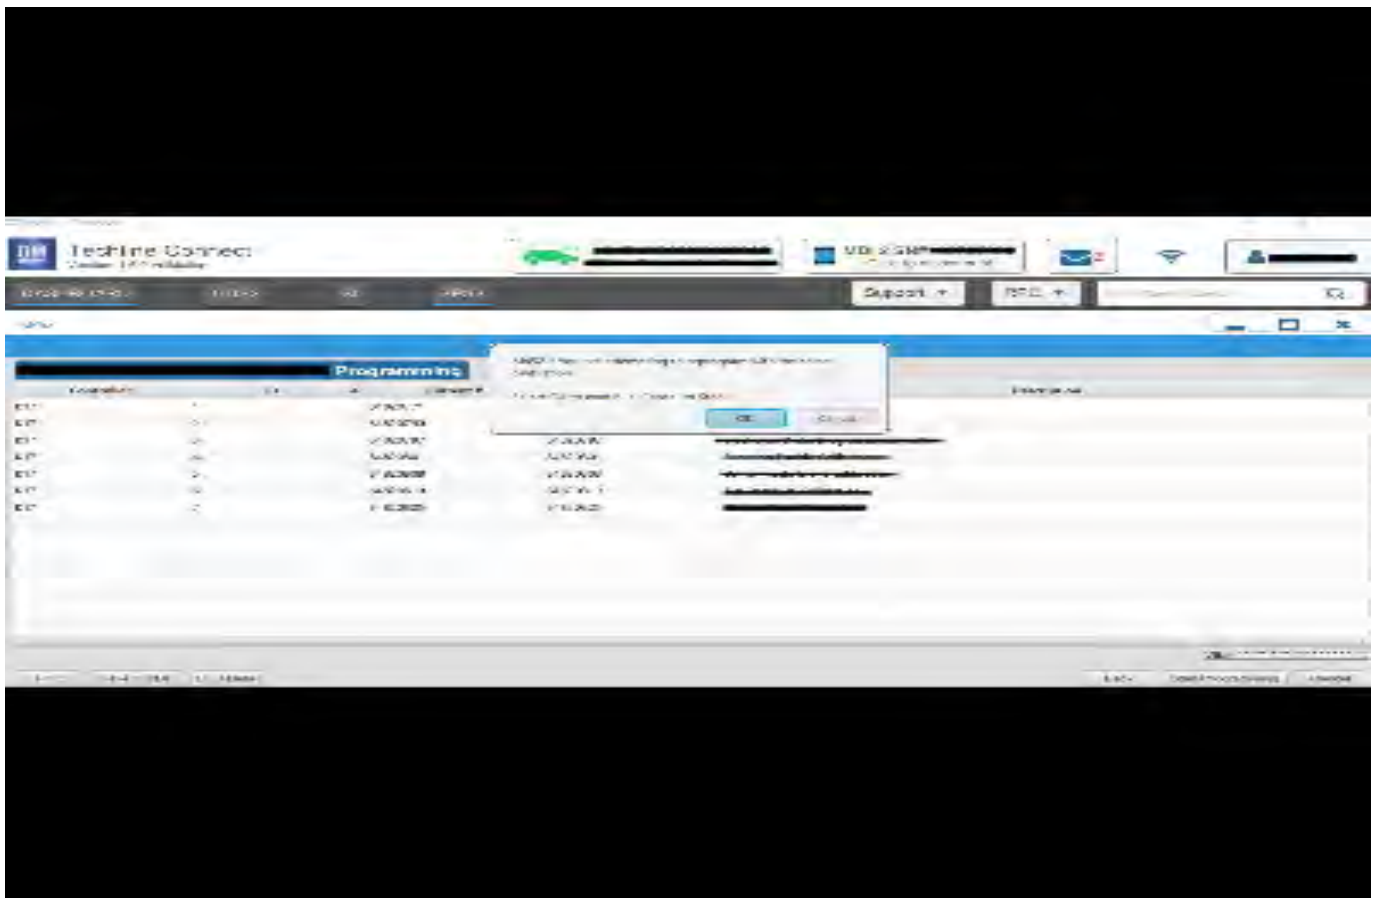
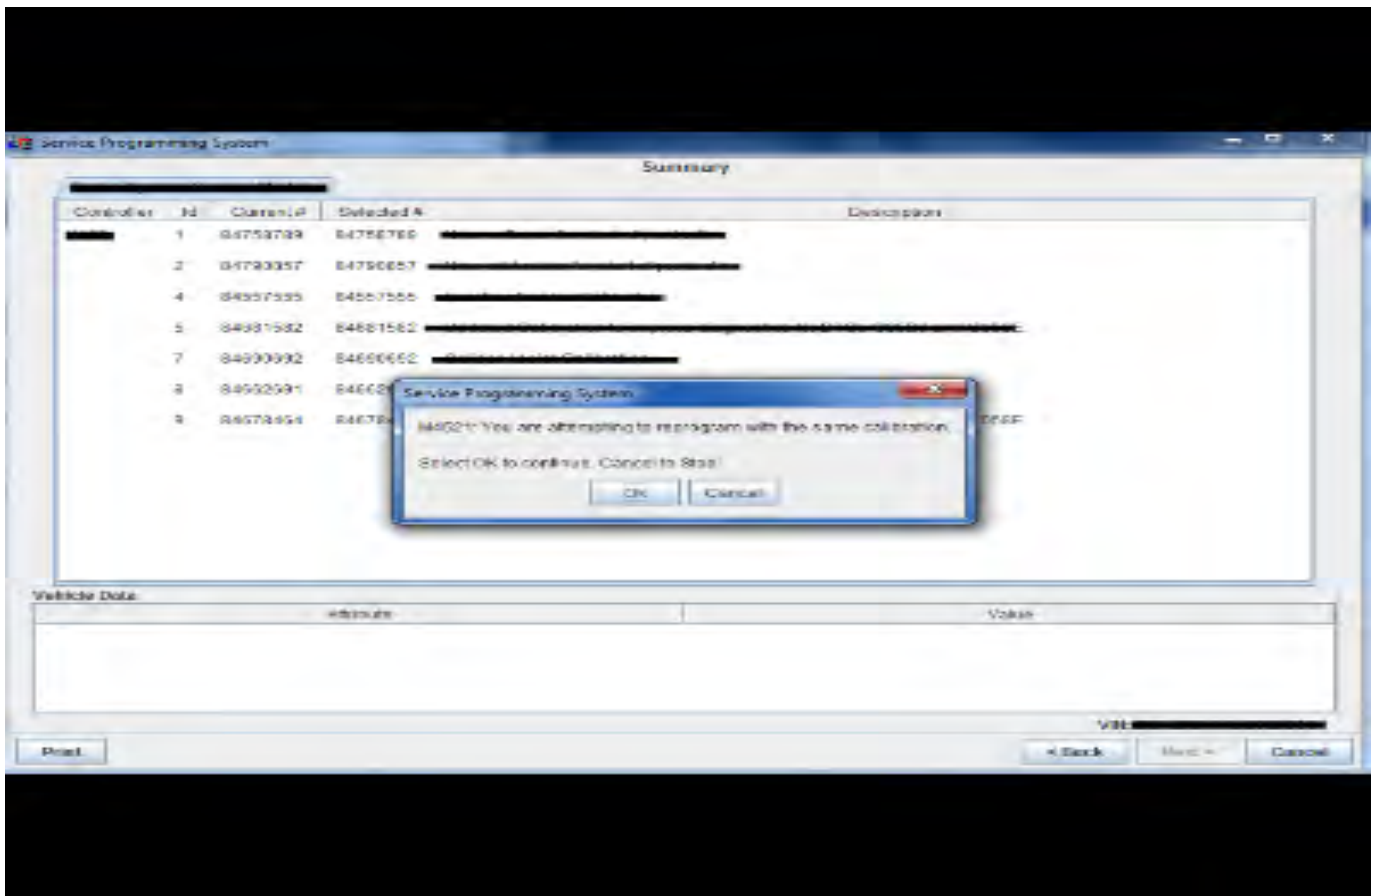
Note: The screenshots above are an example of module programming and may not be indicative of the specific module that is being programmed. Module selection and VIN information have been blacked out.

Important: To avoid warranty transaction rejections, you **MUST** record the warranty claim code provided on the SPS Warranty Claim Code (WCC) screen shown above on the job card. Refer to callout 1 above for the location of the WCC on the SPS screen.

2. Record the SPS Warranty Claim Code on the job card for warranty transaction submission.
