Service Bulletin

Bulletin No.: 20-NA-224

Subject: Air Conditioning Blows Warm Air and/or Does Not Get Cold

Brand:	Model:	Model Year:		Breakpoint Date:		Engine:	Transmission:
		from	to	from	to		
Cadillac	XT4	2018	2020	July	Present	All	All
Chevrolet	Malibu			01, 2019

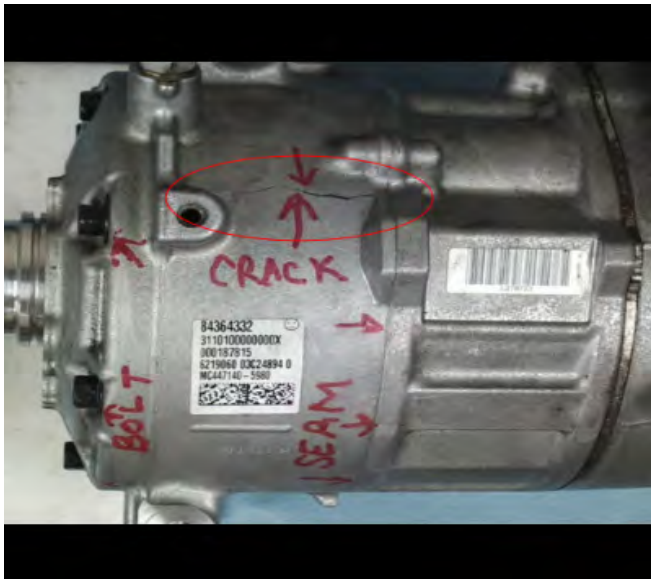
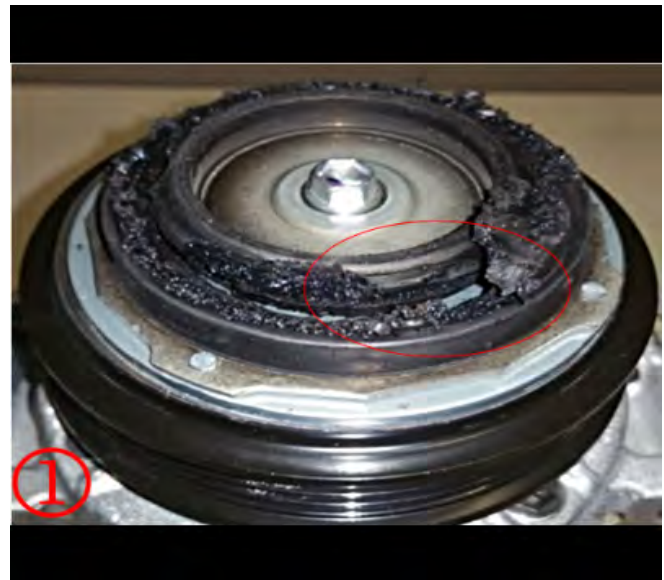
- 1.1. Check the A/C compressor housings for signs of cracks (XT4 and Malibu) as shown in the picture above.

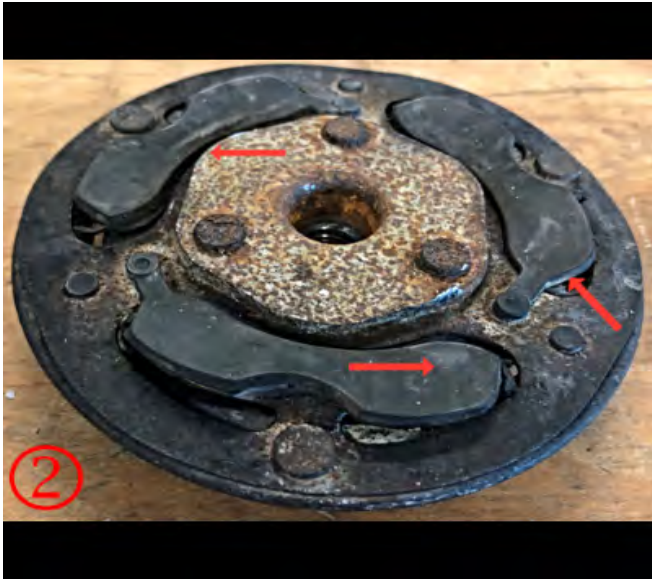
5679447

- 1.2. Check the clutch hub for signs of the rubber being torn/separated (1) (Malibu ONLY (RPOs LFV, LTG)) and/or signs of melted rubber (2) (XT4 and Malibu (RPO L3T)) shown in the pictures above.
- 1.3. Attempt to manually rotate the hub/shaft near the center bolt. If the hub/shaft rotates freely and there are no signs of cracks or damage to the hub, proceed to step 2.
- 1.4. If the hub/shaft does not rotate or the compressor is seized, replace the A/C compressor and oil balancing then proceed to step 2. Refer to *Air Conditioning Compressor Replacement* and *Air Conditioning Compressor Oil Balancing* in SI.

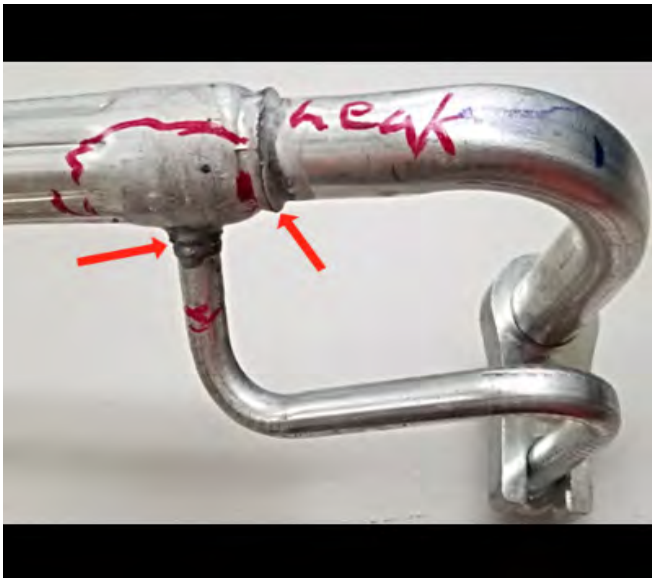
5679468

- 2.1. Inspect the Internal Heat Exchanger (IHX) welds for signs of cracks (XT4 and Malibu) as shown in the picture above.

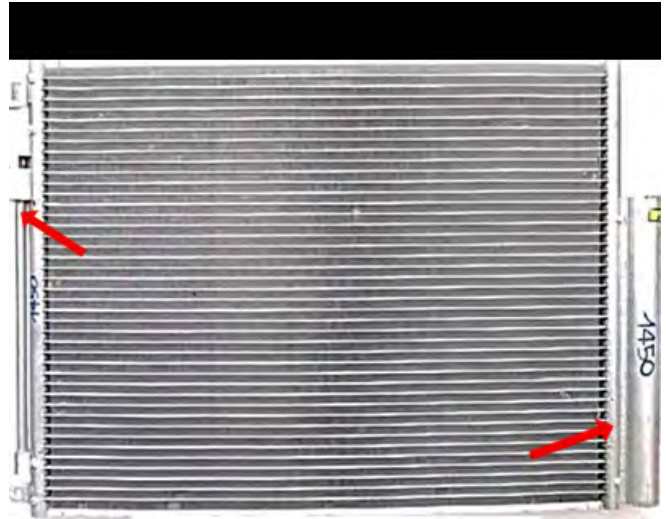
5679469

- 2.2. Inspect the condenser, including the receiver and dehydrator cap, and also inspect for any signs of brazed joints and connections (XT4 and Malibu) as shown in the picture above.

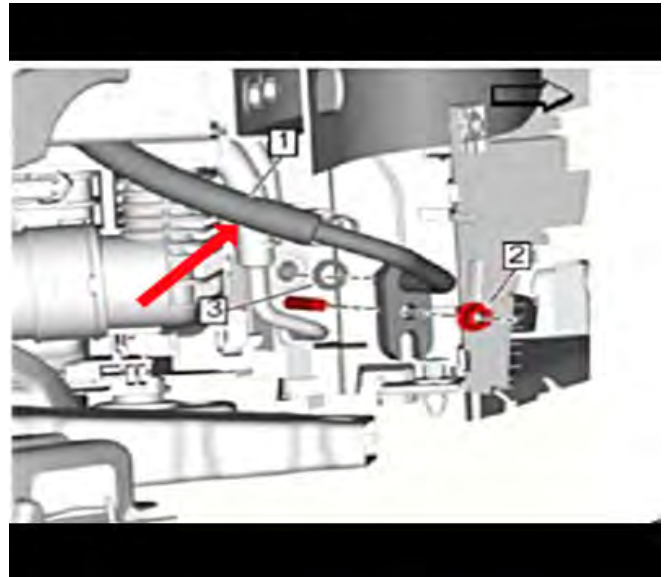
5679479

- 2.3. Inspect the A/C compressor hose to see if the hose is rubbing against the fan shroud and exhaust manifold (Malibu ONLY) as shown in the picture above.
- 2.4. If leaks are not found at these areas, continue leak testing the rest of the A/C system. Refer to *Leak Testing (R-1234yf)* diagnostic found in the HVAC section in SI.
