Service Bulletin

Bulletin No.: 20-NA-238

Subject: Radio Software Version V153 Update

Brand:	Model:	Model Year:		VIN:		Engine:	Transmission:
		from	to	from	to		
Cadillac	CT4	2021	2021	—	—	—	—
	CT5						
Chevrolet	Suburban	2021	2021				
	Tahoe						
GMC	Yukon	2021	2021				
	Yukon XL

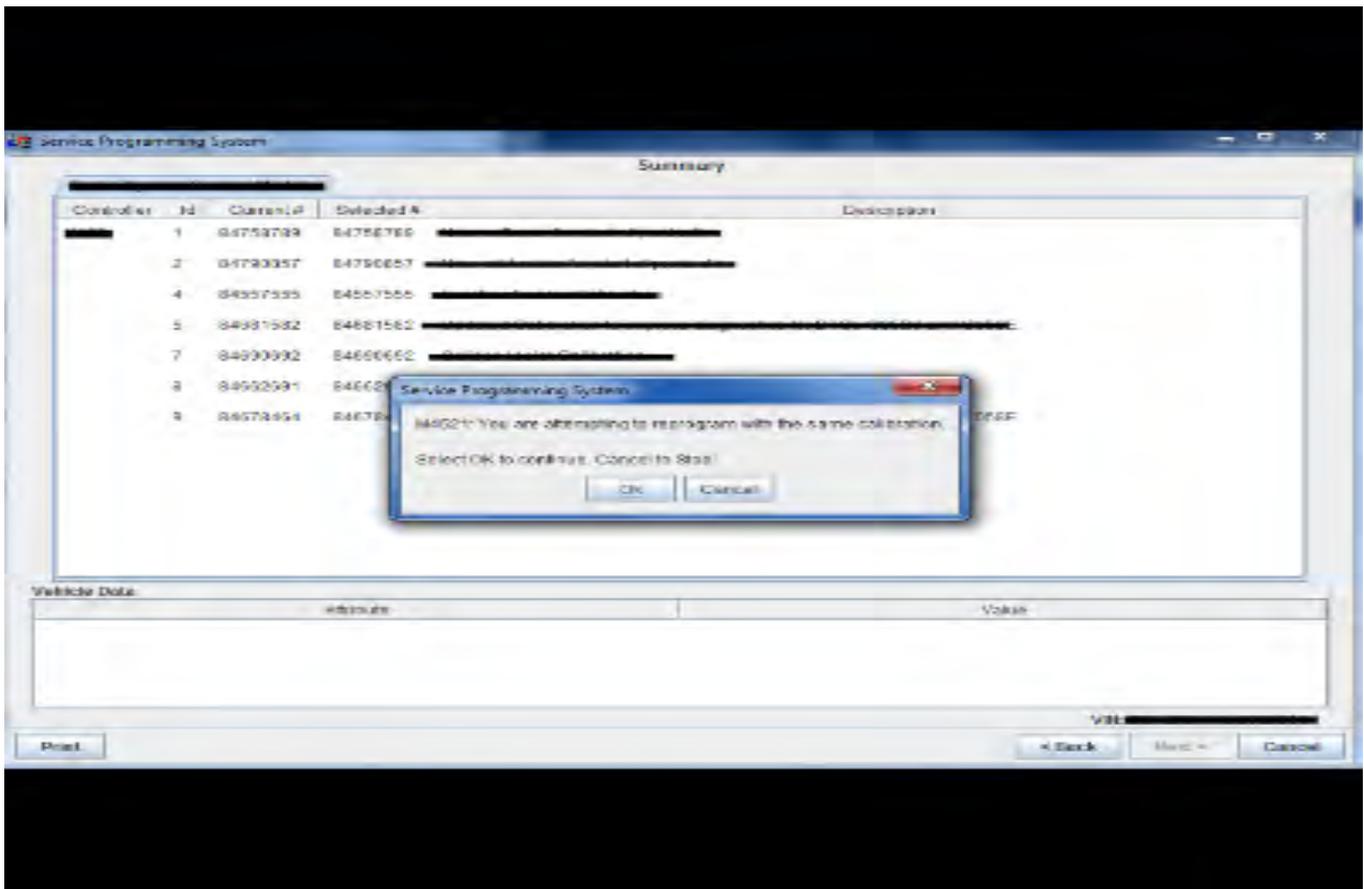
5431207

Important: Techline Connect and TIS2WEB screens shown above.

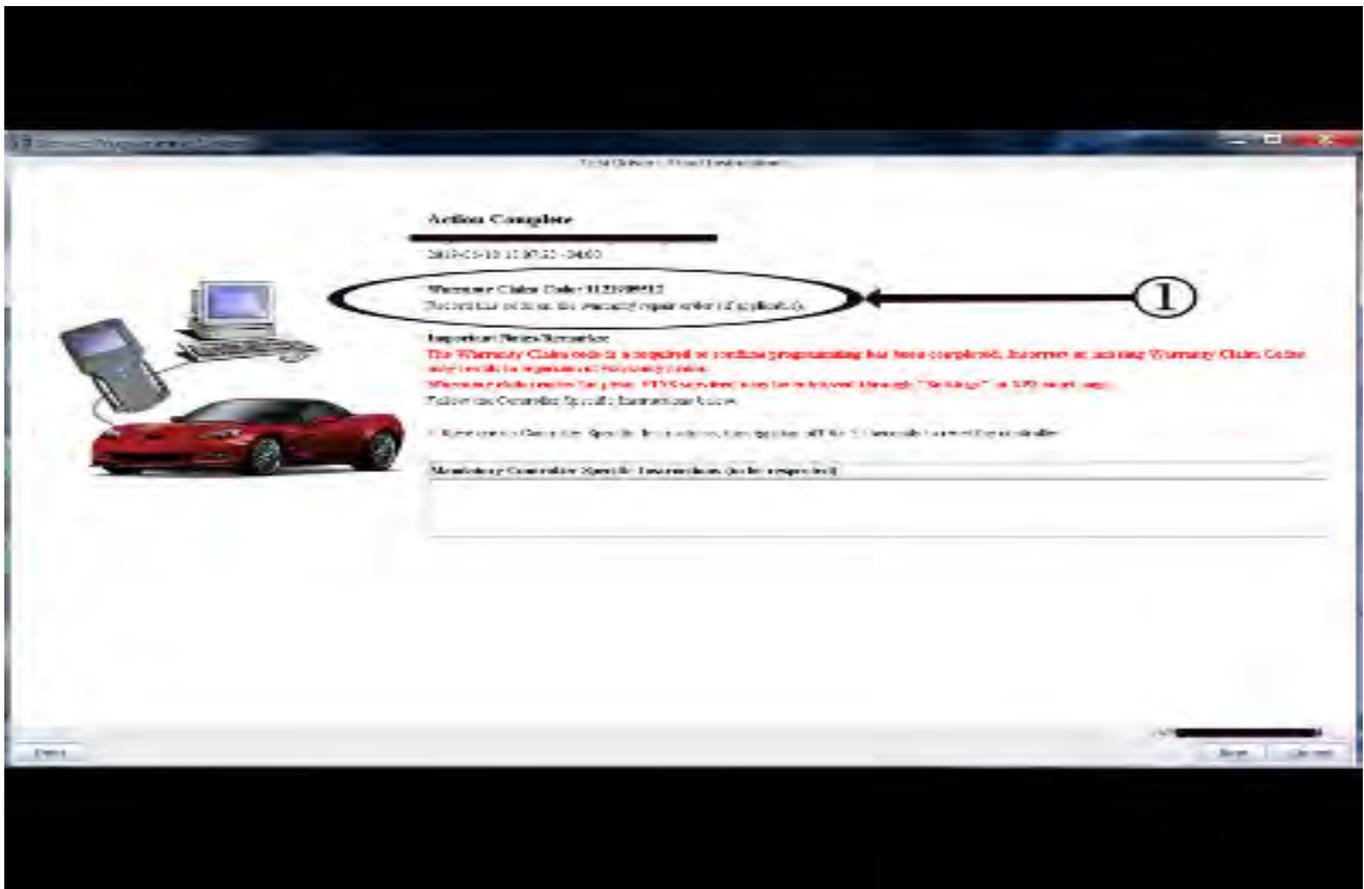
5431209

Note: The screenshots above are an example of module programming and may not be indicative of the specific module that is being programmed. Module selection and VIN information have been blacked out.

Important: To avoid warranty transaction rejections, you **MUST** record the warranty claim code provided on the SPS Warranty Claim Code (WCC) screen shown above on the job card. Refer to callout 1 above for the location of the WCC on the SPS screen.

- Record the SPS Warranty Claim Code on the job card for warranty transaction submission.
