GLOBAL SAFETY FIELD INVESTIGATIONS
DCS5614
URGENT - DISTRIBUTE IMMEDIATELY

Subject: N202310850 02 - Customer Satisfaction Program
Airbag Indicator Light Intermittent
Revised Service Procedure and Part Ordering Information

Models: 2021 Cadillac Escalade, Escalade ESV
2021 Chevrolet Suburban, Tahoe
2021 GMC Yukon, Yukon XL
Equipped with Restraint System-Seat, Inflatable, Driver & Pass Frt, Frt
Seat Side, Frt Inboard Seat Side, Roof Side (RPO AYQ)

N202310850 Airbag Indicator Light Intermittent

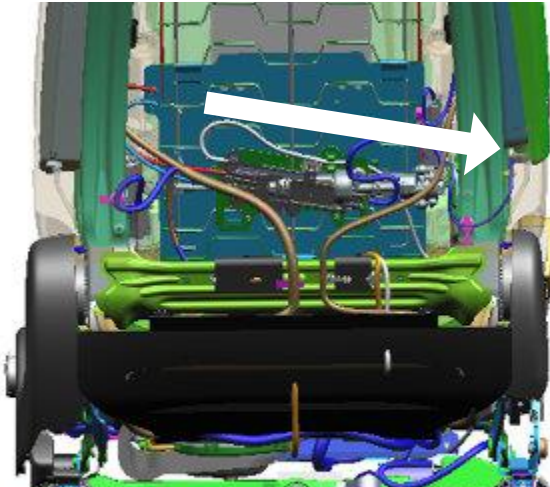
5672137

- Unzip the inboard zipper on the seat back cover.
- Disengage the lower seat cover retainers from the seat frame.

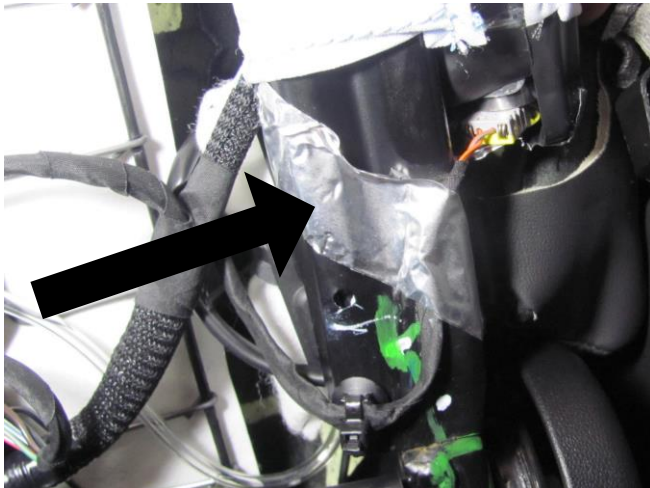
5672139

4. Disengage the two CPA's on the inboard airbag electrical connector and remove the connector from the airbag.

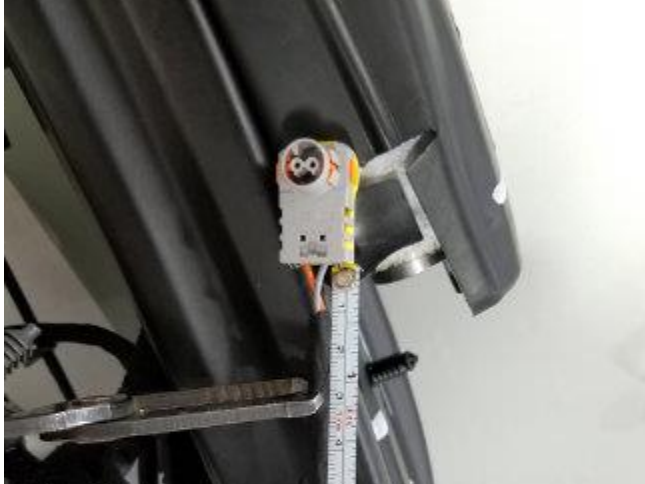
5672141

Note: There may be butyl tape over the harness and connector from a previous repair. Remove the butyl tape as necessary. Tape residue can be left on the repair area, it does not need to be completely removed.

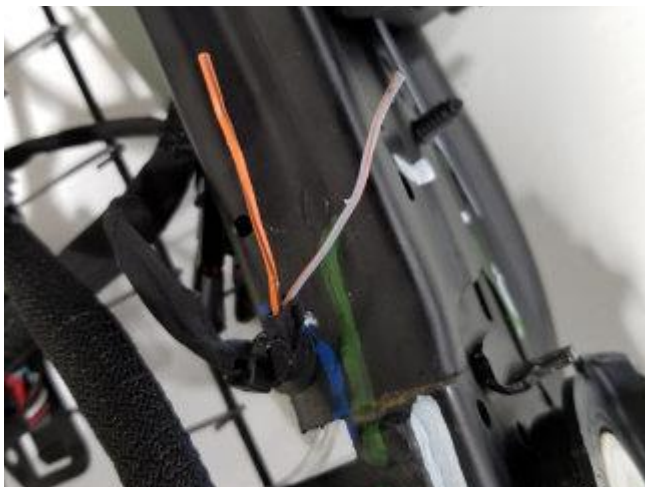
5672147

5. Measure 30 mm from the connector on the seat harness and cut the two wires at this point.

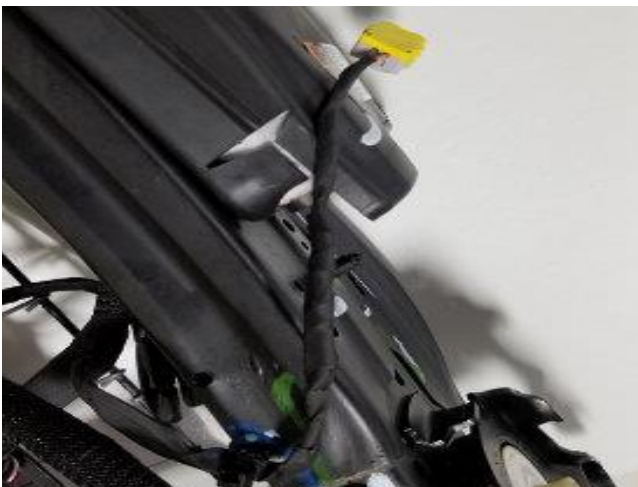
5672150

7. On the service connector, measure 80 mm from the connector and cut the two wires at this point.
8. Splice the service connector to the seat wiring harness. Refer to *Wire to Wire Repair* in SI.

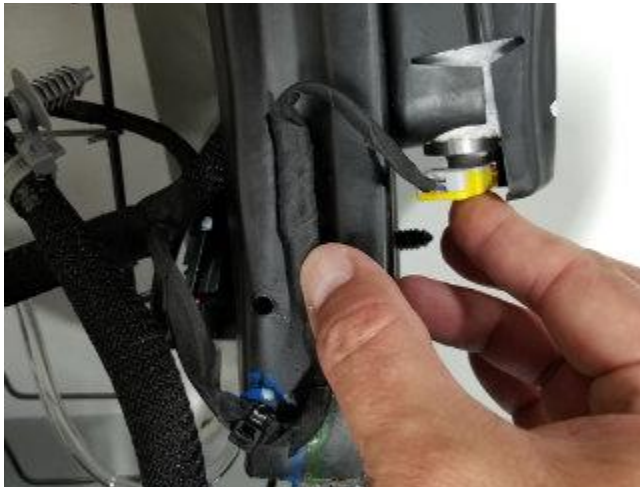
5672151

9. Using fabric anti abrasion electrical tape, rewrap the wiring harness.
10. Connect the seat side harness to the airbag. Ensure the CPA's are fully engaged.

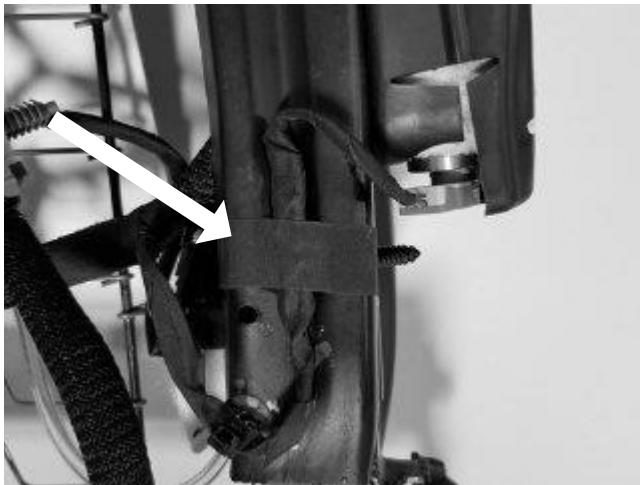
5672152

11. Position the harness into the channel on the seat frame as shown.

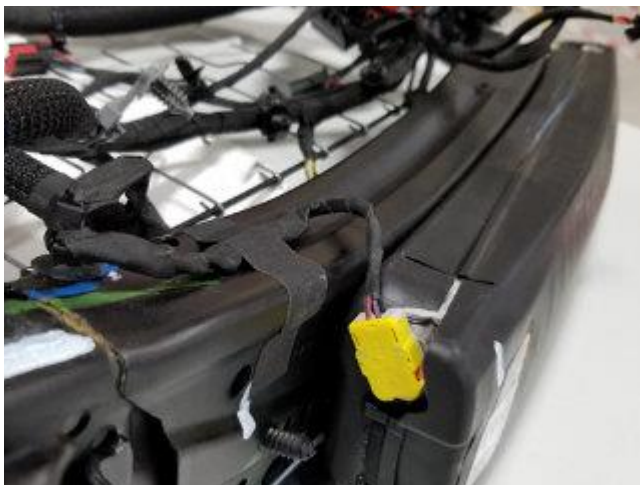
5672153

12. Secure the harness to the seat frame using fabric anti abrasion electrical tape.
