GLOBAL SAFETY FIELD INVESTIGATIONS
DCS5626
URGENT - DISTRIBUTE IMMEDIATELY

Subject: N202317060 - Emission Recall
ECM Reprogramming Datafiles Incorrect

Models: 2019 Chevrolet Silverado
2019 GMC Sierra
Equipped with 6.6L, 8-cylinder engine (RPO L5P)

Product Emission Recall

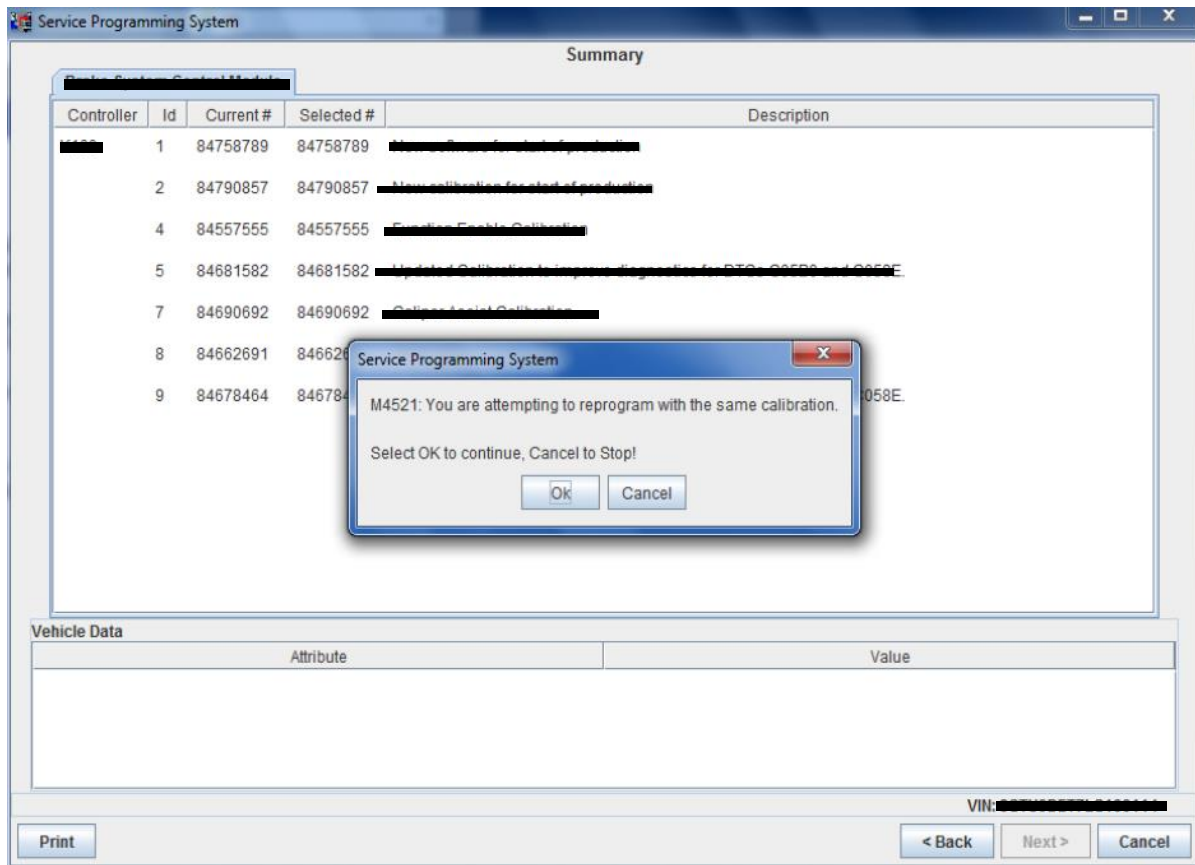
5431207

Important: Techline Connect and TIS2WEB screens shown above.

Important: If the same calibration/software warning is noted on the TLC or SPS Summary screen, select OK and follow screen instructions. After a successful programming event, the WCC is located in the Service Programming System dialogue box of the SPS Summary screen. No further action is required. Refer to the Warranty section of the bulletin.

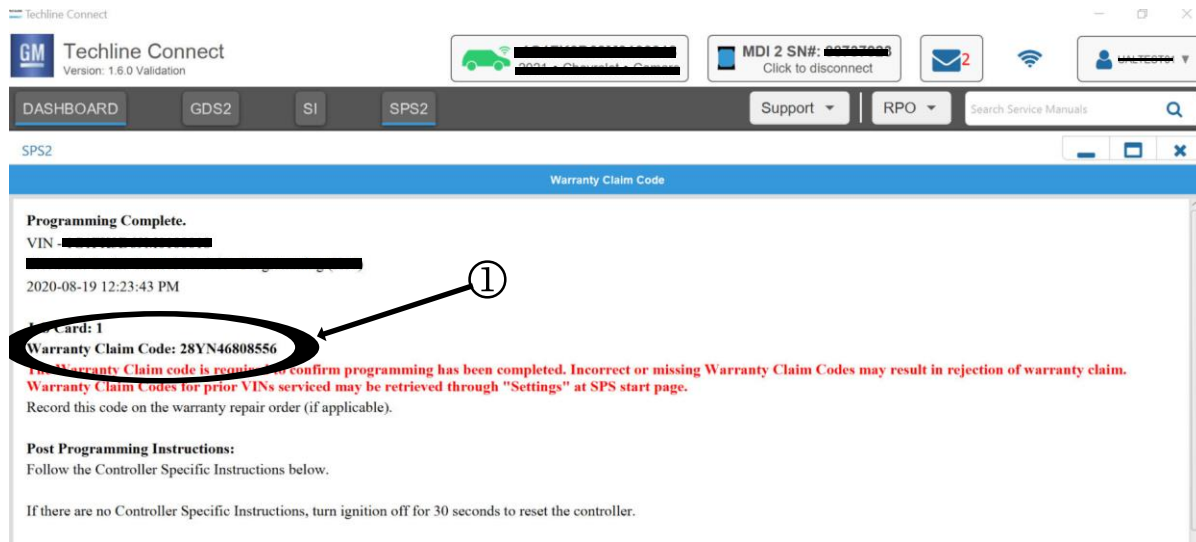
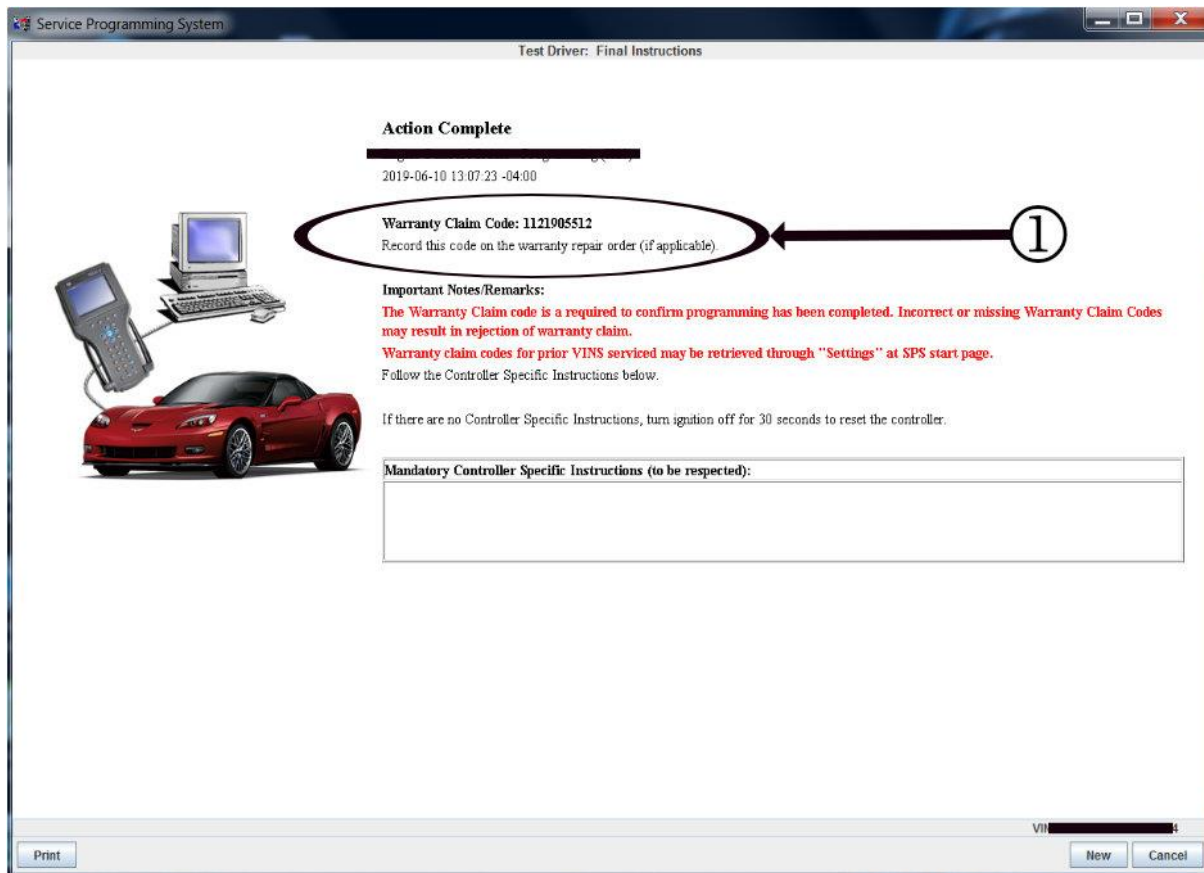
Note: The screenshots above are an example of module programming and may not be indicative of the specific module that is being programmed. Module selection and VIN information have been blacked out.

Important: To avoid warranty transaction rejections, you MUST record the warranty claim code provided on the Warranty Claim Code (WCC) screen shown above on the job card. Refer to callout 1 above for the location of the WCC on the screen.

- Record SPS Warranty Claim Code on job card for warranty transaction submission.
