## **Customer Satisfaction Notification W85 Radio Connected Services**

**2020 (BV) Jeep® Renegade**

*NOTE: This campaign applies only to the above vehicles equipped with TBM (Sales Code RDG) and VP2 Refresh 7 radio (Sales Code UAG).*

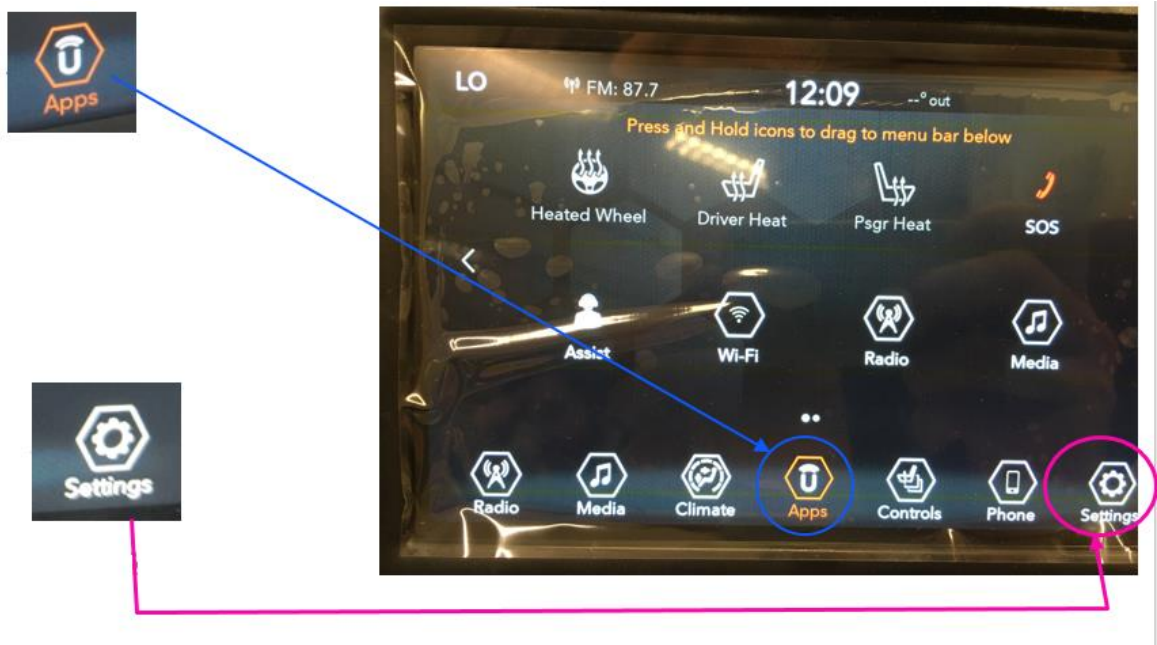
Figure 1 – Select Apps and Settings Buttons

4. Scroll through all of the screens, and verify that the "**Apps Setup**" button is NOT present.
5. Push the "**Settings**" button at the bottom of the screen (Figure 1).

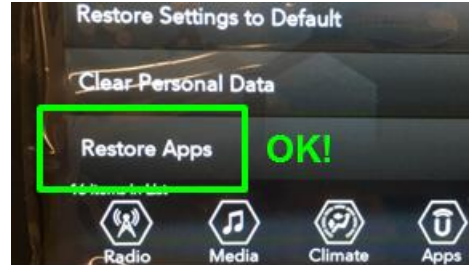
**Figure 2 – Restore Apps Setting**

6. Scroll through the list and verify that the “**Restore Apps**” setting is present (Figure 2).

7. If steps 4 and 6 are verified, the Apps are correctly installed. If not, proceed to Install the Apps.

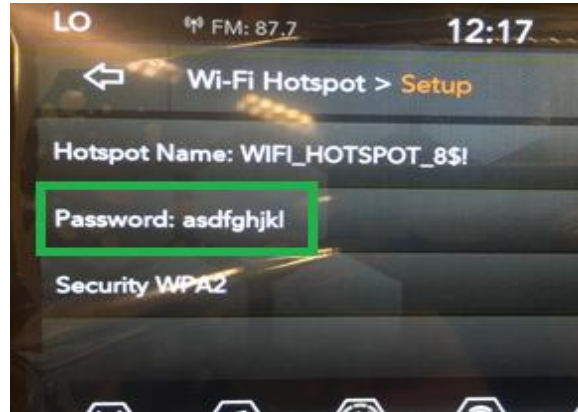
Figure 6 – Password Displayed

4. Verify that a password is displayed (Figure 6).
5. If a password is displayed, the Proxi Alignment is correct. If no password is present, perform the Proxi Alignment under Service Procedure below.
