NUMBER: 23-035-20

DATE: December 5, 2020

Active Head Restraint (AHR) Inadvertent Deployment - X92 Warranty Extension

2011 (JC) Dodge Journey
 2011 (JS) Chrysler Sebring/Avenger/Sebring Convertible

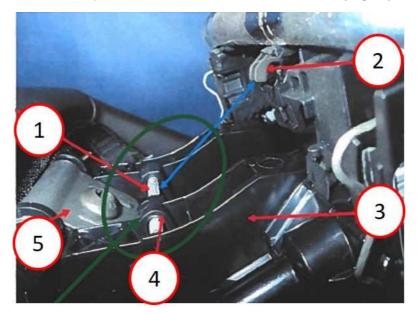
Fig. 1
Normal Deployed Position - AHR Can Be Reset

- 1 Striker Pin Correctly Attached To The Sled Bracket
- 2 Latch Pawls
- 3 Sled
- 4 Sled Bracket With Pin Attached
- 5 Tilt Clip

- 2. Is the striker pin attached to the sled bracket (Fig. 1)?
 - YES >>> This bulletin has been completed, use inspection LOP (23-20-48-9H) to close the bulletin.

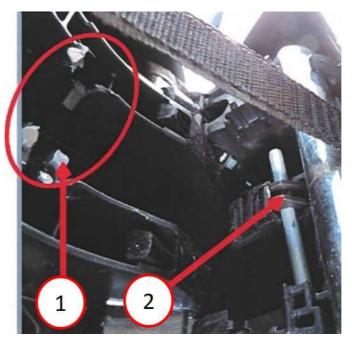
Fig. 2
Deployed AHR Has Failed And Will Not Reset

- 1 Sled Bracket Failed
- 2 Striker Pin Fastened/Locked To Latch (Will Not Reset)

• NO >>> The striker pin is locked in the AHR latch (Fig. 2) . Proceed to Step 1 of the Repair Procedure.

- 1. Replace the AHR. Refer to the detailed procedures available in DealerCONNECT > Service Library> under: 23 Body/Seats/Headrest, Front/Removal/Installation.
- 2. Cycle the ignition 'OFF' then 'ON', after performing the AHR replacement to ensure there are no DTCs set.
