NUMBER: 23-029-20 REV. A

GROUP: 23 - Body

DATE: December 5, 2020

Active Head Restraint (AHR) Inadvertent Deployment - X86 Warranty Extension

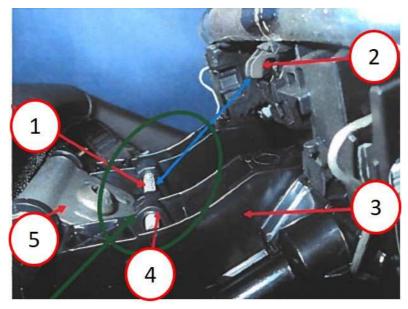
Fig. 1 Normal Deployed Position - AHR Can Be Reset

1. Verify the sled bracket striker pin is attached to the sled bracket (Fig. 1) and (Fig. 2) .

- 1 Striker Pin Correctly Attached To The Sled Bracket
- 2 Latch Pawls
- 3 Sled
- 4 Sled Bracket With Pin Attached
- 5 Tilt Clip

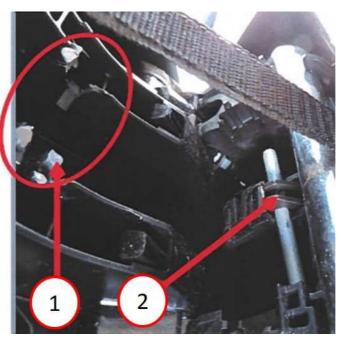
Fig. 2 Deployed AHR Has Failed And Will Not Reset

1 - Sled Bracket Failed

2 - Striker Pin Fastened/Locked To Latch (Will Not Reset)

- 2. Is the striker pin attached to the sled bracket (Fig. 1)?
  - YES >>> This bulletin has been completed, use inspection LOP (23-20-48-9E) to close the bulletin.
  - NO >>> The striker pin is locked in the AHR latch (Fig. 2). Proceed to Step 1 of the Repair Procedure.

- 1. Replace the AHR. Refer to the detailed procedures available in DealerCONNECT > Service Library> under: 23 Body/Seats/Headrest, Front/Removal/Installation.
- 2. Cycle the ignition 'OFF' then 'ON', after performing the AHR replacement to ensure there are no DTCs set.
