NUMBER: 23-036-20

GROUP: 23 - Body

Active Head Restraint (AHR) Inadvertent Deployment - X92 Warranty Extension

2011	(WD)	Dodge Durango
2011	(WK)	Jeep Grand Cherokee

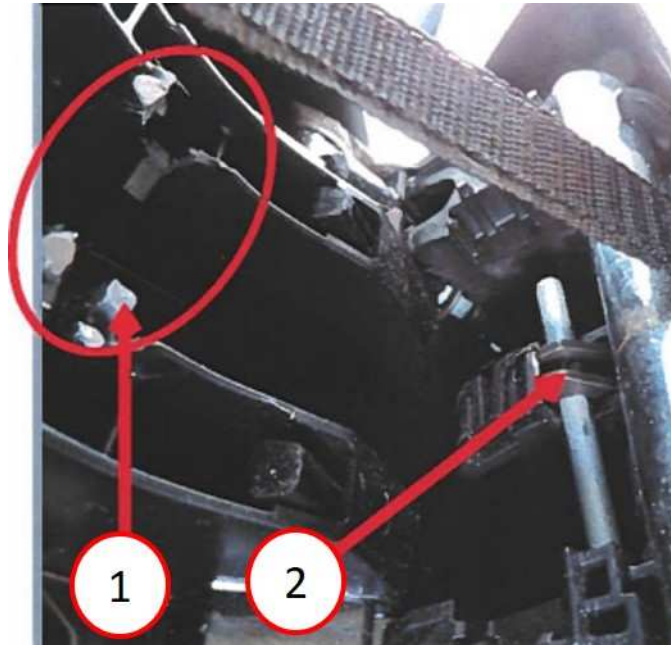
Fig. 2

Deployed AHR Has Failed And Will Not Reset

- 1 - Sled Bracket Failed
- 2 - Striker Pin Fastened/Locked To Latch (Will Not Reset)

- YES >>> This bulletin has been completed, use inspection LOP (23-20-48-98) to close the bulletin.
- NO >>> The striker pin is locked in the AHR latch (Fig. 2) . Proceed to [Step 1](#) of the Repair Procedure.

1. Replace the AHR. Refer to the detailed procedures available in DealerCONNECT > Service Library> under: 23 - Body/Seats/Headrest, Front/Removal/Installation.
2. Cycle the ignition 'OFF' then 'ON' after performing the AHR replacement to ensure there are no DTCs set.
