**NUMBER:** 23-037-20

Active Head Restraint (AHR) Inadvertent Deployment - X92 Warranty Extension

2011 (RT) Dodge Caravan/Town & Country

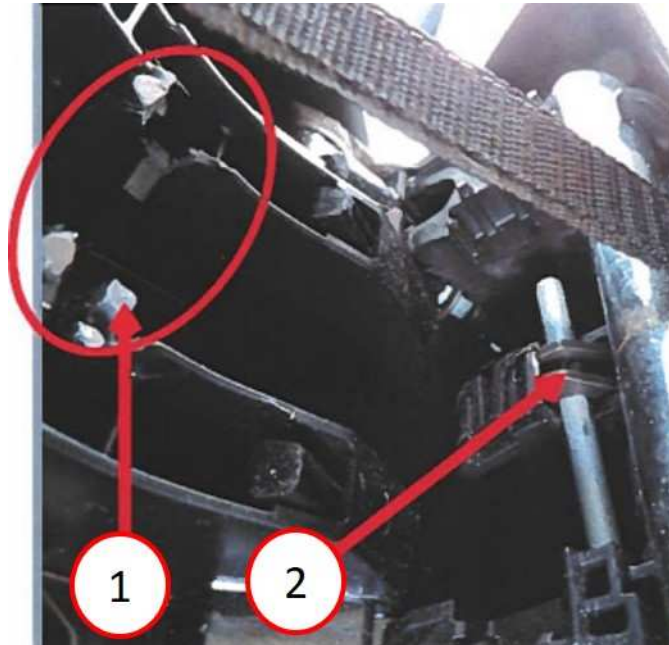
Fig. 2

**Deployed AHR Has Failed And Will Not Reset**

- 1 - Sled Bracket Failed
  - 2 - Striker Pin Fastened/Locked To Latch (**Will Not Reset**)
-

- YES >>> This bulletin has been completed, use inspection LOP (23-20-48-9B) to close the bulletin.
- NO >>> The striker pin is locked in the AHR latch (Fig. 2) . Proceed to [Step 1](#) of the Repair Procedure.

1. Replace the AHR. Refer to the detailed procedures available in DealerCONNECT > Service Library> under: 23 - Body/Seats/Headrest, Front/Removal/Installation.
2. Cycle the ignition 'OFF' then 'ON' after performing the AHR replacement to ensure there are no DTCs set.
