**NUMBER:** 14-003-20

**GROUP:** 14 - Fuel System

Fuel Fill Tube Loose or Unable to Fill Properly

2020 (DT) RAM 1500 Pickup

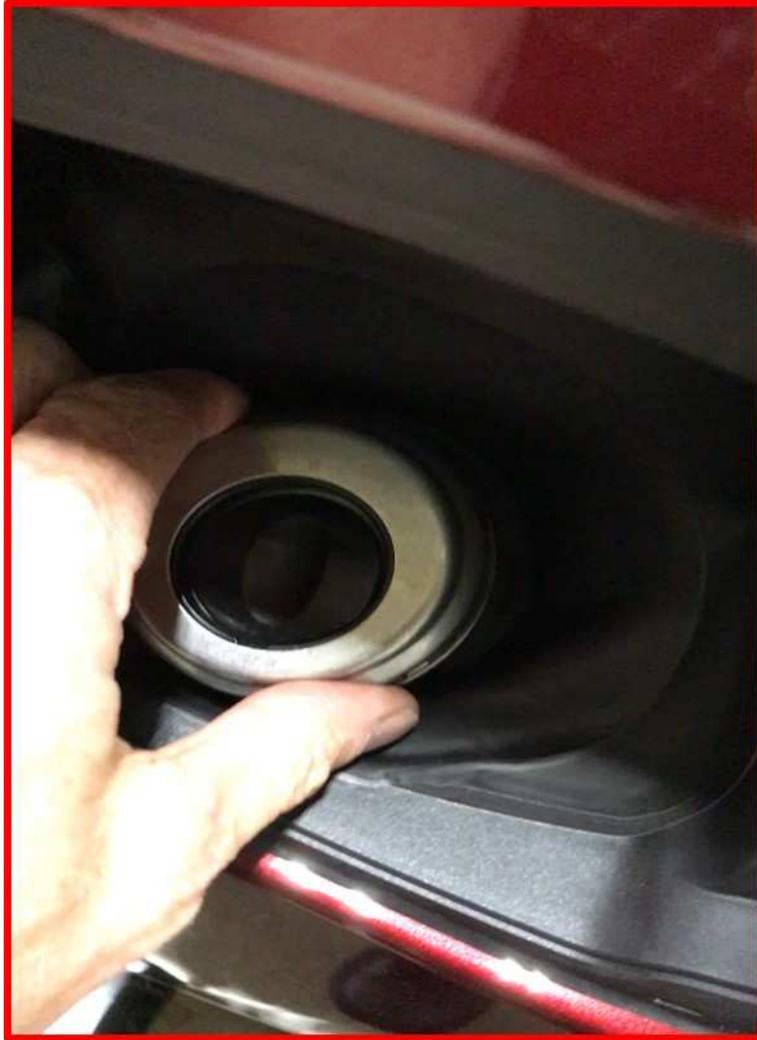
1. Does the fuel fill tube have an excessive amount of movement at the fuel fill area ([Fig. 1](#)) ?
  - YES>>> The fuel fill tube weld is broken. Proceed to [Step 1](#) of the Repair Procedure.
  - NO>>> The fuel fill tube weld is not broken. This bulletin has been completed, use inspection LOP (14-60-15-9C) to close the active RRT.

**Fig. 1**  
**Excessive Movement in the Fuel Fill Tube**

1. Remove and replace the fuel fill tube with a new part. Refer to the detailed service procedures available in DealerConnect> Service Library under: Service Info>14 - Fuel System / Fuel Delivery, Gas / Tube, Fuel Tank Filler / Removal and Installation.

**NOTE: The rubber portion between metal fill tube and fuel tank, do not need to be replaced**

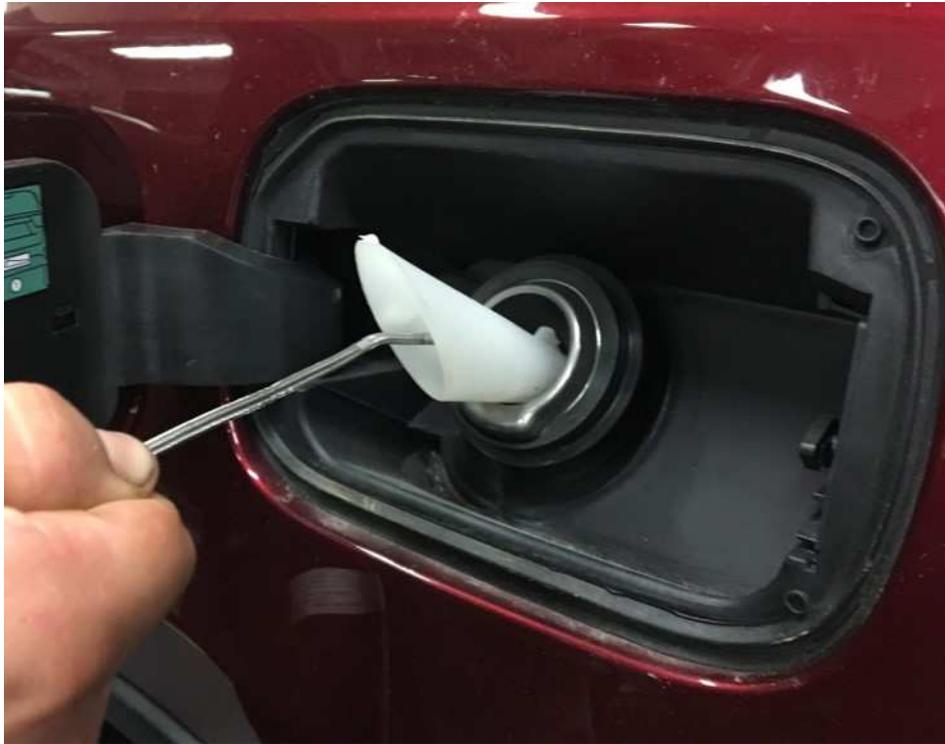
2. Is the customer complaint that vehicle is difficult to fill with fuel, fuel pump nozzle pre-maturely shuts off (before tank is full), and/or fuel spits back/spills out from the fuel fill tube?
  - YES>>> Proceed to [Step 3](#).
  - NO>>> This Bulletin does not apply. Normal diagnosis should be performed.
3. Insert a funnel into the fuel fill tube to a depth that it will opens both doors ([Fig. 2](#)) .
4. Insert a borescope line inside the funnel.
5. Look for obstruction in fuel fill tube. If any obstruction is seen, then replace the fuel fill tube. Proceed to [Step 1](#) of the Repair Procedure
6. If no obstruction is seen. This Bulletin does not apply. Normal diagnosis should be performed.

**Fig. 2**  
**Funnel Inserted into the Fuel Fill Tube**

2. Using the borescope, inspect the fuel tank inlet check valve (ICV) for any plastic pieces of nozzle guide trapped at the inlet check valve of the fuel tank. Remove any pieces of debris found.

**NOTE: Check for any pieces of debris from the flow guide nozzle - since these pieces can become lodged at the inlet valve of the fuel tank causing fill issues even if the pipe has been replaced.**
