NUMBER: 23-042-20

Headlamp Condensation and Fogging

2015 - 2017	(LA)	Dodge Challenger
2011 - 2017	(LX)	Chrysler 300

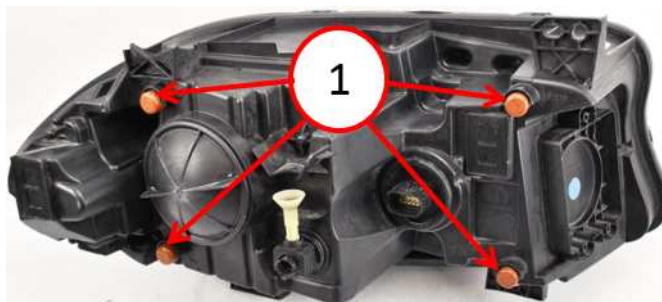
Fig. 3
Example Location Of Vent Caps - Charger

1 - Four Old Style Vent Caps

1. Remove the headlamp assembly. Refer to the detailed service procedures available in DealerCONNECT> Service Library> 8L - Lamps and Lighting / Lamps/Lighting - Exterior / Unit, Front Lamp/Removal.
2. Remove and discard the old vent caps by pulling them rearward off the headlamp assembly (Fig. 3) .

3. Install the new (brown) vent caps by pushing them on the bosses of the headlamp assembly.
4. Install the headlamp assembly. Refer to the detailed service procedures available in DealerCONNECT> Service Library>08 - Electrical/8L - Lamps and Lighting/Lamps/Lighting - Exterior/Unit, Front Lamp/Installation.
