NUMBER: 23-043-20

Headlamp Condensation and Fogging

2015 - 2020 (LD) Dodge Charger

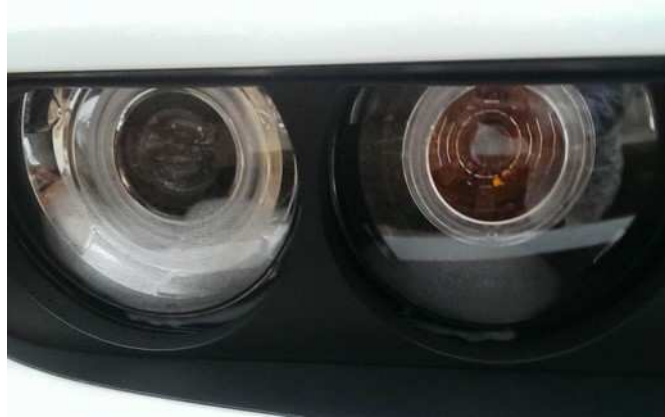
Fig. 1

NOTE: If the condensation/fogging has begun to clear from the lamp lenses after 20 minutes of lamp operation, the headlamp assembly seal is not defective and the headlamp assembly does not need to be replaced. The figures below are examples of good (Fig. 1) and faulty (Fig. 2) headlamp assemblies.

Normal Headlamp Clearing - Install Updated Closure Caps

2. Did **both** headlamp lenses start to clear (Fig. 1) ?
 - YES>>> Install the updated closure caps on the both headlamp assemblies. proceed to [Step 1](#) of the Repair Procedure.
 - NO>>> Proceed to [Step 3](#) of the Diagnosis Procedure.
3. If one headlamp assembly cleared and the other still has heavy condensation in it, only replace the updated closure cap on the assembly that cleared up. Proceed to [Step 1](#) of the Repair Procedure.

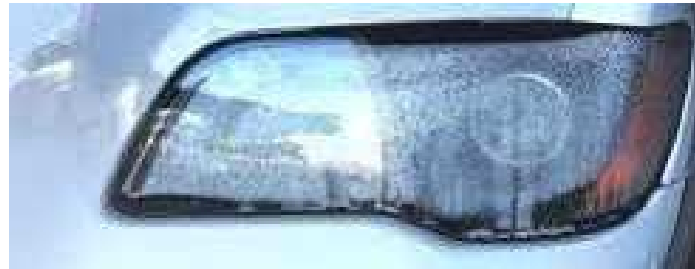
Fig. 2

Heavy Condensation With No Clearing - Replace Headlamp Assembly

NOTE: The headlamp that still has condensation with no clearing in it will need to be replaced. Use normal Service Information and normal warranty process and procedures. Replacement headlamp assemblies will already have the updated closure cap installed.

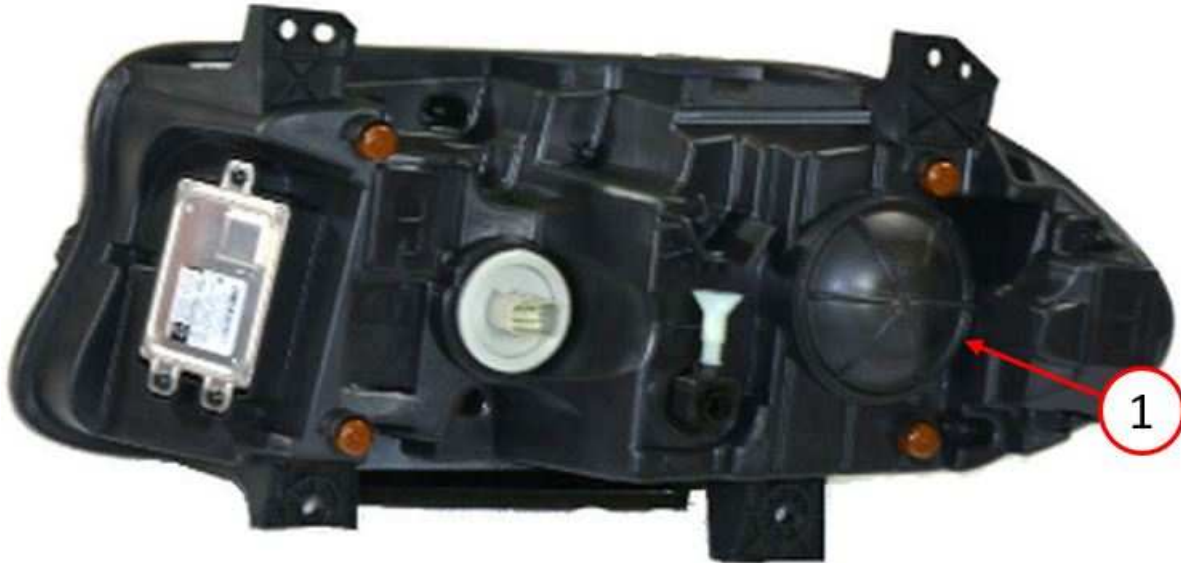
Fig. 3
Closure Cap Location

1 - Closure Cap

1. Open the Hood.
2. Remove the old closure cap(s) by turning it counterclockwise and discard (Fig. 3) .

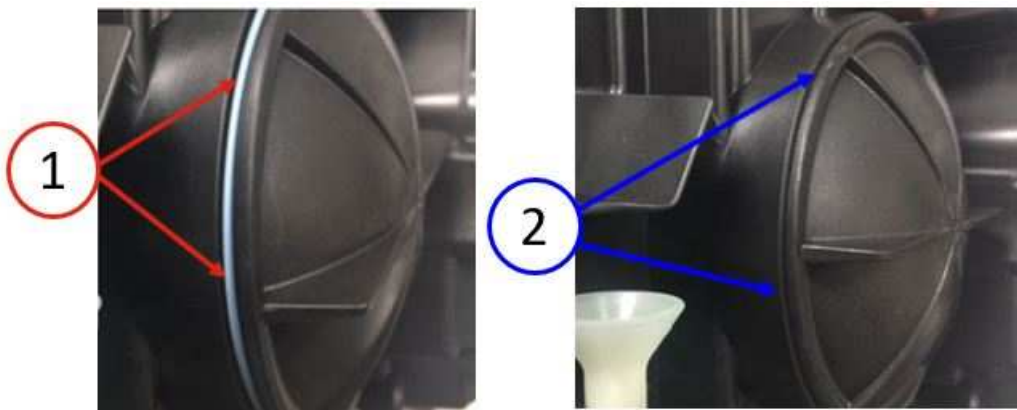
Fig. 4
Closure Cap Installed

NOTE: Make sure the Closure cap(s) are properly installed. If the seal on the cap is visible, it is not installed properly (Fig. 4) .

1 - Closure Cap Not Installed Properly

2 - Closure Cap Installed Properly

3. Install the new closure cap(s) by turning the cap clockwise. Make sure the cap is fully seated and all lugs are engaged.
