NUMBER: 08-067-20 REV. B

UGQ Radio Enhancements

2018	(BU)	Jeep Renegade
2019 - 2020	(BV)	Jeep Renegade

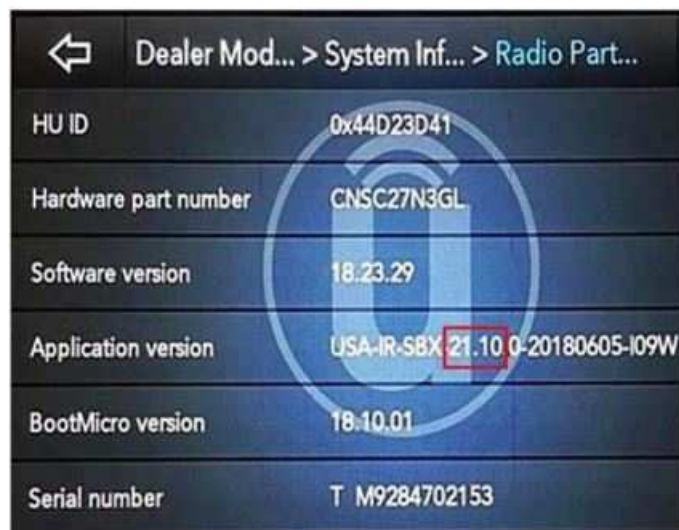
Fig. 1
Radio Software Level Screen

1. Verify the radio software version. Radio must be in Dealer Mode to verify by following these steps:
 - a. Press and hold both lower corners of the display screen, until the Dealer Mode screen appears (approximately seven seconds). Release screen.
 - b. Select "Radio Part Information". The software version will be listed next to "Application Version" (Fig. 1) .

2. What is the radio software level (Application Version) at?
 - 39.2 or higher >>> The radio software is already up to date. Normal diagnostics should be performed.
 - At or above 28.31 and under 39.2 >>> The radio will only need one USB flash drive to update the radio. Create a USB flash drive with 39.2 software. Proceed to [Step 1](#) of the Repair Procedure.

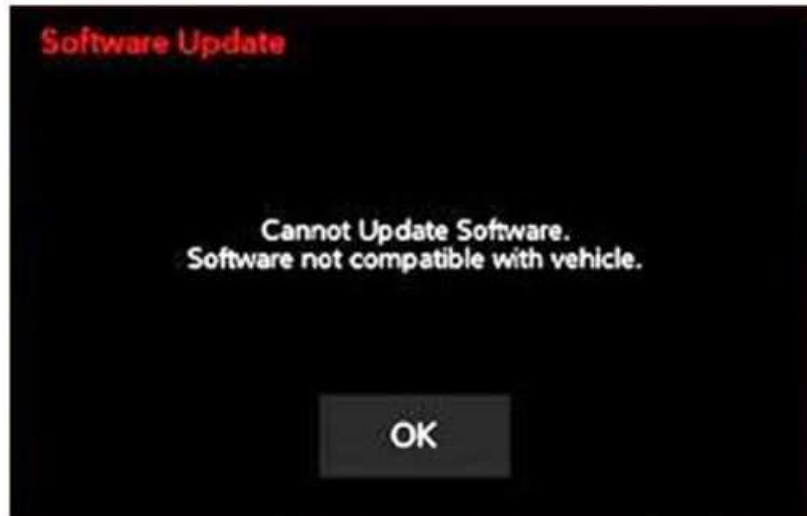
Fig. 5

Software Not Compatible Screen

11. If the screen in (Fig. 5) is displayed, the USB flash drive was not set up correctly. Use a top name brand USB flash drive, like Kingston, create a new USB flash drive and start the update again.

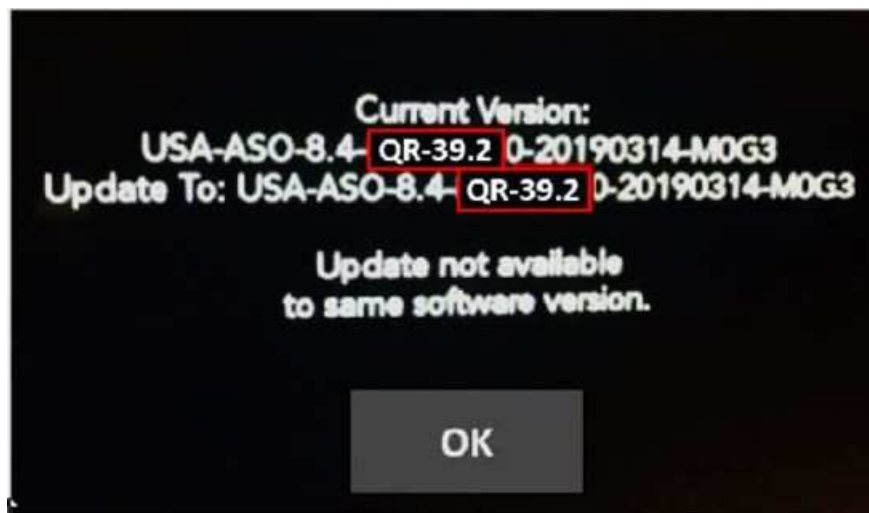
Fig. 6

Screen Displayed When Radio Software Level Is Up To Date

12. If the radio software is already up to date, the screen in (Fig. 6) will be displayed. Press "OK" and remove the USB flash drive.

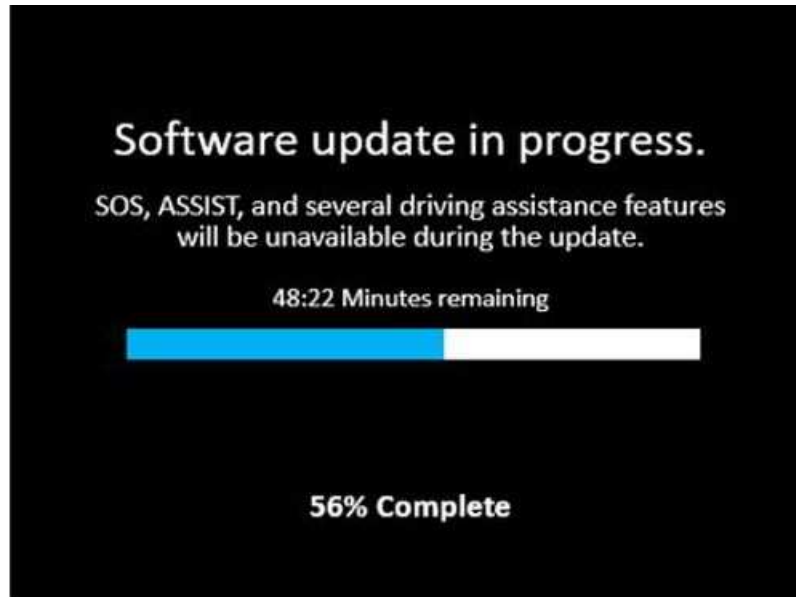
Fig. 9
Software Update In Progress

15. The radio will reboot and the update will begin. The update should only take 25 minutes, the timer on the screen may display the incorrect time remaining, (Fig. 9) .

NOTE: The completion indicator may not reach 100%, even though the software update has been completed. Once the software update has finished, the radio and display screen will turn off.

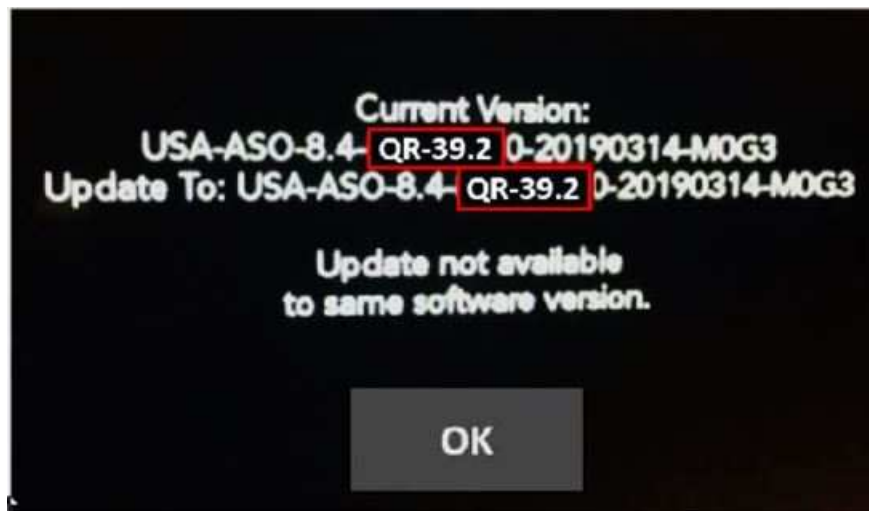
Fig. 10
Radio Software Has Been Updated

16. After the update has completed, the radio will shut down. With the USB flash drive still inserted in the USB port, cycle the ignition back to the run position. If the radio software was updated correctly the "Current Version:" and the "Update To:" software levels in (Fig. 10) will display the identical software level. Press "OK" and remove the USB flash drive.
