NUMBER: 08-068-20 REV. C

GROUP: 08 - Electrical

UGQ Radio Enhancements

Jeep Compass

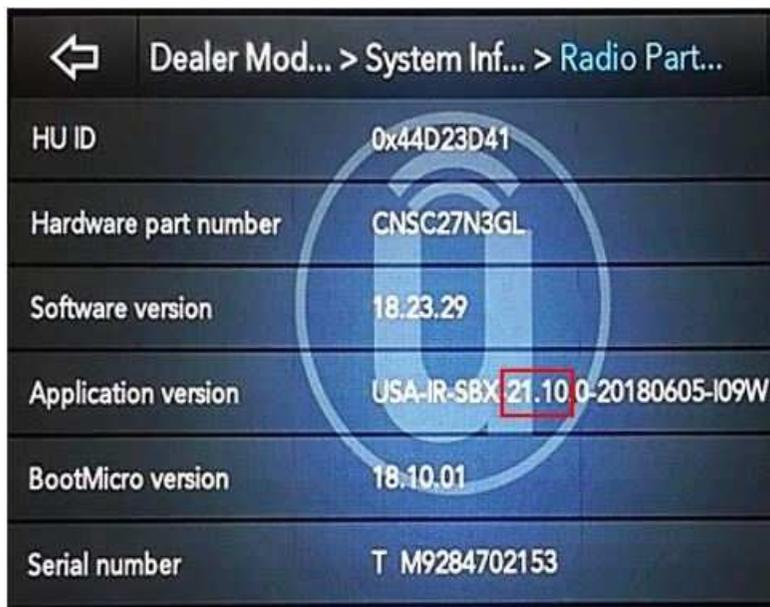
Fig. 1
Radio Software Level Screen

1. Verify the radio software version. Radio must be in Dealer Mode to verify by following these steps:
 - a. Press and hold both lower corners of the display screen, until the Dealer Mode screen appears (approximately seven seconds). Release screen.
 - b. Select "Radio Part Information". The software version will be listed next to "Application Version" (Fig. 1) .

2. What is the radio software level (Application Version) at?
 - 39.2 or higher >>> The radio software is already up to date. Normal diagnostics should be performed.
 - At or above 28.31 and under 39.2 >>> The radio will only need one USB flash drive to update the radio. Create a USB flash drive with 39.2 software. Proceed to [Step 1](#) of the Repair Procedure.

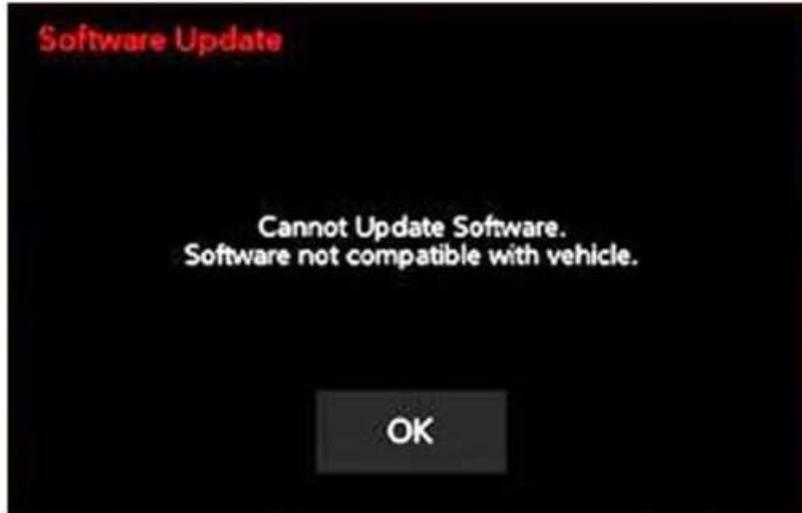
Fig. 5
Software Not Compatible Screen

11. If the screen in (Fig. 5) is displayed, the USB flash drive was not set up correctly. Use a top name brand USB flash drive, like Kingston, create a new USB flash drive and start the update again.

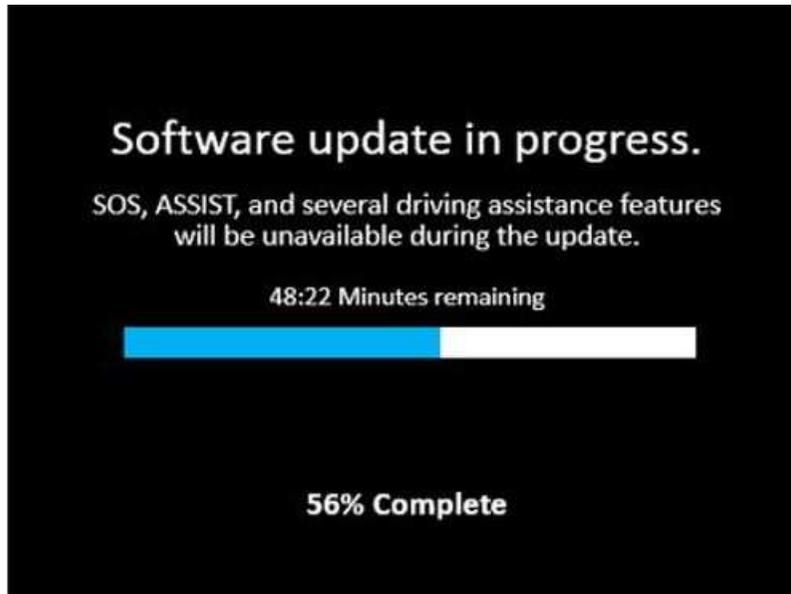
Fig. 9
Software Update In Progress

- 15. The radio will reboot and the update will begin. The update should only take 25 minutes, the timer on the screen may display the incorrect time remaining, (Fig. 9) .

NOTE: The completion indicator may not reach 100%, even though the software update has been completed. Once the software update has finished, the radio and display screen will turn off.

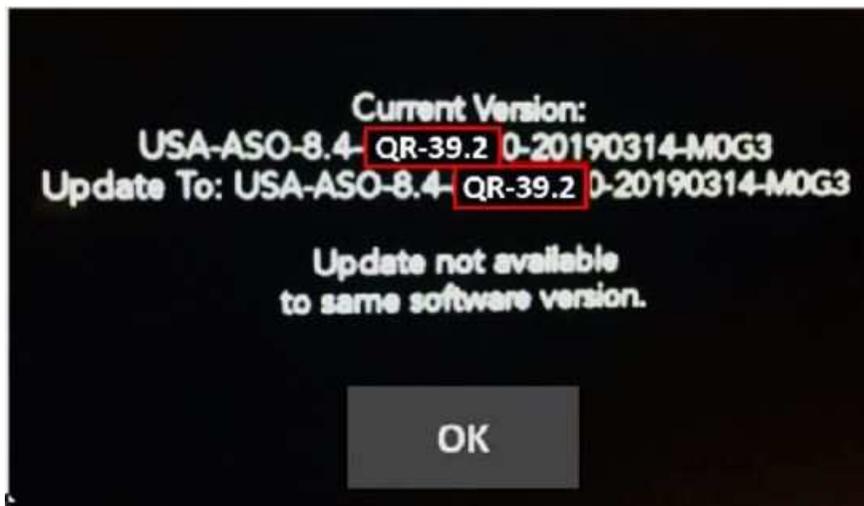
Fig. 10
Radio Software Has Been Updated

- 16. After the update has completed, the radio will shut down. With the USB flash drive still inserted in the USB port, cycle the ignition back to the run position. If the radio software was updated correctly the "Current Version:" and the "Update To:" software levels in (Fig. 10) will display the identical software level. Press "OK" and remove the USB flash drive.
