NUMBER: 08-108-20

GROUP: 08 - Electrical

UDQ Radio Enhancements

2018 (MP) Jeep Compass

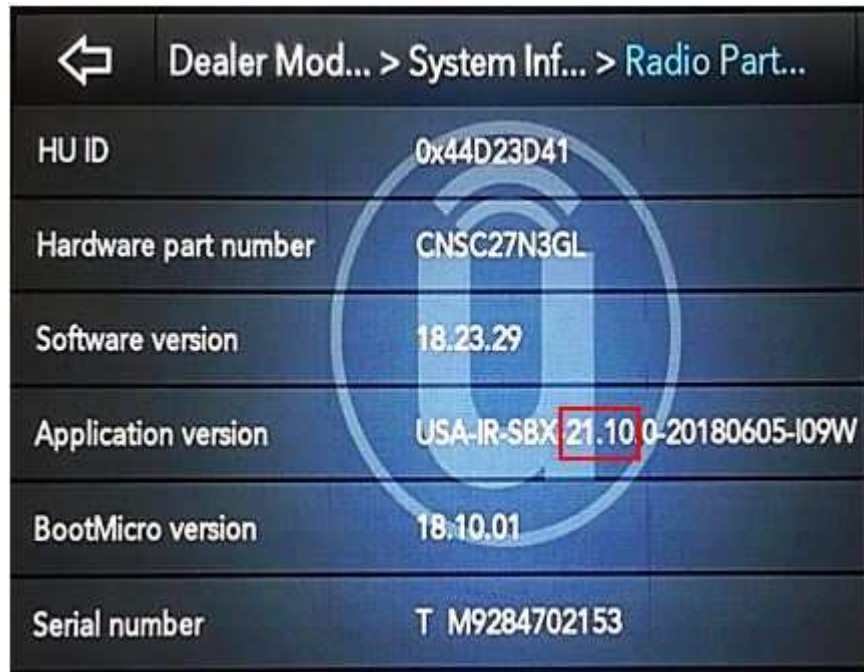
Fig. 1

Radio Software Level Screen

1. Verify the radio software version. Radio must be in Dealer Mode to verify. To put the radio in Dealer Mode, follow these steps:
 - a. Press and hold both lower corners of the display screen, until the Dealer Mode screen appears (approximately seven seconds). Release buttons.
 - b. Select "Radio Part Information". The software level will be listed next to "Application Version" (Fig. 1) .

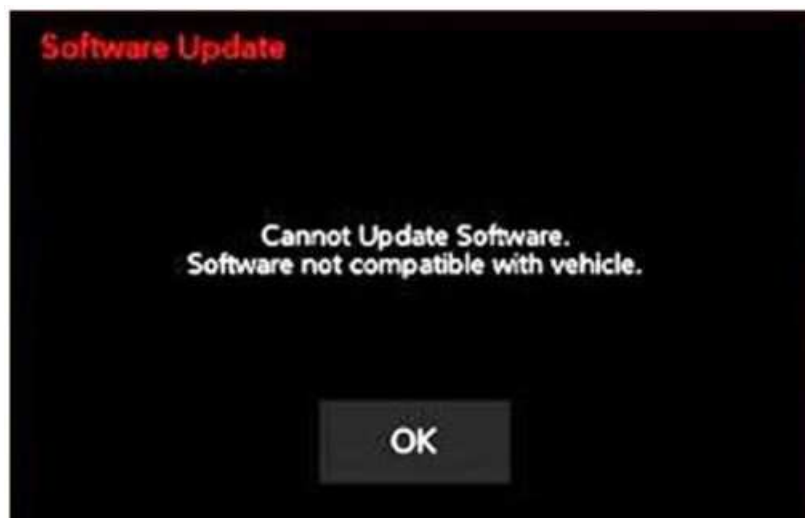
Fig. 5
Software Not Compatible

10. If the screen in (Fig. 5) is displayed, the USB flash drive was not set up correctly. Use a top name brand USB flash drive and create a new USB flash drive. Start the update again.

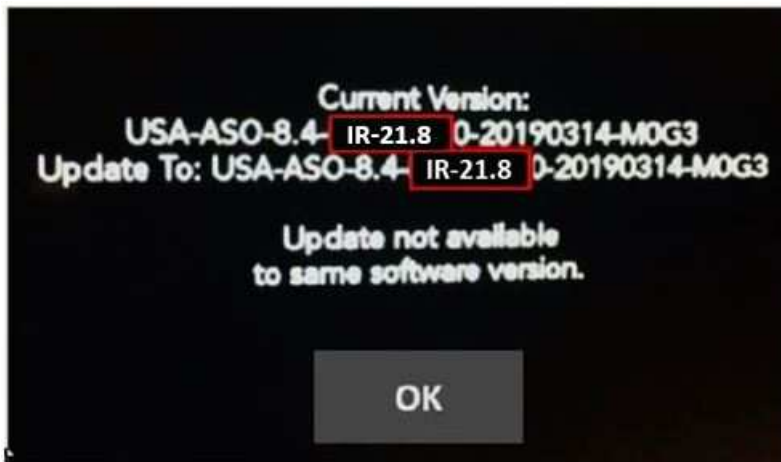
Fig. 6
Screen Displayed When Radio Software Level Is Up To Date

11. If the radio software is up to date, the screen in (Fig. 6) will be displayed. Press “OK” and remove the USB flash drive.

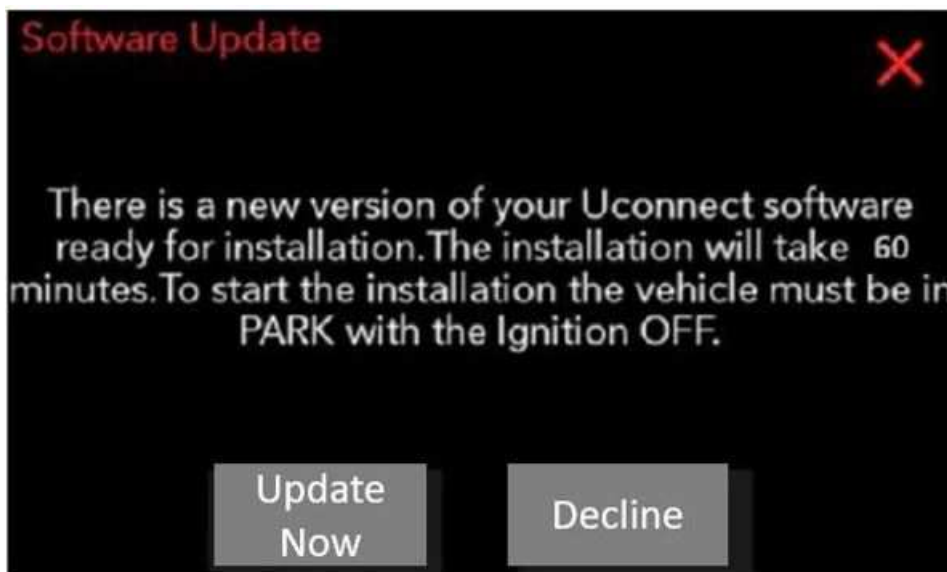
Fig. 7
Software Update Is Available

12. Once the system has verified there is an available update, press the “Update Now” button. Make sure the vehicle is in park. **Do NOT turn off the ignition, (Fig. 7) .**

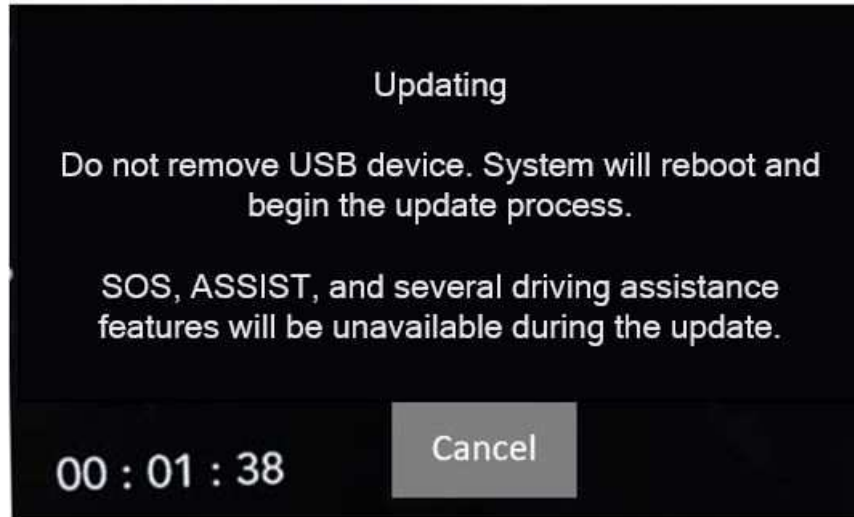
Fig. 8
Radio Update Process Begins

13. When the radio starts updating, the screen in (Fig. 8) will be displayed.

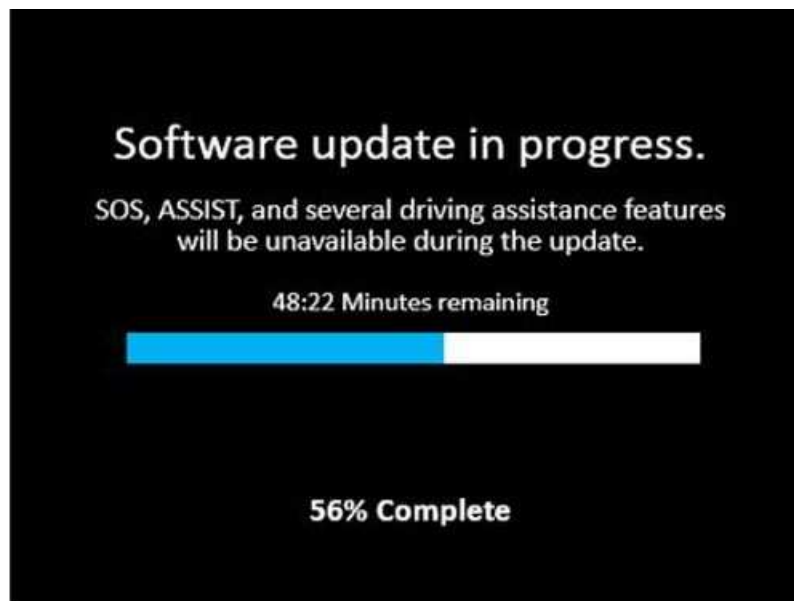
14. The radio will reboot and the update will begin. The update should only take 50 minutes, the timer on the screen may display the incorrect time remaining, (Fig. 9) .

Fig. 9
Software Update In Progress

NOTE: The completion indicator may not reach 100%, even though the software update has been completed. Once the software update has finished, the radio and display screen will turn off.

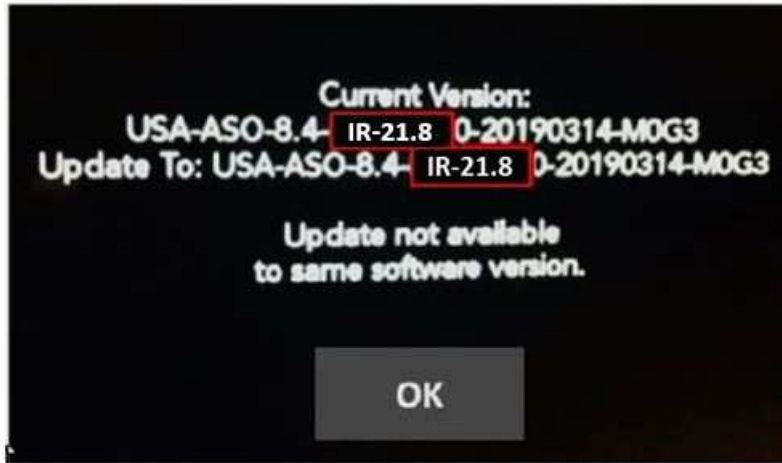
Fig. 10

Radio Software Has Been Updated.

15. After the update has completed, the radio will shut down. With the USB flash drive still inserted in the USB port, turn the ignition back to the run position. If the radio has been updated correctly, the screen in (Fig. 10) will be displayed. Press "OK" and remove the USB flash drive.
