NUMBER: 09-014-20

DATE: December 22, 2020

Transmission Oil Cooler Line Not Fully Connected

2020 - 2021 (DT) RAM 1500 Pickup

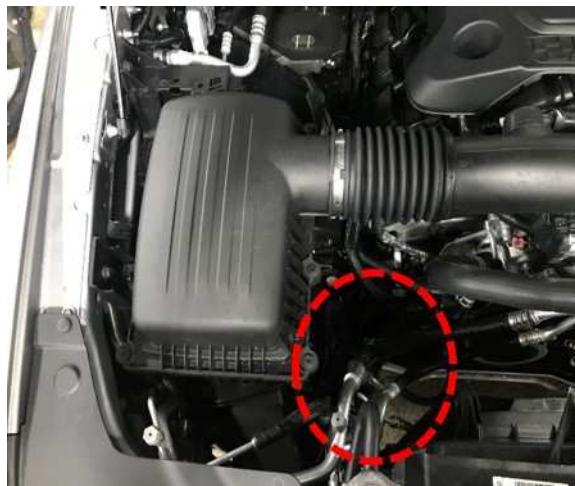
Fig. 1

1. Inspect the TOC lines by pulling on lines to see if they come loose and separate the connection (Fig. 1) .

Transmission Oil Cooler Line (Shown Not Connected)

1. Align the TOC Line and slide into fitting .
2. Press on the tube until a 'click' is heard or felt.

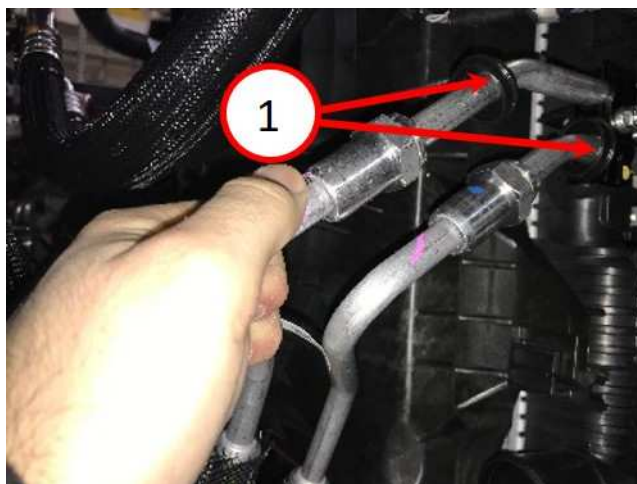
Fig. 2
Pull On TOC Lines

2. The black assurance caps (Fig. 2) need to be pulled back to inspect for painted area. If yellow paint can be seen on the tube, this is an indication that the tube is not seated completely into the fitting.

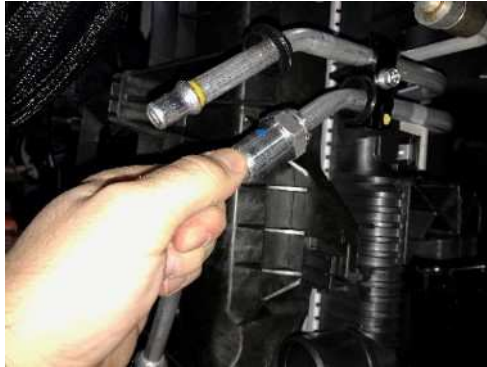
NOTE: The yellow paint bead will disappear into the fitting when tube is properly installed into quick connect (Fig. 3) .

**Fig. 3****Transmission Oil Cooler Line (Connected)**

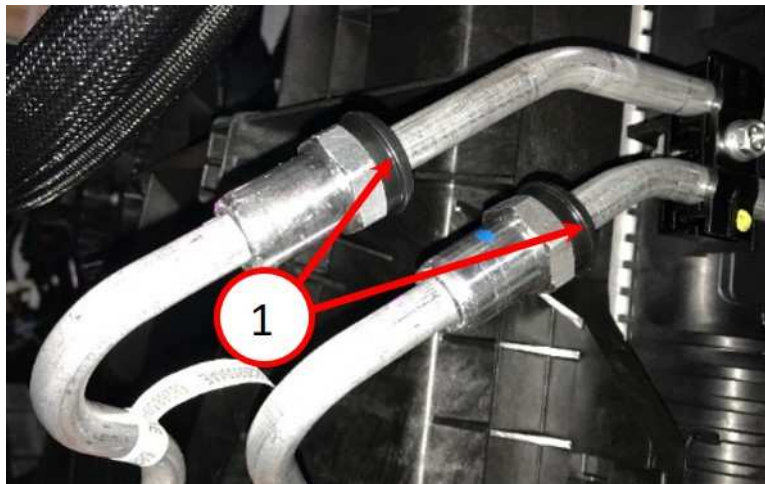
**Fig. 4****Assurance Cap (In Place)**

3. Slide the assurance caps down the tube and snap the cap over the fitting. Listen or feel for a "snap" or "click" as the cap engages with the fitting (Fig. 4) .
