NUMBER: 23-003-20 REV. A

GROUP: 23 - Body

Driver Side Seat Trim Panel Replacement

2019 - 2020 (M6) Jeep Compass

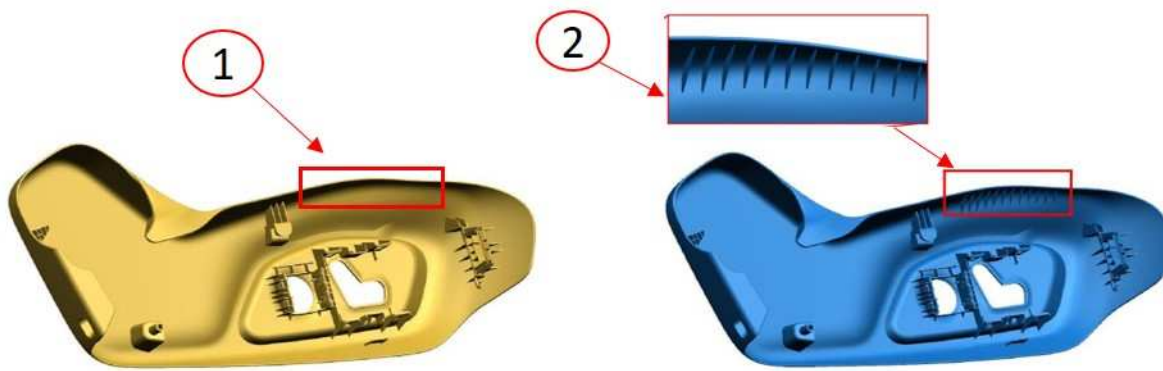
Fig. 5
Trim Piece Difference

- 1 - Old Design
- 2 - New Design

6. Discard the old trim piece, then verify that the new trim piece has the reinforced design (Fig. 5) .
